Individual Station Report

Fairfield

Connecticut Department of Transportation

CONDITION INSPECTION
FOR THE
FAIRFIELD STATION

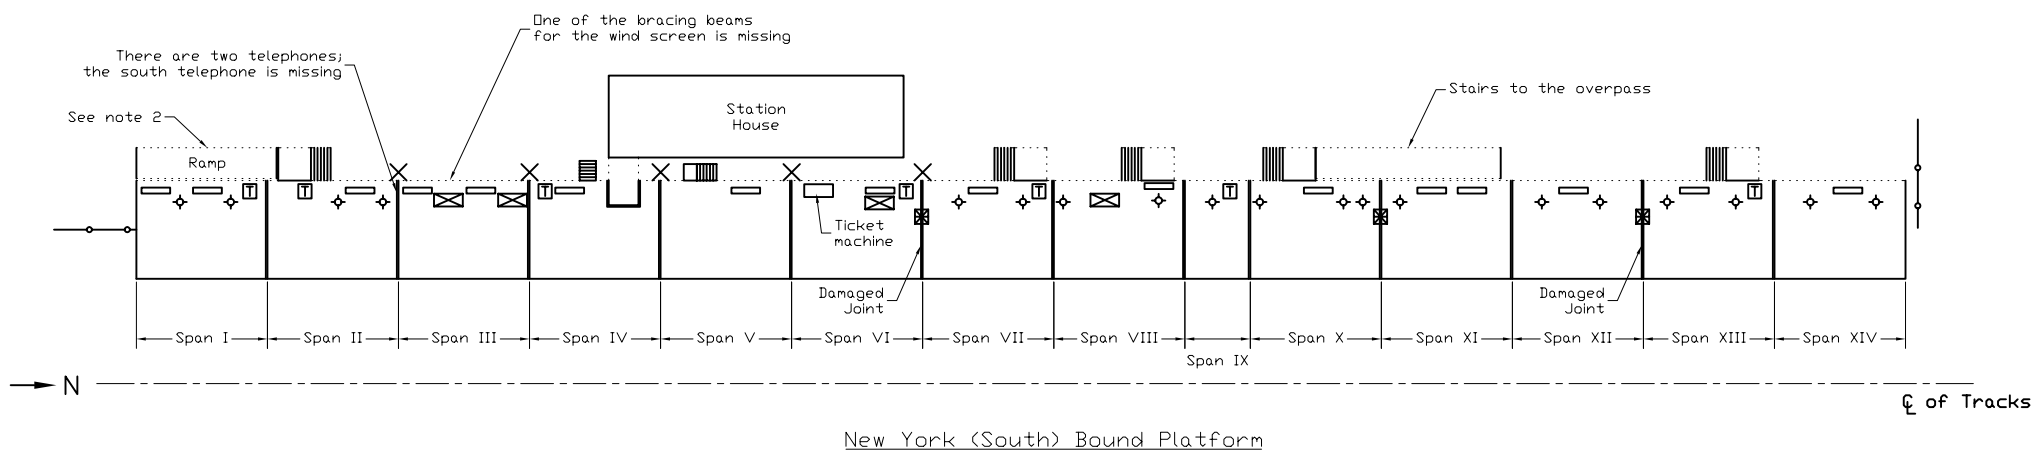
New Haven (North) Bound Platform

- NOTES:
1. The railings on the New Haven Bound and New York Bound platforms are bent throughout the length of the platform.
 2. The railing base plates for the ramps on the New York bound and New Haven bound platforms are rusted (12 plates per ramp).

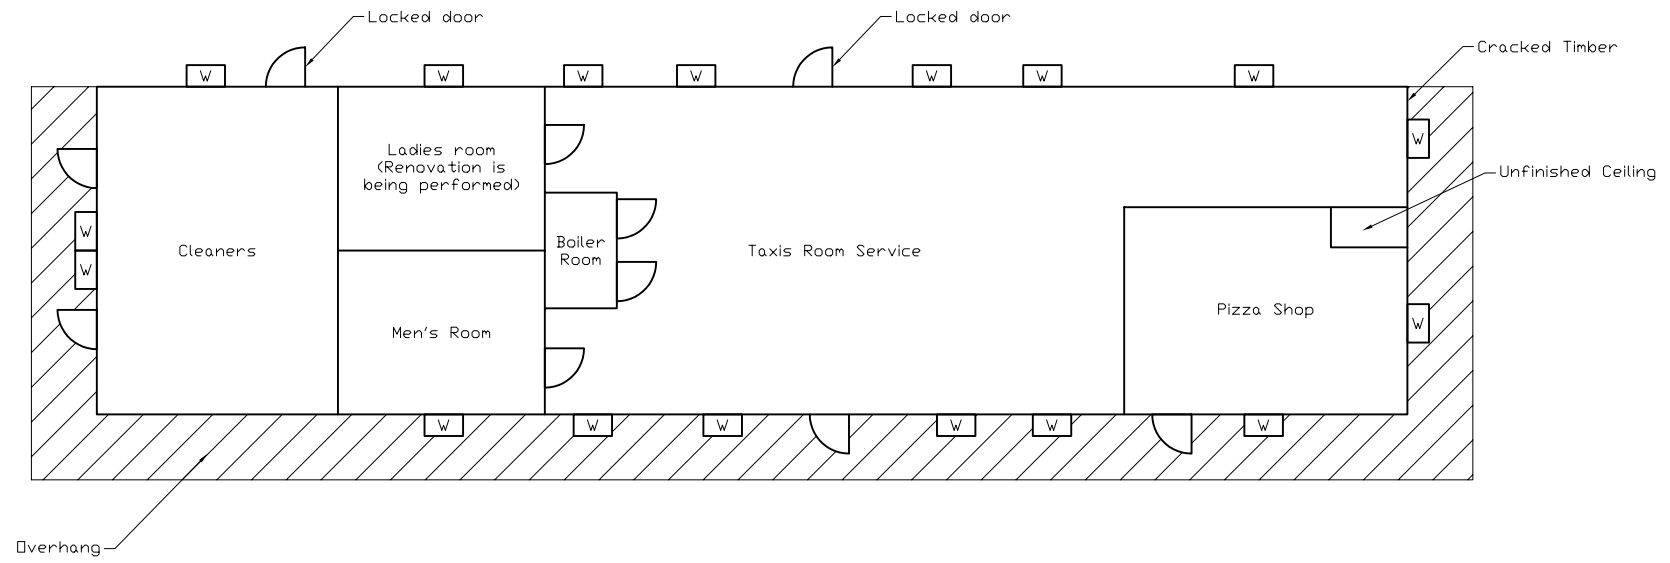
Urbitran Associates, Inc.
Connecticut Dept. of Transportation
New Haven Bound Station House Plan
Date: 7/16/02

- 1. The roof's overhang contains chipped paint (30%).
- 2. 8% of the brick facade is missing, broken, contains holes, or missing mortar.

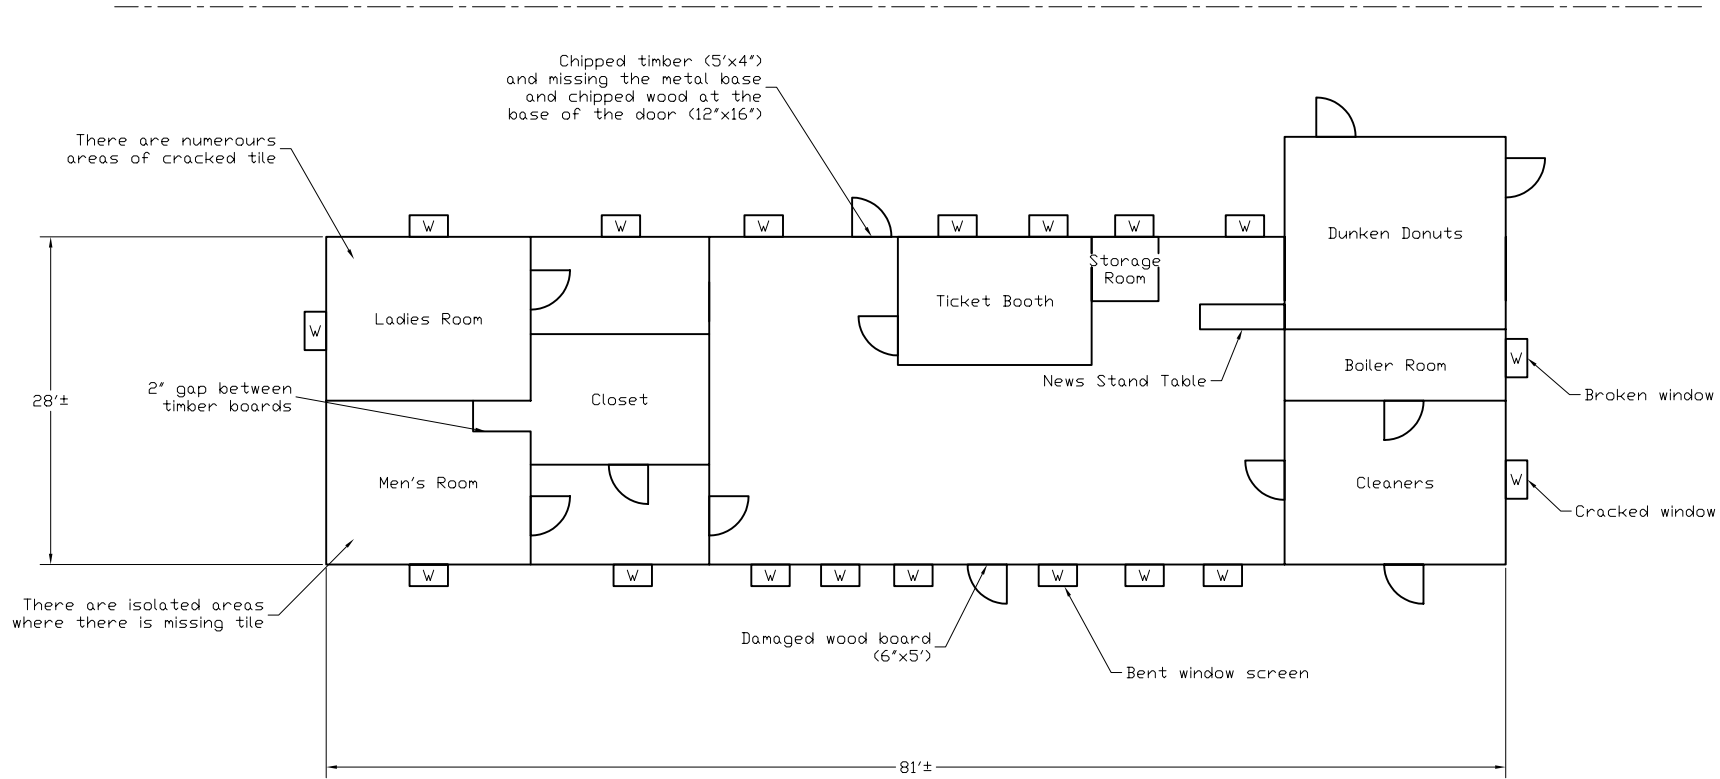
Urbitran Associates, Inc.
Connecticut Dept. of Transportation
New York Bound Station House Plan
Date: 7/16/02

1. Missing roofing material (1'x42') along the west side.
2. Missing roof board (1'x6") along the west side.
3. As told by the station building maintenance, they are going to fix the roofing; Maybe they will install new gutters.
4. Minor damage to the timber molding with chipped paint (17'x2') along the south elevation.
5. The west and east side windows are missing screws that attach the window screen and window frame.

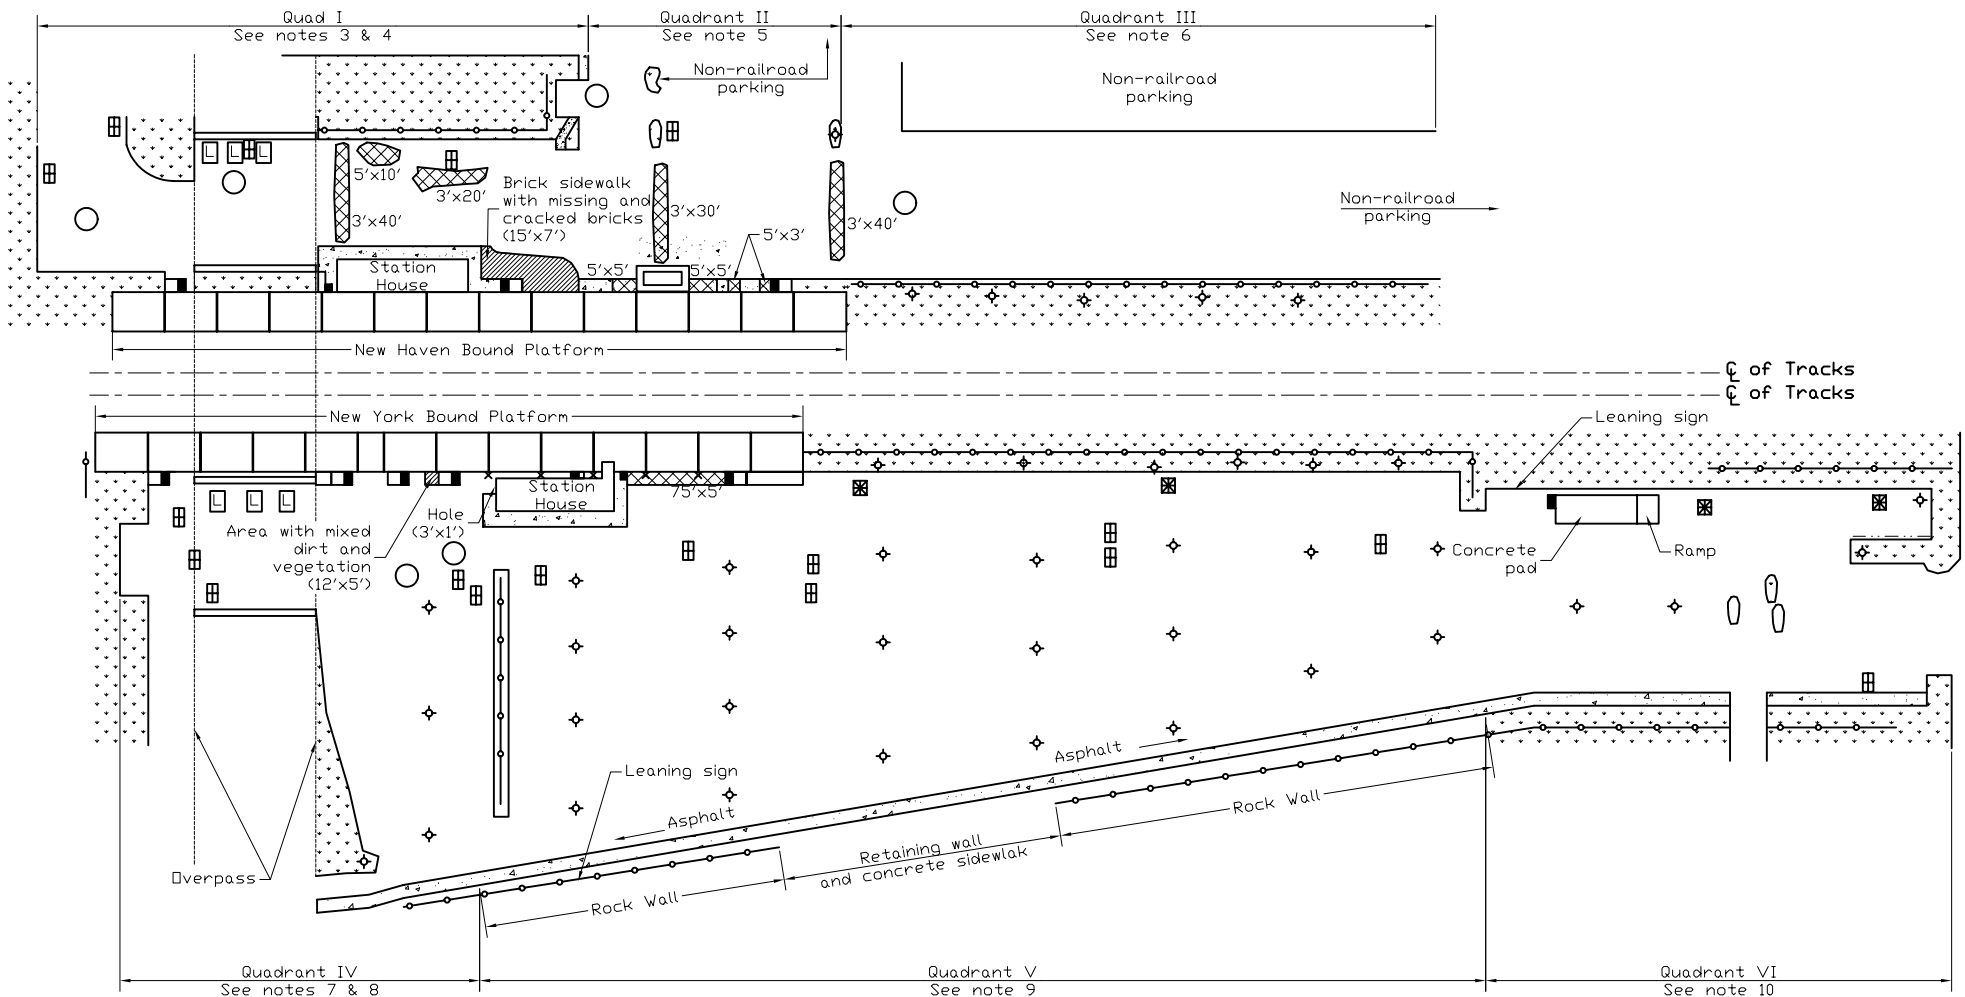
- NOTES:
1. All of the train power line foundations are rusted and deteriorated.
 2. All of the fences are rusted, bent, or damaged (1500').
 3. Quadrant I contains 100' of asphalt cracks.
 4. Quadrant I contains 10' of missing, spalled, or cracked asphalt curb.
 5. Quadrant II contains 500' of asphalt cracks.
 6. Quadrant III contains 200' of asphalt cracks.
 7. Quadrant IV contains 200' of asphalt cracks.
 8. Quadrant IV contains 10' of missing, spalled, or cracked asphalt curb.
 9. Quadrant V contains 1000' of asphalt cracks.
 10. Quadrant VI contains 500' of asphalt cracks.
