Individual Station Report

Riverside

Connecticut Department of Transportation

Urbitran Associates, Inc.

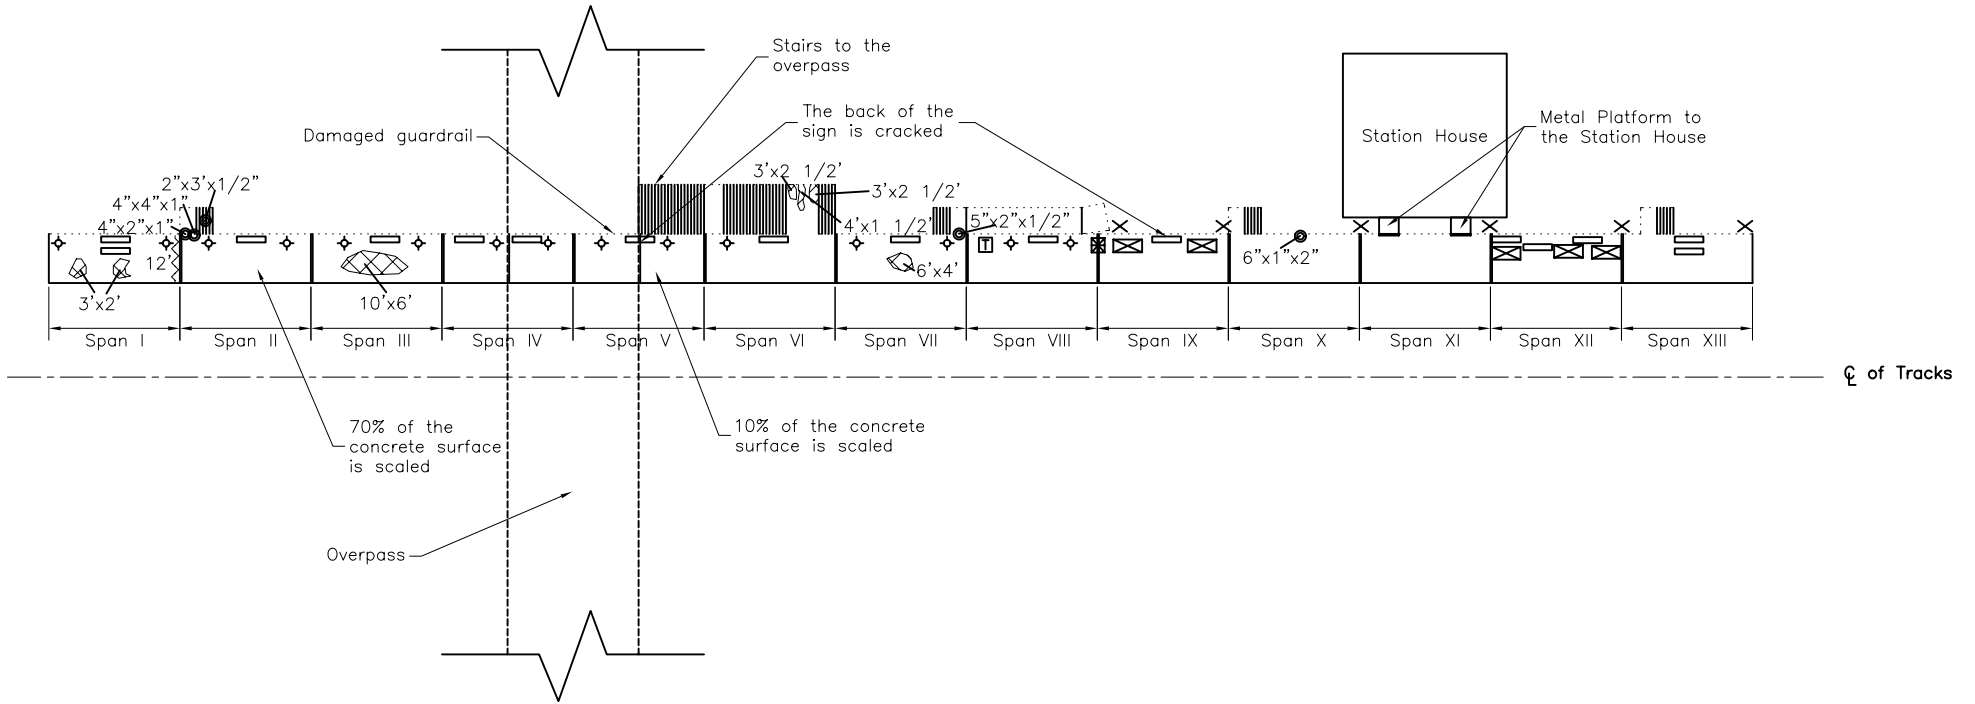
Urbitran Associates, Inc.
Connecticut Dept. of Transportation
Riverside Station West Platform (Southbound) Plan
Date: 3/5/02

70% of the concrete surface is scaled

10% of the concrete surface is scaled

1. The canopy roof (metal decking) in Spans IX–XIII are rusted, deteriorated and contain holes.
2. The base plates for the double tees are typically rusted.

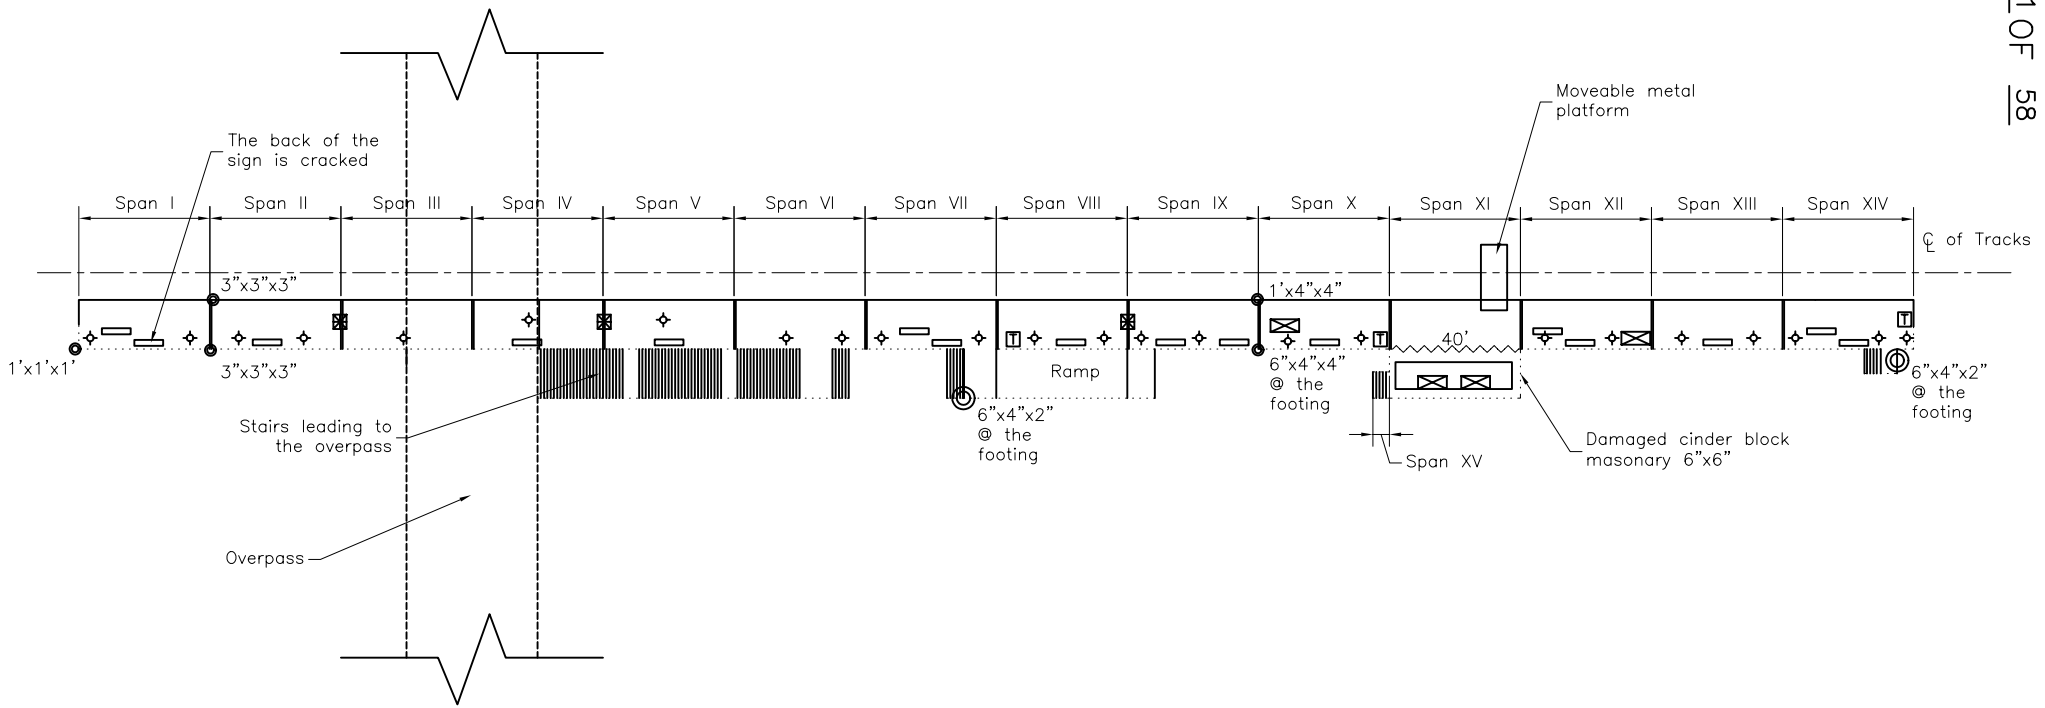
Urbitran Associates, Inc.
Connecticut Dept. of Transportation
Riverside Station East Platform (Northbound) Plan
Date: 3/5/02

1. The base plates for the double tees are typically rusted.
2. The pedestrian railing is bent in Span I, IX, XI, and XII.
3. The train's power line foundations are typically spalled, rusted, and deteriorated.

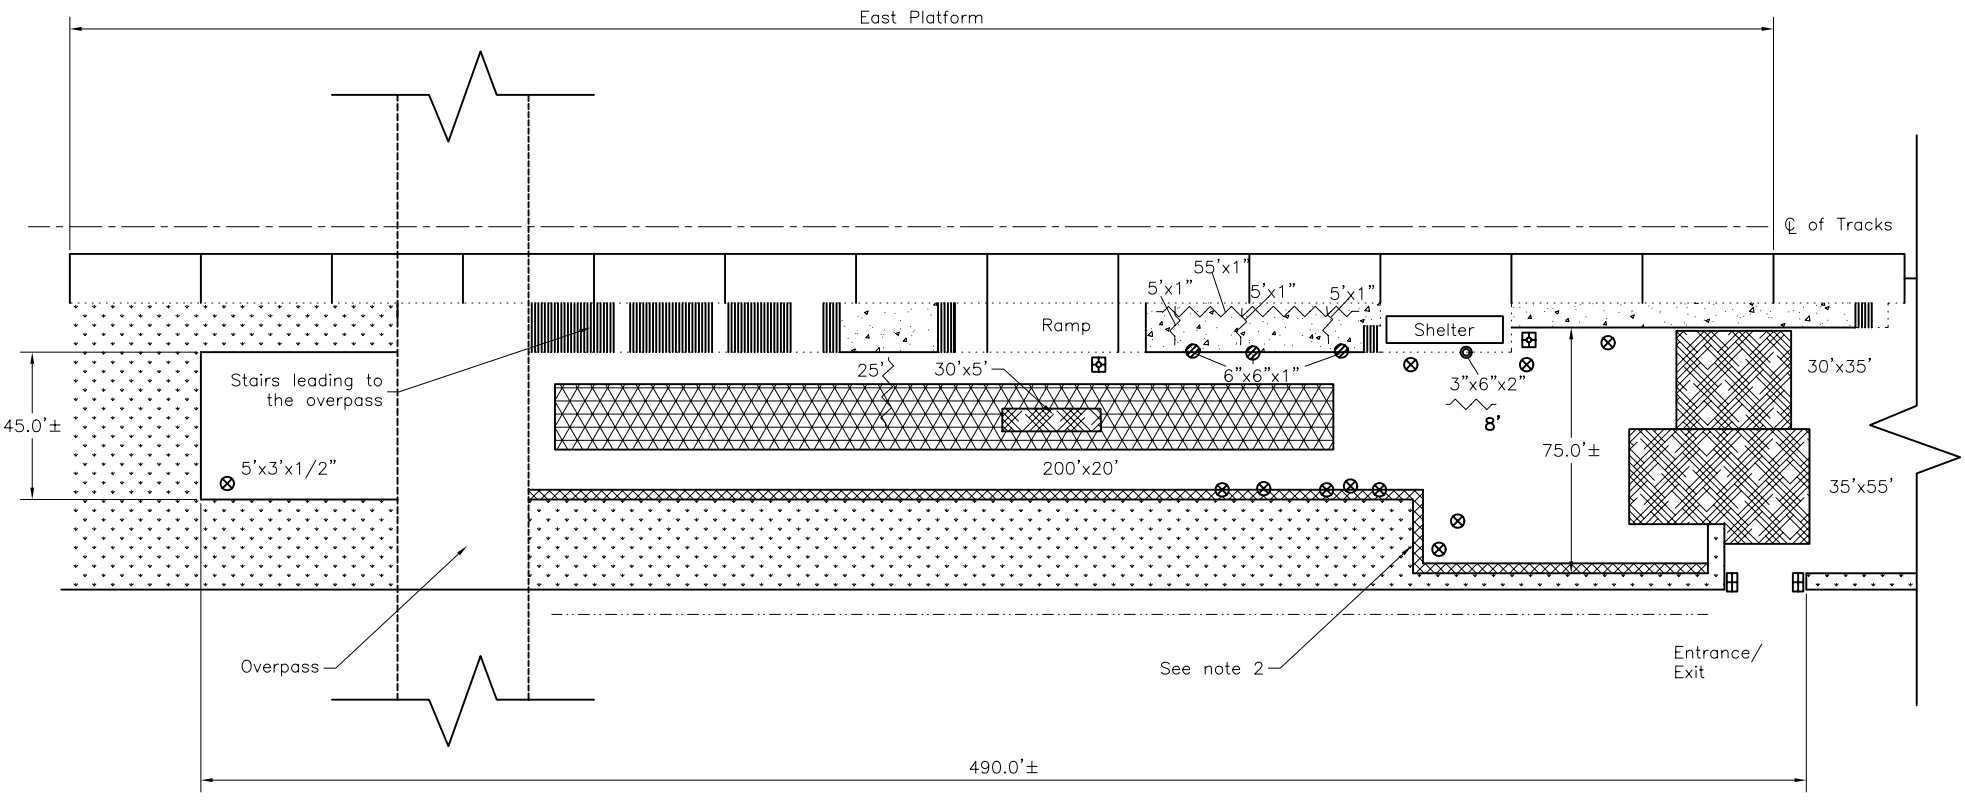
Urbitran Associates, Inc.
Connecticut Dept. of Transportation
Riverside Station Quadrant I Plan
Date: 3/5/02

- NOTES:
1. The potholes vary in size from 4"x4"x1" to 5'x3'x1/2"
 2. There is mapcracking and uneven settlement along the east side (3' wide x 360')

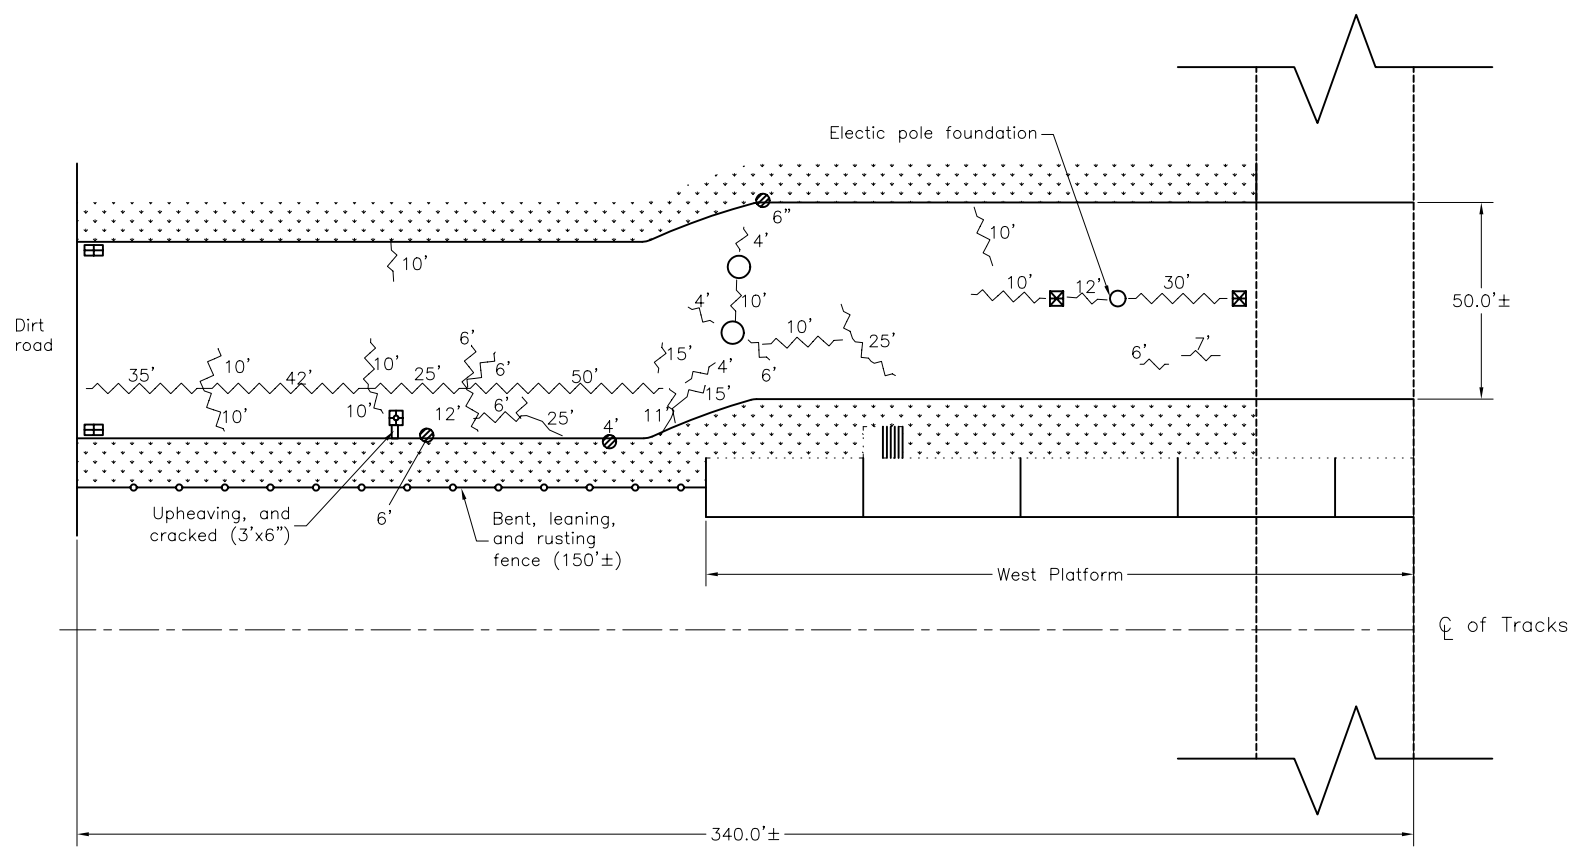
Urbitran Associates, Inc.
Connecticut Dept. of Transportation
Riverside Station Quadrant III Plan
Date: 3/5/02

NOTES:
 1. The east side curb is cracked in multiple locations (total of 30'±)

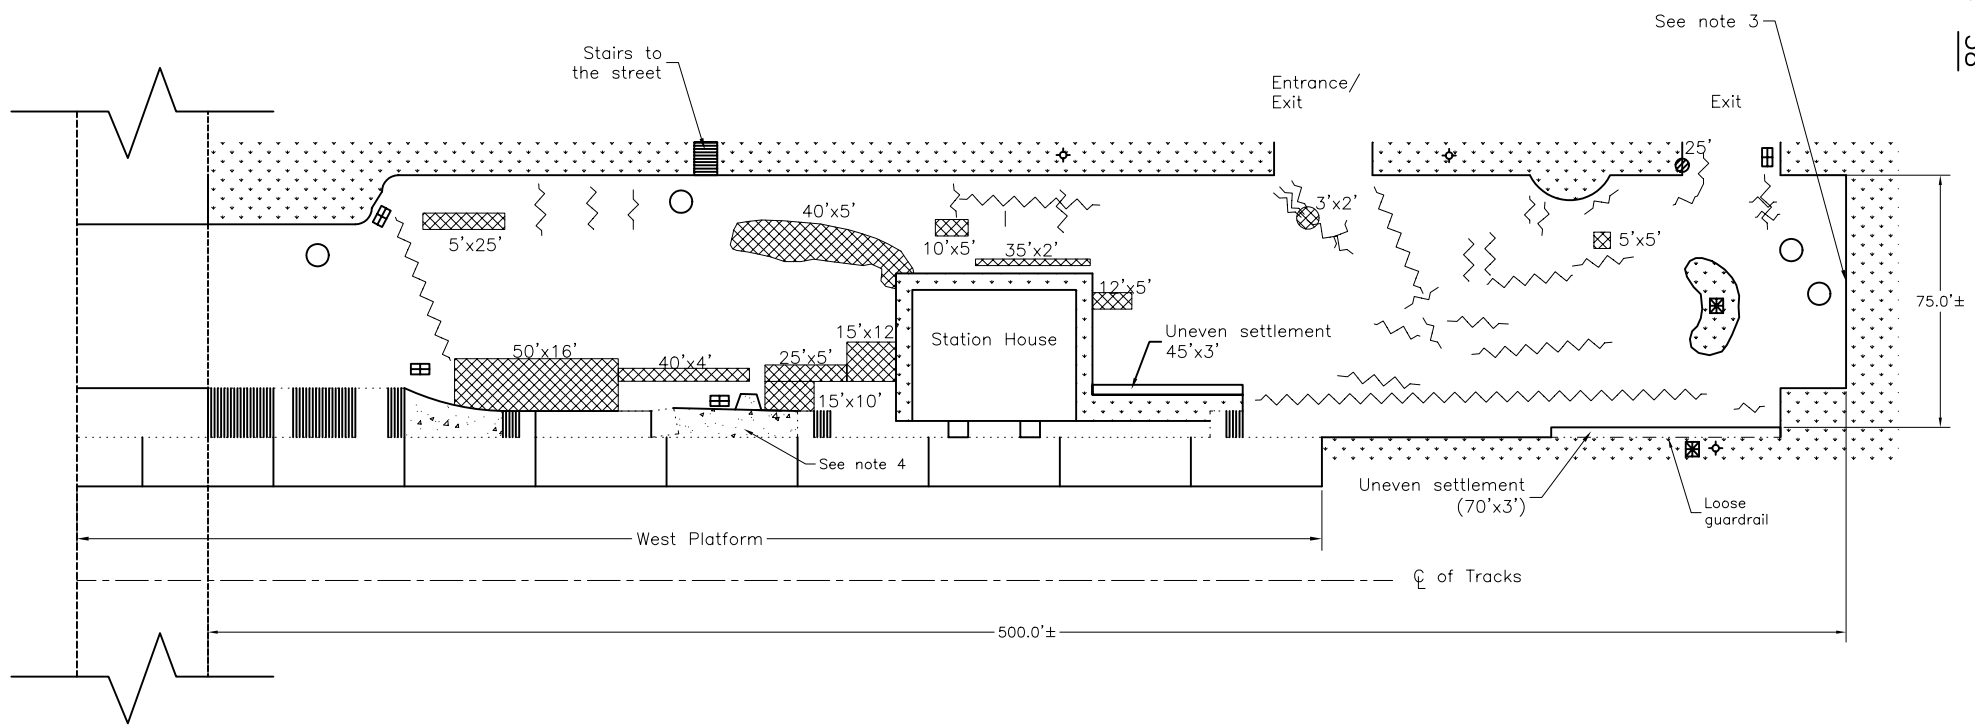
Urbitran Associates, Inc.
Connecticut Dept. of Transportation
Riverside Station Quadrant IV Plan
Date: 3/5/02

1. There is no curb on the west side except for 25' which is damaged.
2. 40% of the asphalt surface is cracked.
3. There are 10 concrete parking blocks displaced on the north side.
4. The sidewalk is cracked with an uneven walking surface.
