CONNECTICUT
DEPARTMENT
OF
TRANSPORTATION

CONDITION INSPECTION
FOR THE
WESTPORT STATION

**CONN. DEPT OF TRANSPORTATION
STATION INSPECTION**

STATION: Westport
 LINE: New Haven Line
 INSPECTION DATE: 8/02/02
 INSPECTION AGENCY / FIRM: UA
 INSPECTORS: RGW
 WEATHER: Sunny, 80's

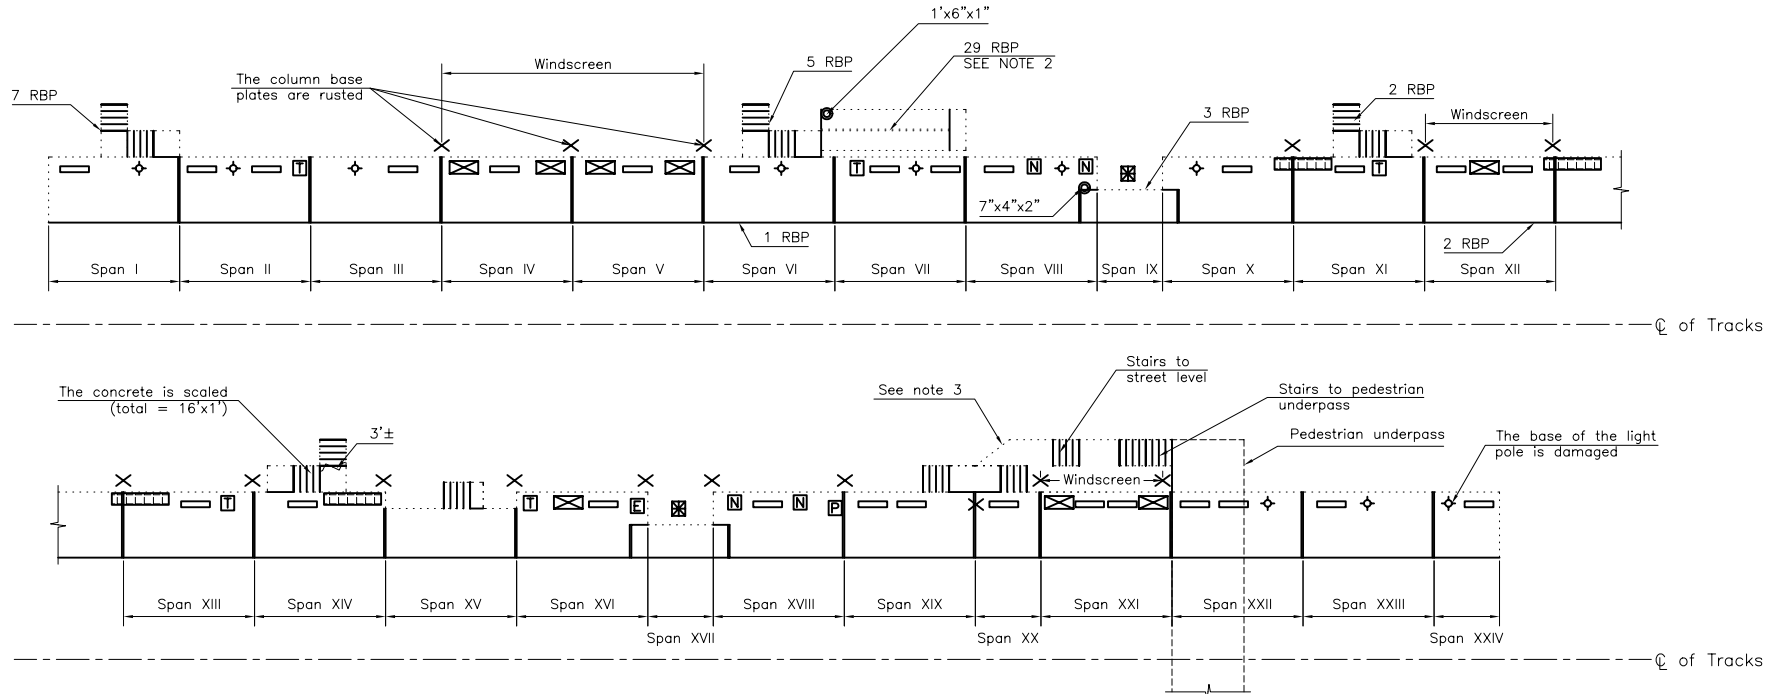
Urbitran Associates, Inc.
Connecticut Dept. of Transportation
Westport Station (Southbound) North Platform Plan
Date: 8/02/02

1. Through out the platform the base plates for the double tee are rusted and deteriorated.
2. There are five locations where the railing post is damaged.
3. The concrete curb/retaining wall is spalled.
4. The paint on the canopy structure is chipping and peeling.

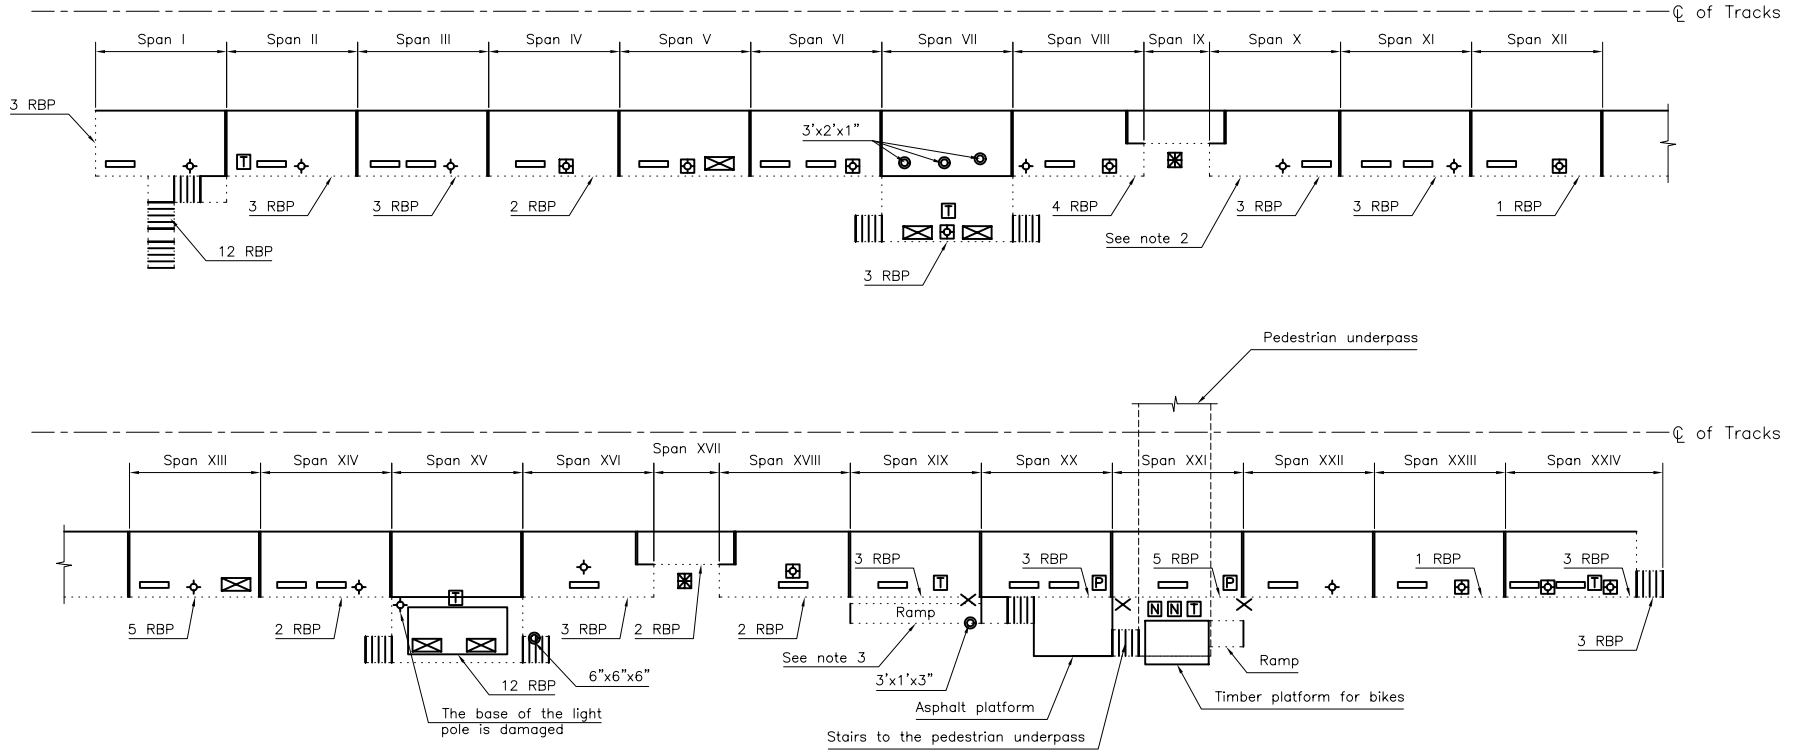
Urbitran Associates, Inc.
Connecticut Dept. of Transportation
Westport Station (Northbound) South Platform Plan
Date: 8/02/02

1. Through out the platform the base plates for the double tee are rusted and deteriorated.
2. There are two cut posts.
3. There are six locations of spalled concrete adjacent to the rusted and deteriorated railing base plate.
4. The paint on the canopy structure is chipping and peeling.

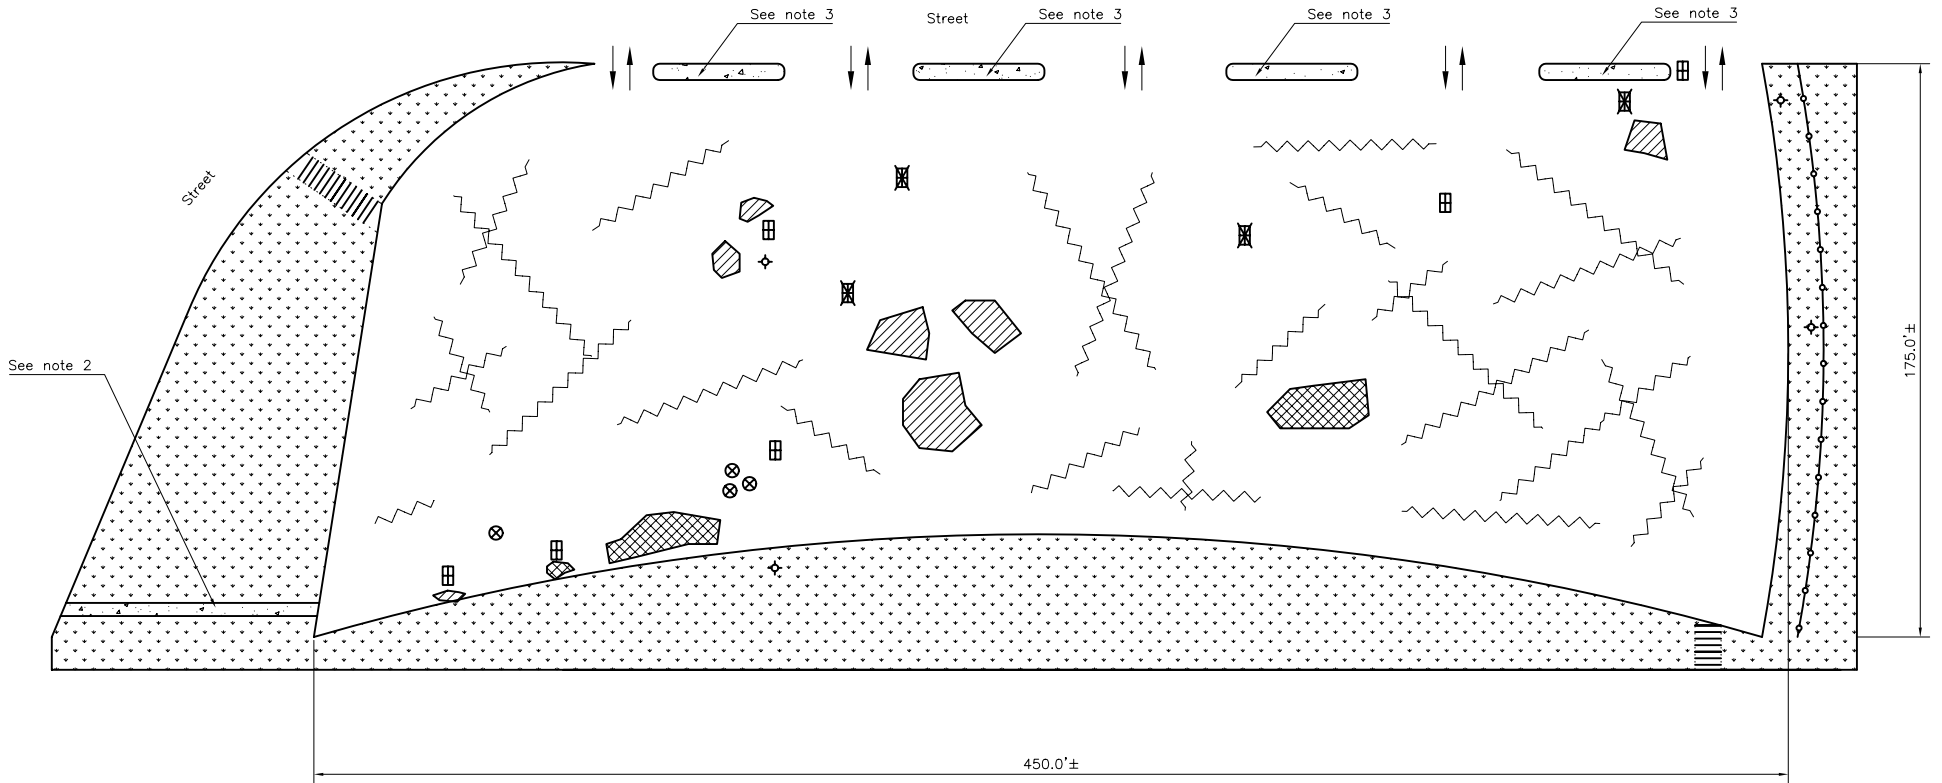
Urbitran Associates, Inc.
Connecticut Dept. of Transportation
Westport Station Quadrant I Plan
Date: 8/03/02

1. The entire asphalt surface contains numerous cracks with vegetation growth. There are multiple locations of potholes and an uneven asphalt surface where ponding of water was noted.
2. The asphalt sidewalk is cracked with an uneven walking surface.
3. There is vegetation growth from the asphalt sidewalk / median.

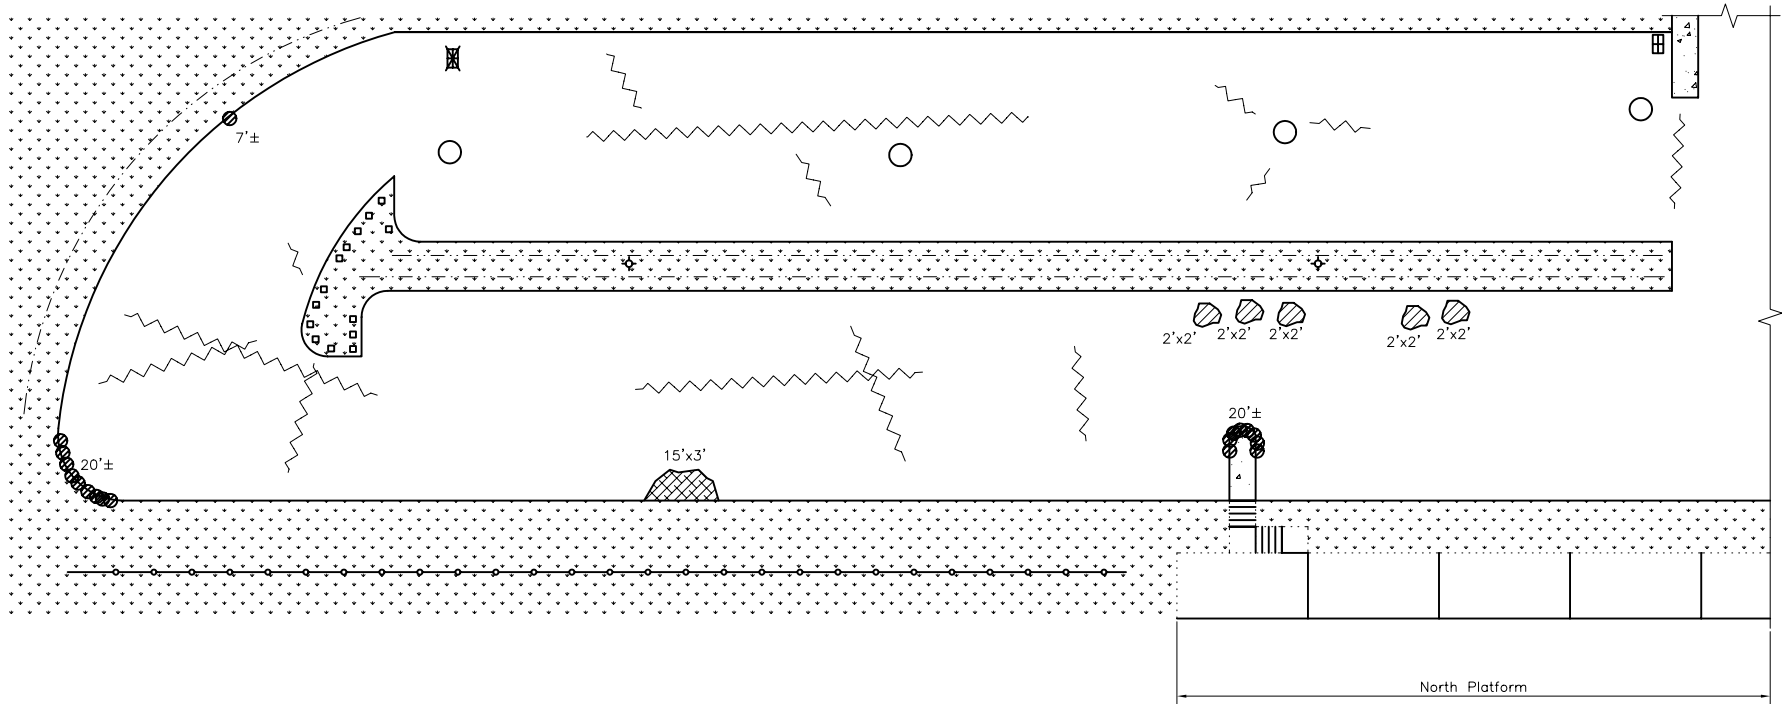
Urbitran Associates, Inc.
Connecticut Dept. of Transportation
Westport Station Quadrant III Plan
Date: 8/03/02

1. The asphalt surface is cracked 1000'±.

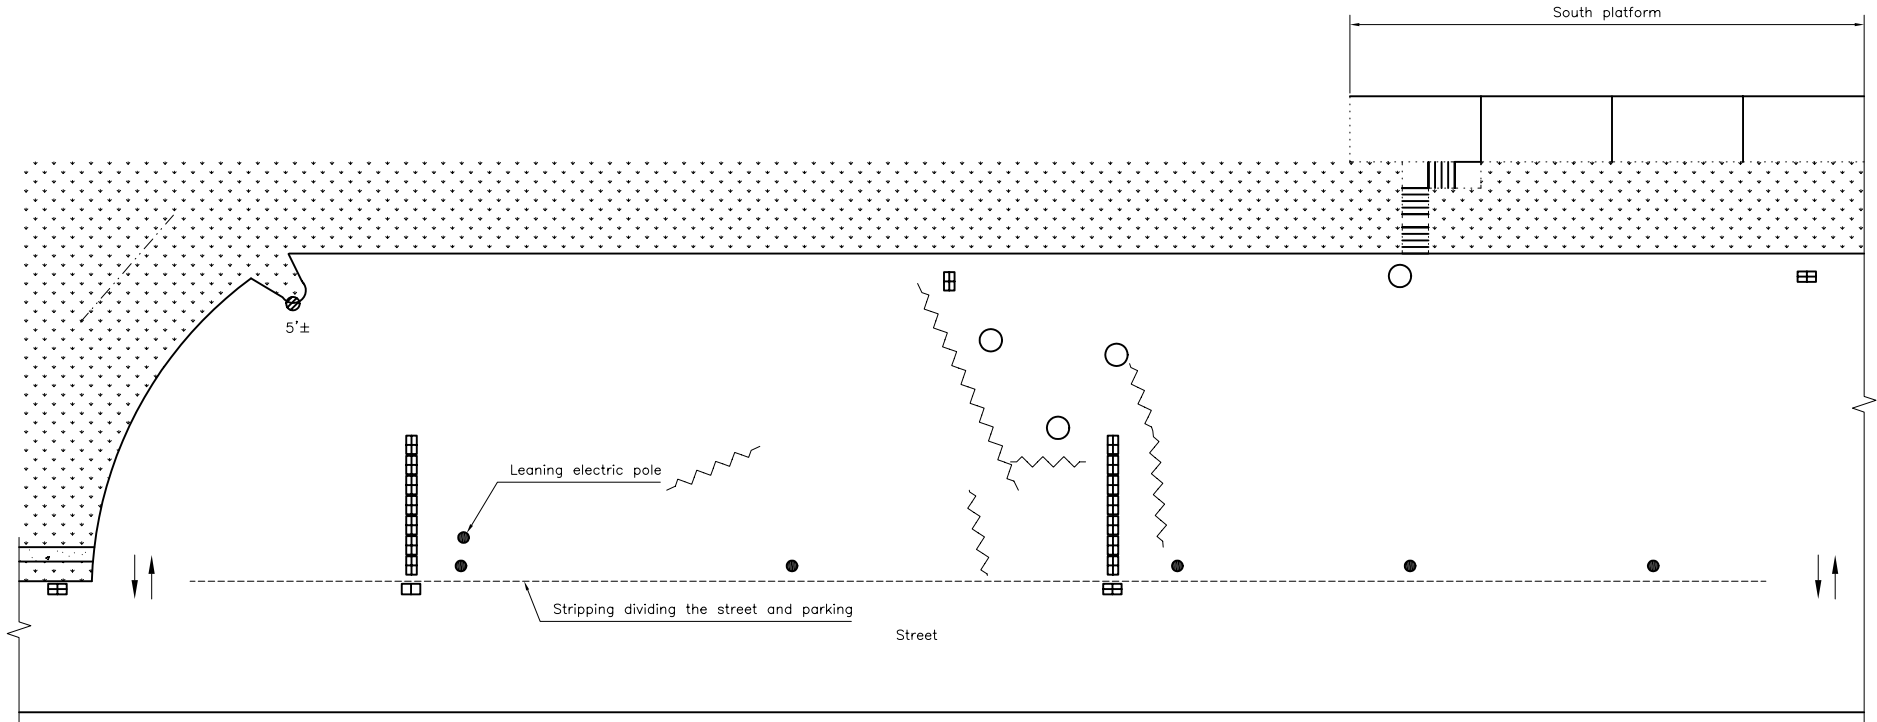
Urbitran Associates, Inc.
Connecticut Dept. of Transportation
Westport Station Quadrant V Plan
Date: 8/03/02

1. The asphalt surface is cracked 200'±.
2. The street and parking are at the same elevation. Stripping divides the two areas.

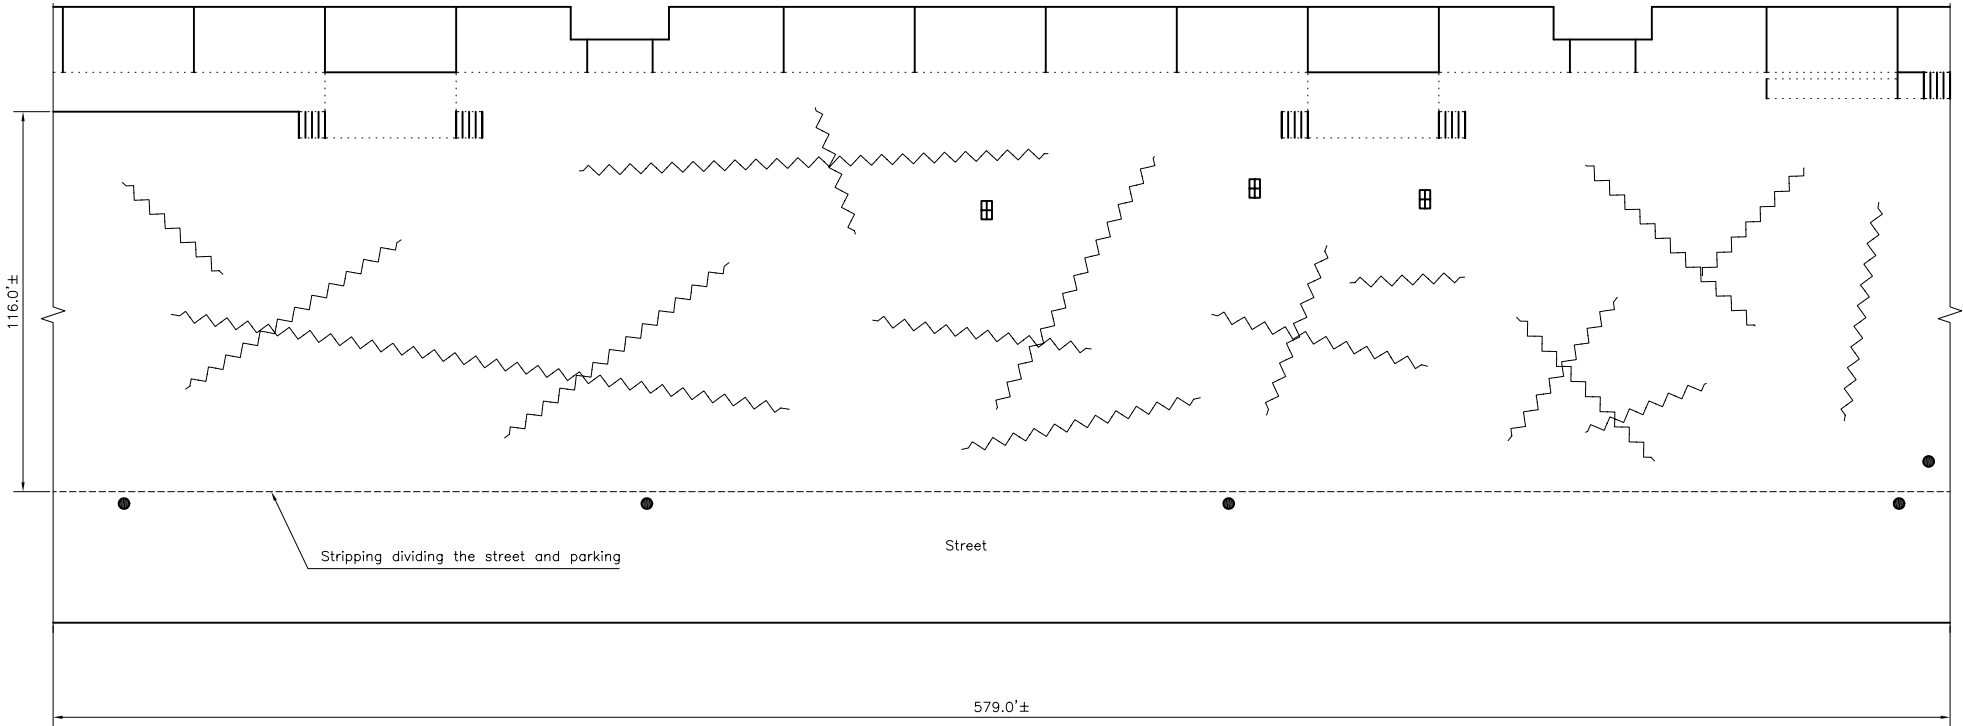
Urbitran Associates, Inc.
Connecticut Dept. of Transportation
Westport Station Quadrant VI Plan
Date: 8/03/02

1. The entire asphalt surface contains numerous cracks with an uneven driving surface.
2. The street and parking are at the same elevation. Stripping divides the two areas.

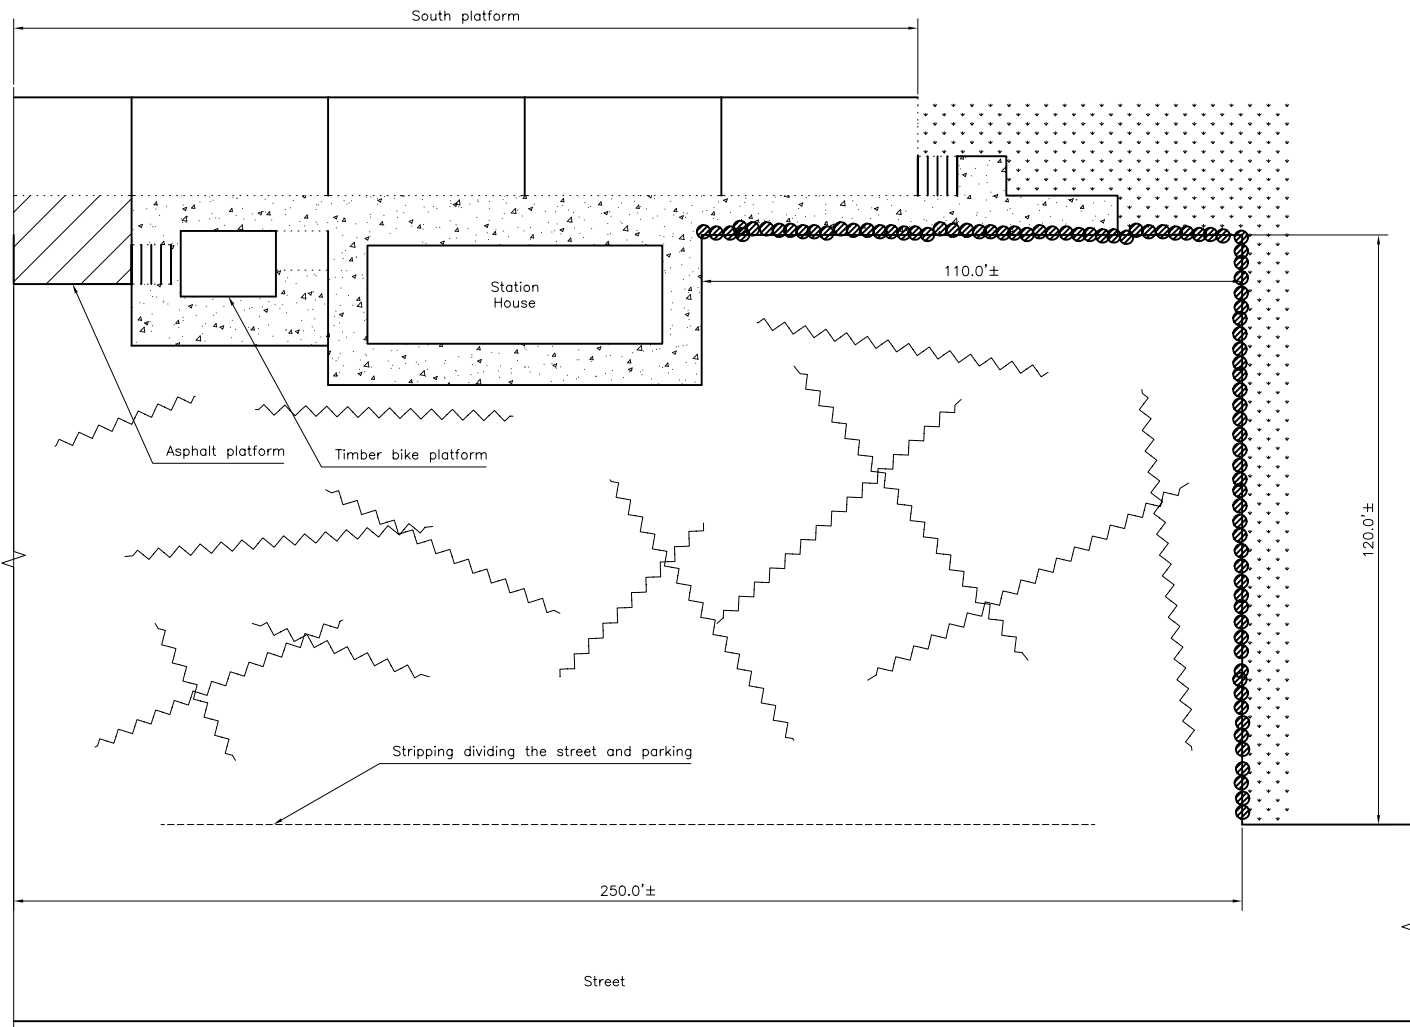
Urbitran Associates, Inc.
Connecticut Dept. of Transportation
Westport Station Quadrant VII Plan
Date: 8/03/02

1. The entire asphalt surface contains numerous cracks with an uneven driving surface.
2. This parking area is only for Taxis, Avis car rentals, and LiLi's car rentals.
3. The street and parking are at the same elevation. Stripping divides the two areas.

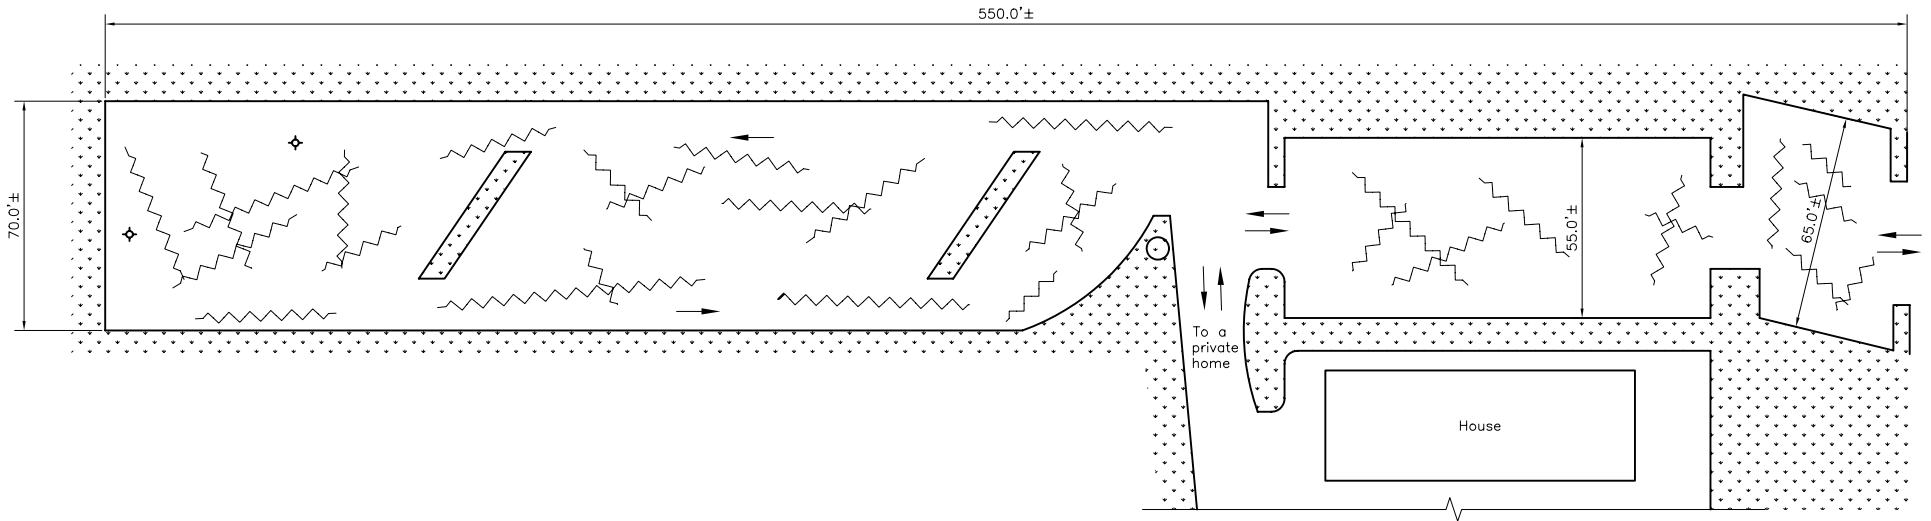
Urbitran Associates, Inc.
Connecticut Dept. of Transportation
Westport Station Quadrant VIII Plan
Date: 8/03/02

1. The entire asphalt surface contains numerous cracks with vegetation growth and an uneven driving surface.

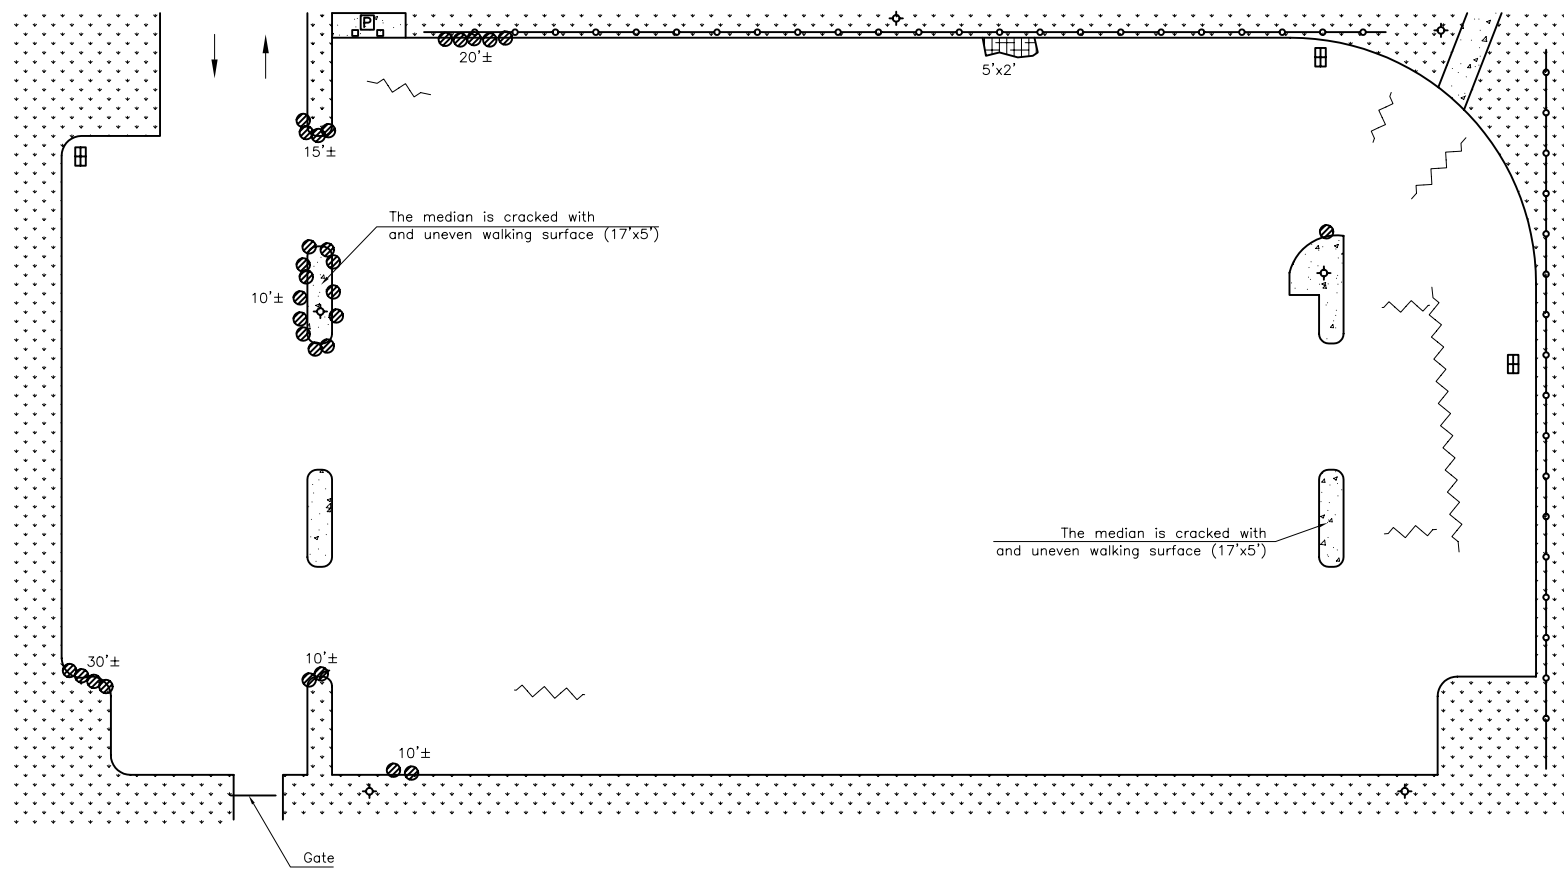
Urbitran Associates, Inc.
Connecticut Dept. of Transportation
Westport Station Quadrant IX Plan
Date: 8/03/02

NOTES:
 1. The asphalt surface is cracked 200'±

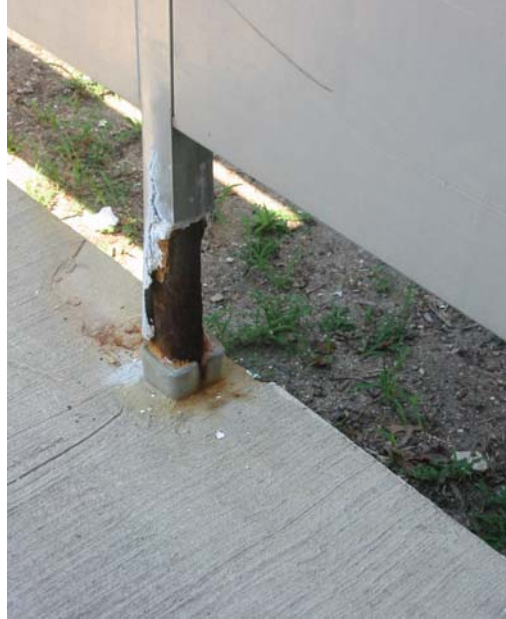
RATINGS		PHOTO NO.	REMARKS:
NEW	PREV		
2		23	Span VII (N-platform) 1 - The railing post is cracked, rusted, and deteriorated
2		24	Span I,VI,VII,IX,XI,XII (N-platform) 2 - The railing base Span I-IV,VII,VIII,X-XXI,XXIII,XXIV (S-platform) plate is rusted.
2		25	Span XIX (S-platform) 5 - The concrete is spalled and cracked adjacent to the rusted railing base plate
3		33	Span XXII (N-platform) 10 - There are four isolated areas Span XXI (S-platform) where the slate tile is cracked / chipped
3		26	Span III,IV,V (N-platform) 11 - The column base plates are rusted and deteriorated
2		27-28	Span III-V, X-XXI (N-platform) 14 -The canopy paint is chipping Span XIX-XXI (S-platform) and peeling
2		29	Span XX (N-platform) NA - The concrete curb below the railing is cracked
2		30	All spans NA - The base plates for the double tee are rusted and deteriorated
3		31	Span X (S-platform) NA - There are two missing sign/billboard posts

Description: _____
Cracked, rusted, and
deteriorated railing
post

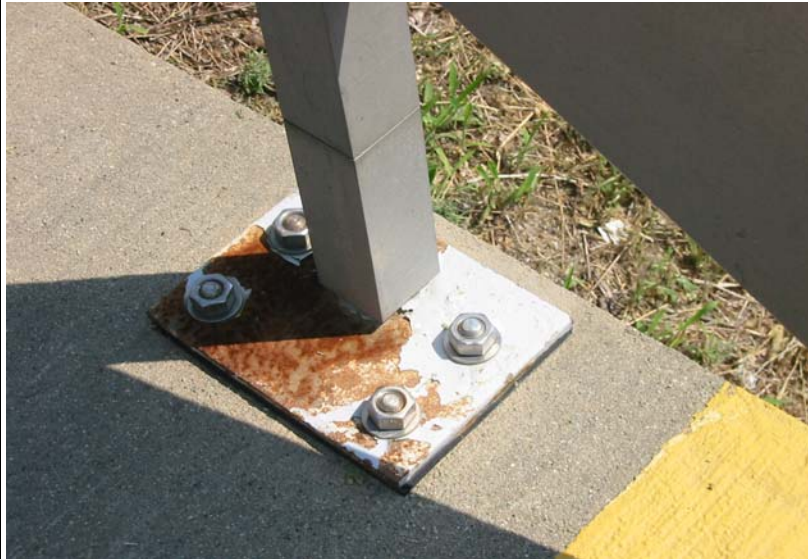
PHOTO NO. 24

Description: _____
Typical rusted base
plate

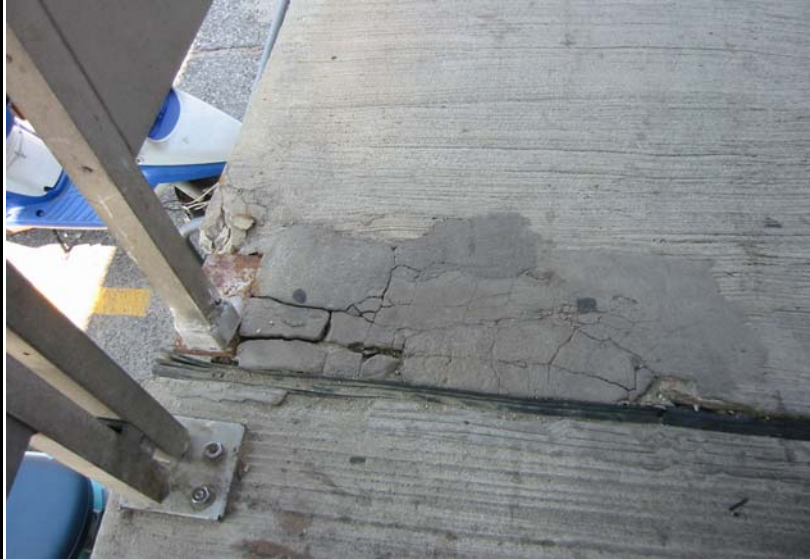
Description: Spalled and crack concrete adjacent to the rusted railing base plate

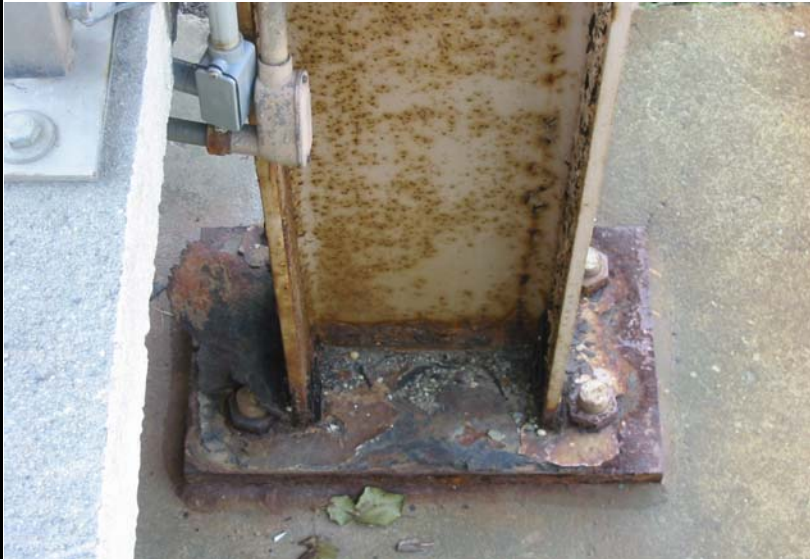
PHOTO NO. 26

Description: Typical rusted and deteriorated column base plate

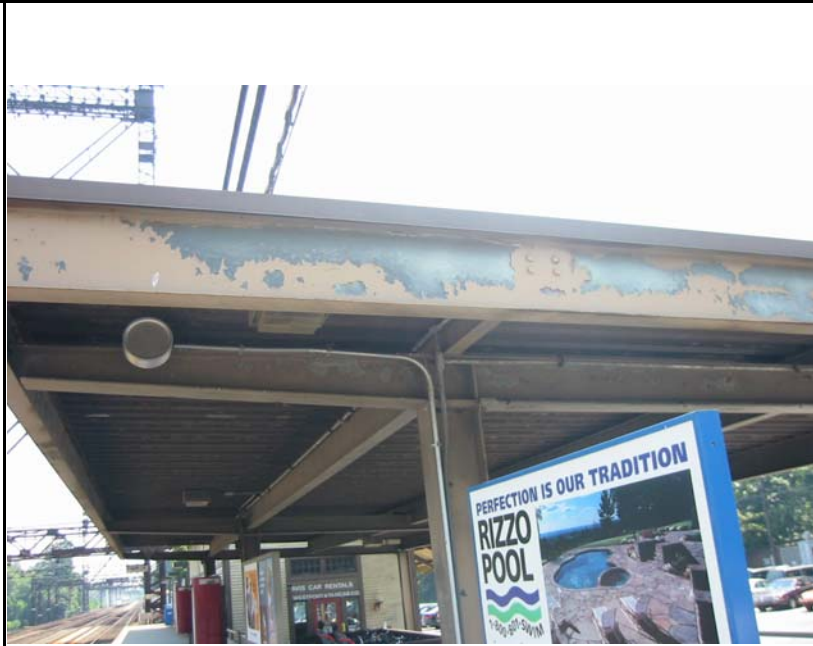
Description: _____
Typical chipping and
peeling paint

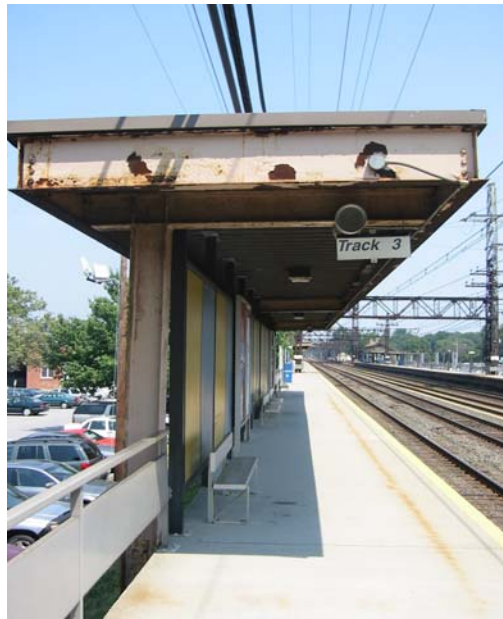
PHOTO NO. 28

Description: _____
Typical chipping and
peeling paint

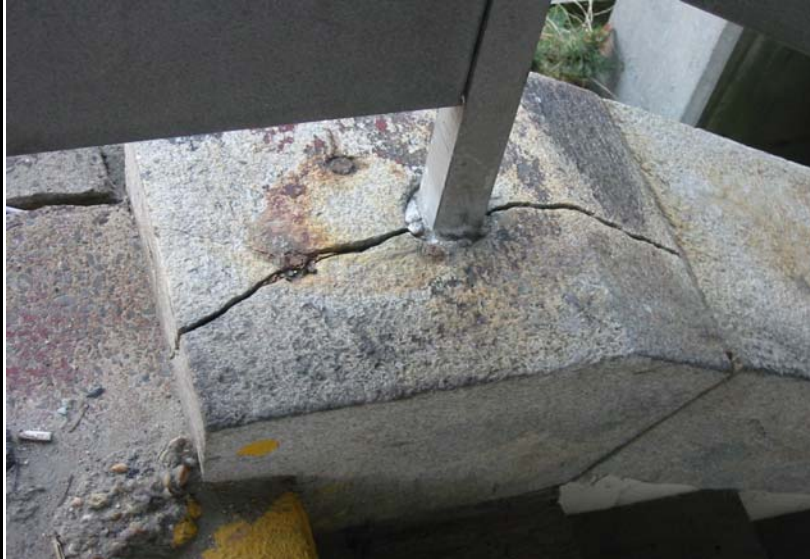
Description: _____
Cracked concrete
adjacent to the railing
post

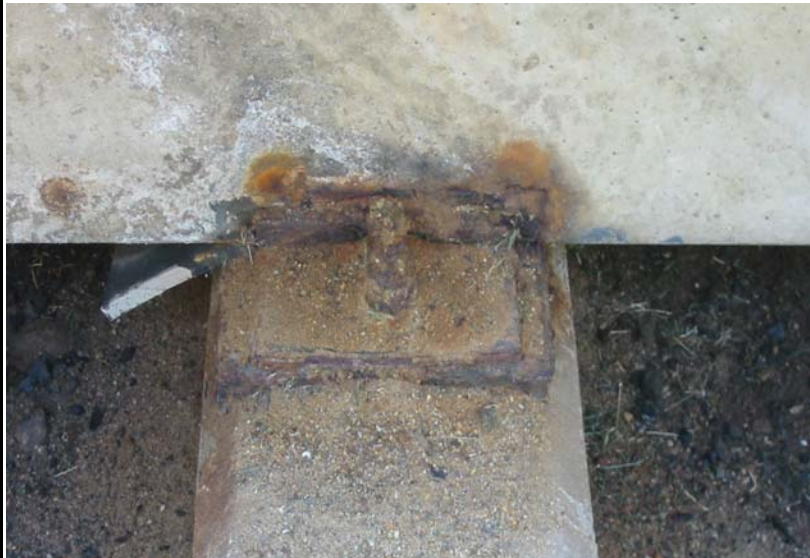
PHOTO NO. 30

Description: _____
Typical rusted and
deteriorated double
tee base plate

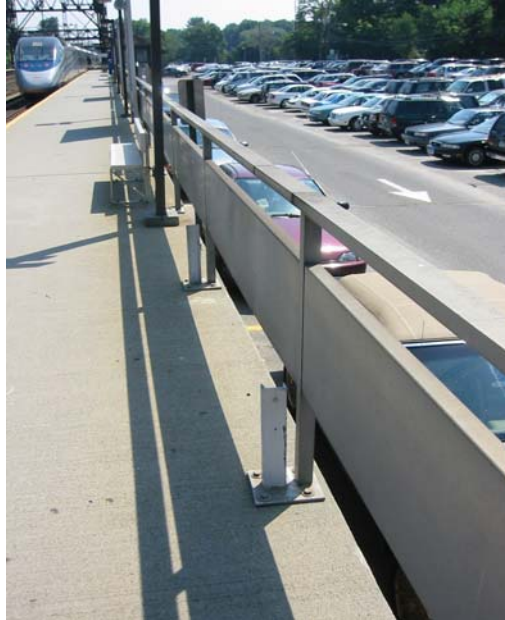
Description: _____
Two missing
sign/billboard posts

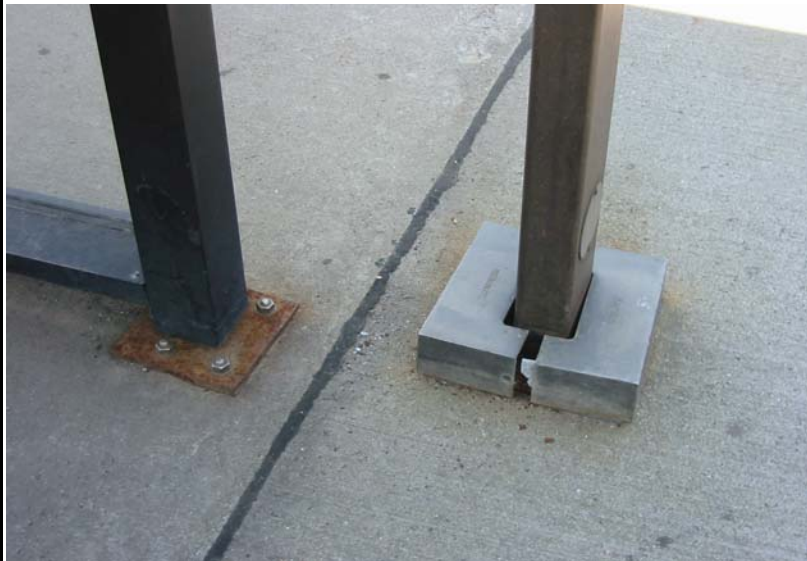
PHOTO NO. 32

2		32	Span XV (S-platform) NA - The base of the lighting pole is damaged
2		34	Quad I,VI,VII, VIII, X Surface - The asphalt surface contains numerous cracks with vegetation growth
2		35	Quad I,VI,VII, VIII, X Surface - The asphalt surface contains multiple locations of map cracking
2		36	Quad I Surface - Ponding of water was noted in multiple locations

Description: _____
Damaged light pole
base

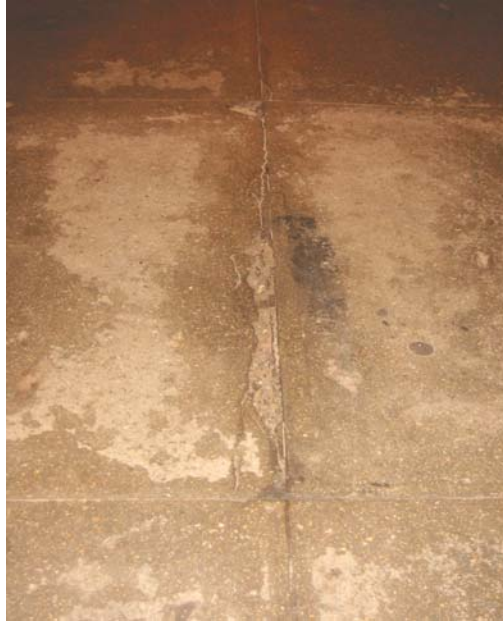
Description: _____
Typical cracked/chipped
slate tile

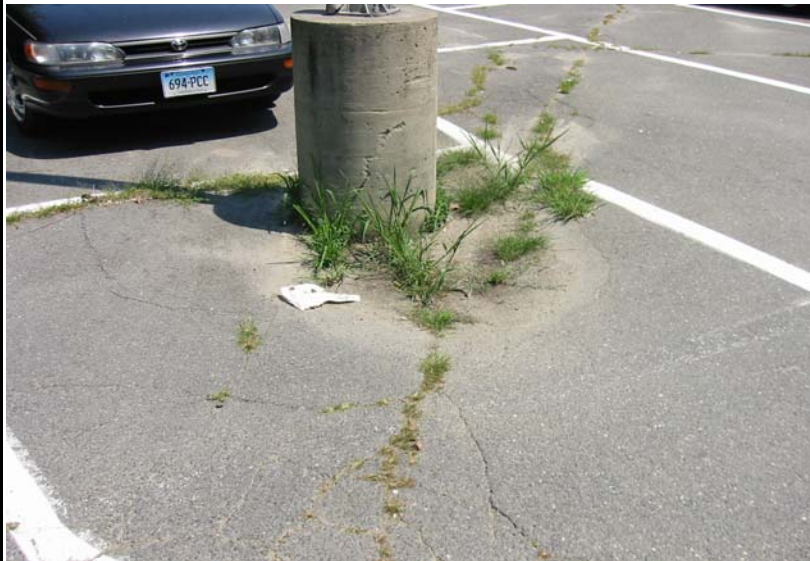
PHOTO NO. 34

Description: _____
Typical cracks with
vegetation growth

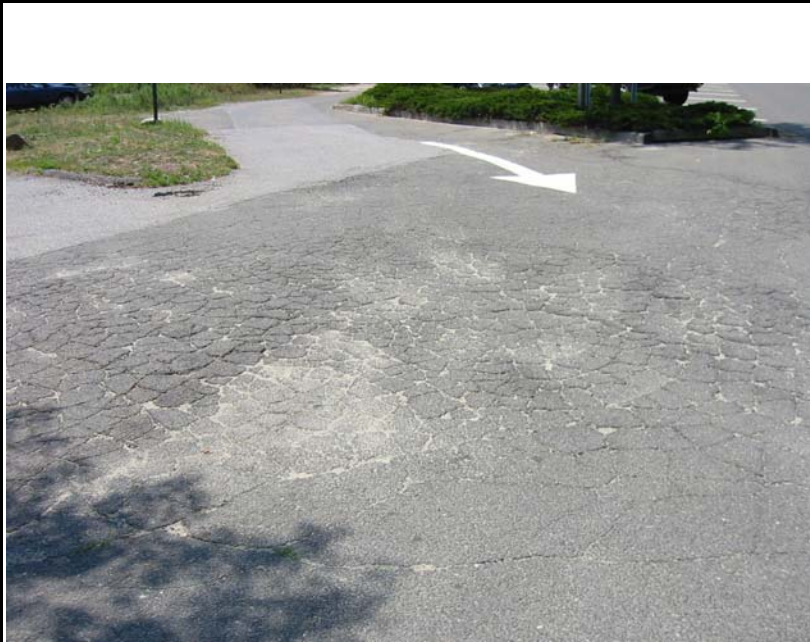
Description: _____
Typical map cracking

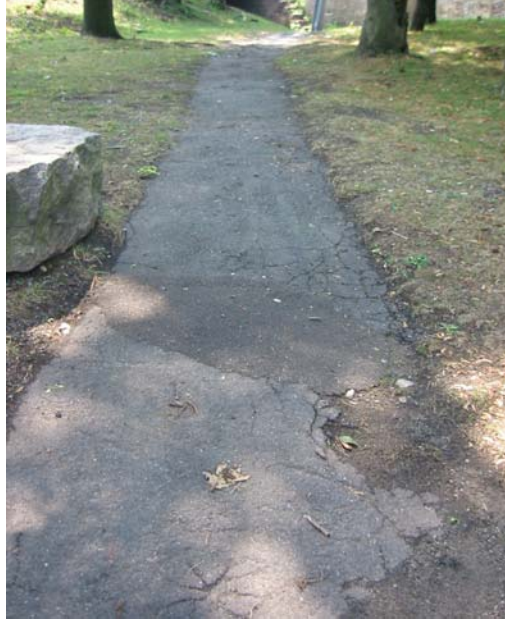
Description: _____
The asphalt sidewalk
is cracked with an
uneven walking surface

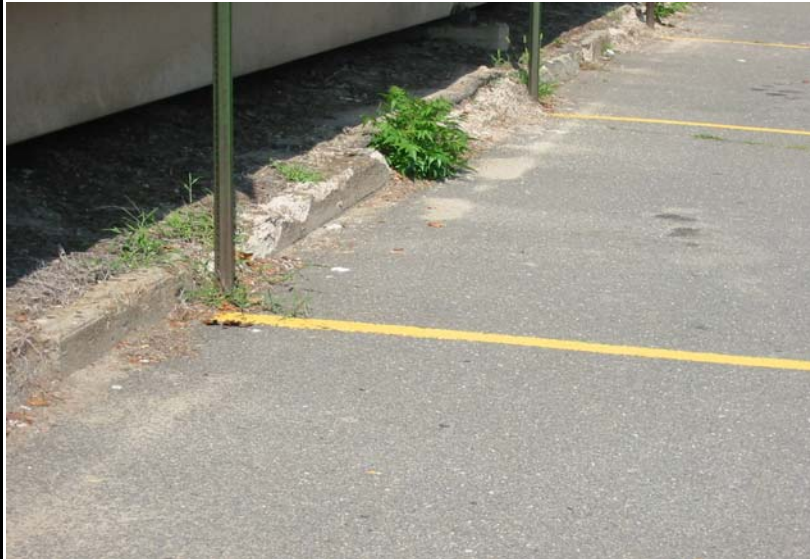
PHOTO NO. 40

Description: _____
Typical spalled curb

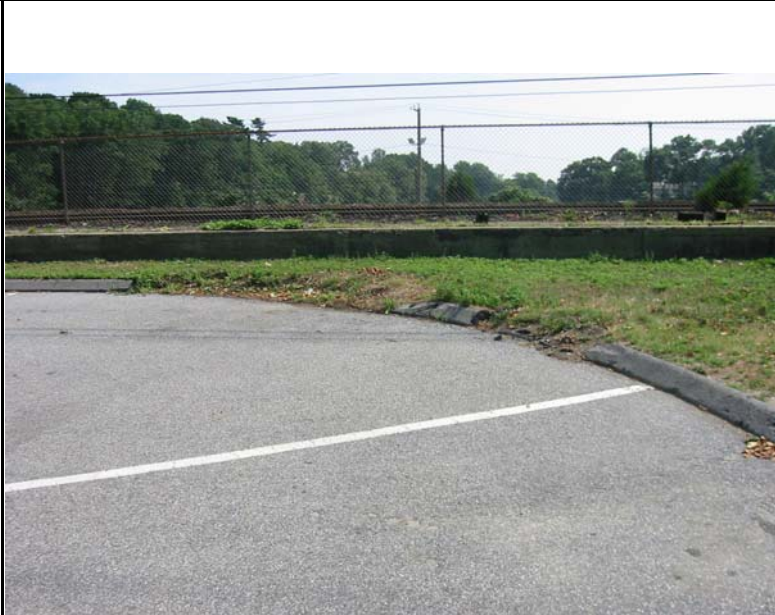
Description: Typical spalled and missing asphalt curb

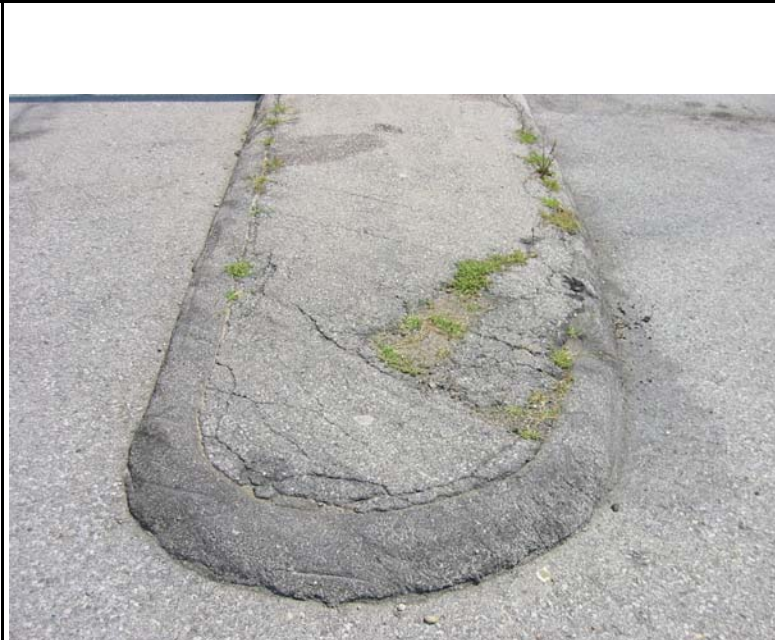
PHOTO NO. 42

Description: Spalled and cracked asphalt median / sidewalk with vegetation growth

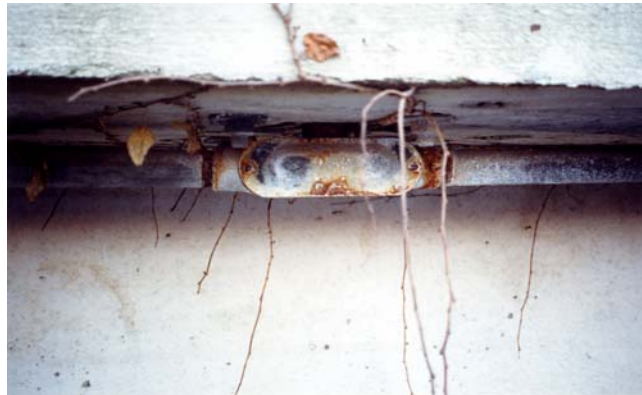
PHOTO NO. 48

Remarks: A typical section of the platform was measured at the location indicated and found to average
7.56 and 7.3 on the southbound and northbound platforms, respectively.
The majority of the light pole bases have failed in the past and attempts have been made to repair them.
Much of the lighting conduit system is corroded and should be replaced.

Description: _____
corroded lighting
conduit

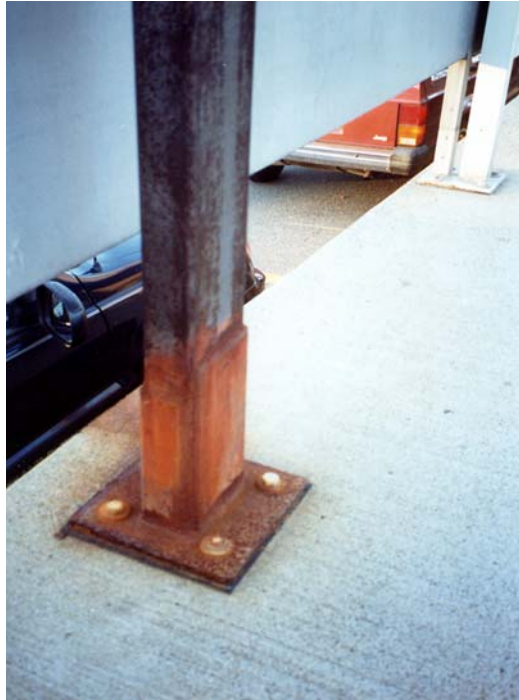
Description: _____
typical repair of
corroded light
pole base

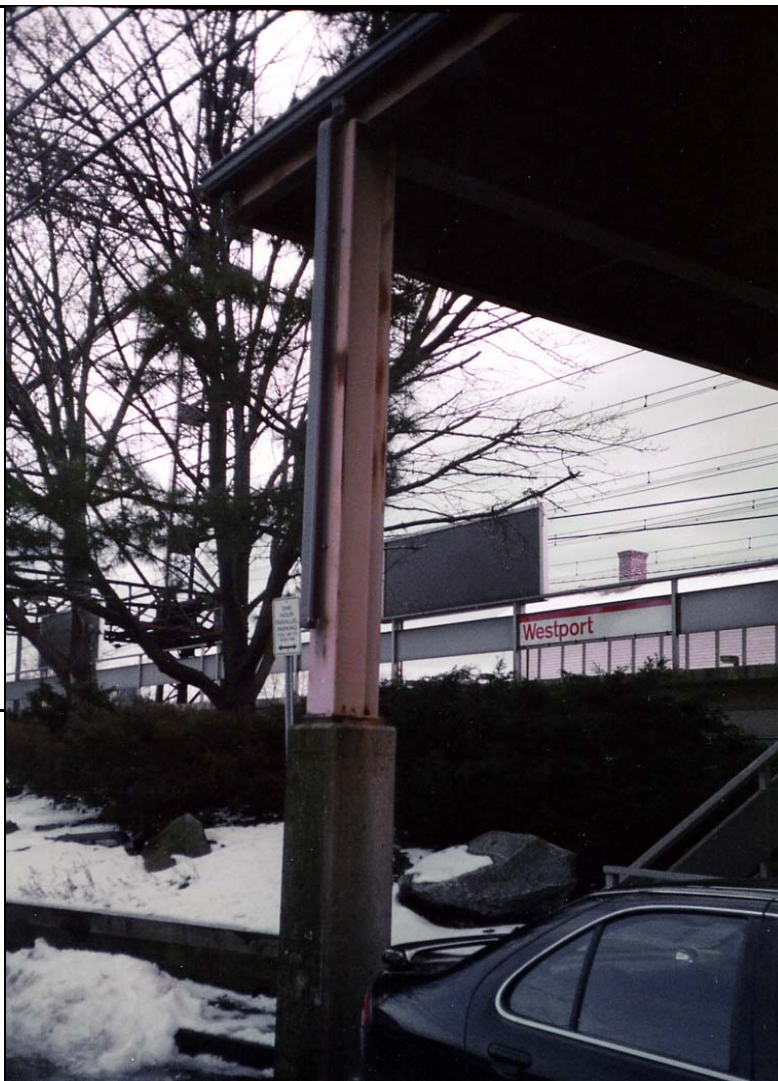
Description:
Downspout
missing bottom
part
