# NRD Project Final Grant Report

**Reporting Organization:** Housatonic Valley Association (HVA)  
**Project Name:** Furnace Brook Fish Ladder Restoration  
**Project Location:** Cornwall Bridge, Connecticut  
**Cooperative Agreement #:** F12AC00302  
**Period of Agreement:** March 2012 – December 2017  
**Dates covered by this Report:** Project start – March 31, 2018

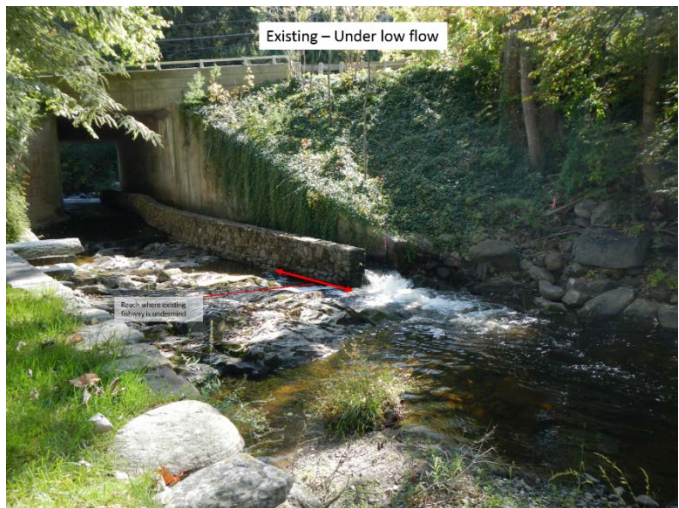
Furnace Brook flows under Furnace Brook Road (Cornwall, CT) through a 120-foot long concrete box culvert, and merges with the Housatonic River 1,000 feet downstream of the culvert. Prior to the refurbishment funded by this grant, the existing fishway passage through this culvert was 3.5 feet wide and 3 feet deep, with the steepest slope in the middle of the culvert. There were wooden baffles (cut as v notch weirs) to aid in fish passage; however, most were lost due to storm events. The last 10-foot section of the fishway was undercut and ineffective.

Figure 1. Pre-construction conditions of the fishway

To improve ease of fish passage in the existing fish ladder, a portion of the concrete floor from the 20-foot downstream end of the existing fishway was removed and modified at a steeper slope (see photos of construction process below). Bedrock under the fishway in this area was also adjusted, allowing backwater from the downstream section to back up into the fishway and improving entrance conditions. Then three prefabricated aluminum Model A Steeppass fishway 10-foot units were installed, one in the steep middle section of the fishway and two in the 20-foot downstream section of the fishway. These aluminum shoots aid in dissipating energy and allowing fish to more easily move upstream through the fishway. Additionally, a high water overflow notch in the existing fishway was saw cut. The areas between the prefabricated aluminum fishway units and the existing fishway and subgrade were backfilled with concrete as shown on the design plans. Water controls adjacent to the fishway were

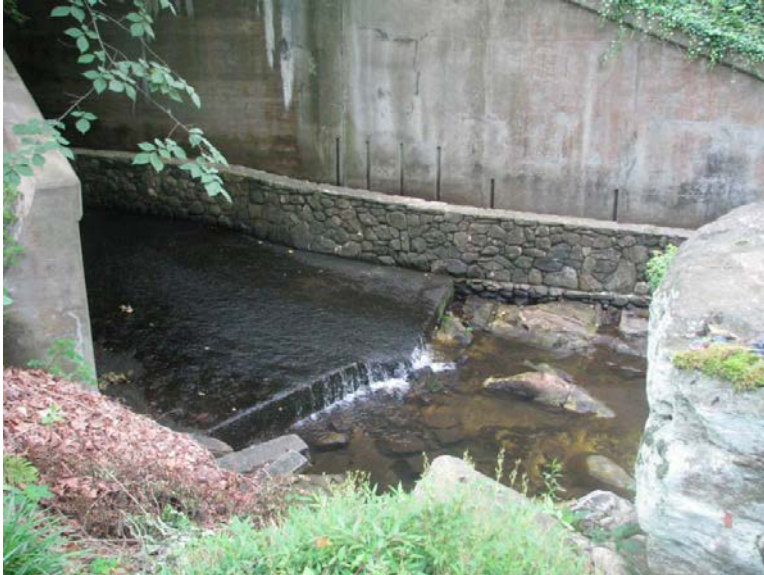
Figure 2. Pre-construction view of the downstream end of the culvert. Note the fast, shallow water flowing over the concrete bottom.

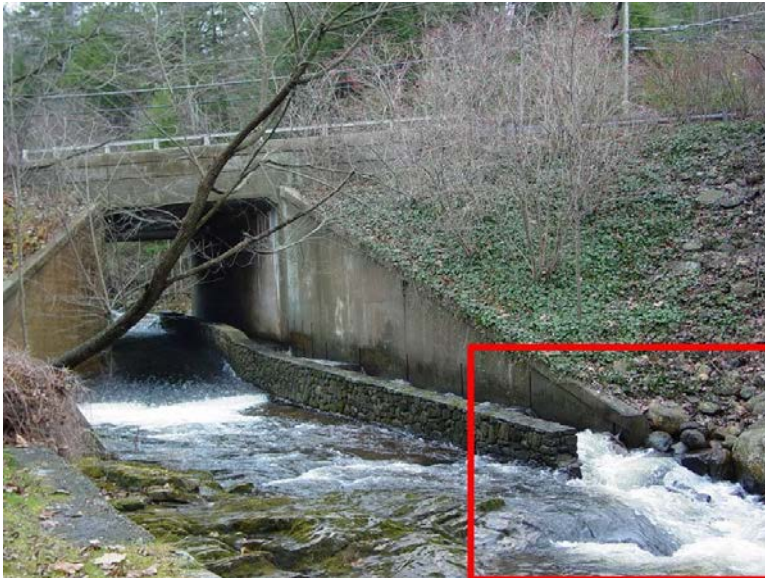
Figure 3. Pre-construction view of the fishway entrance and the downstream outlet of the culvert. Note the high velocities in both areas.

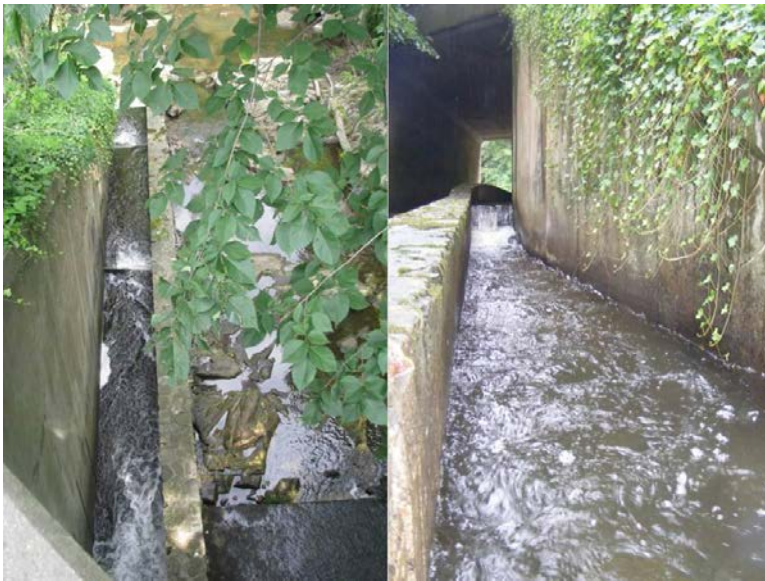
Figure 4. Two pre-construction views of the interior of the fishway. There was no internal flow control, consequently the flows inside the fishway were too fast for fish to pass through.

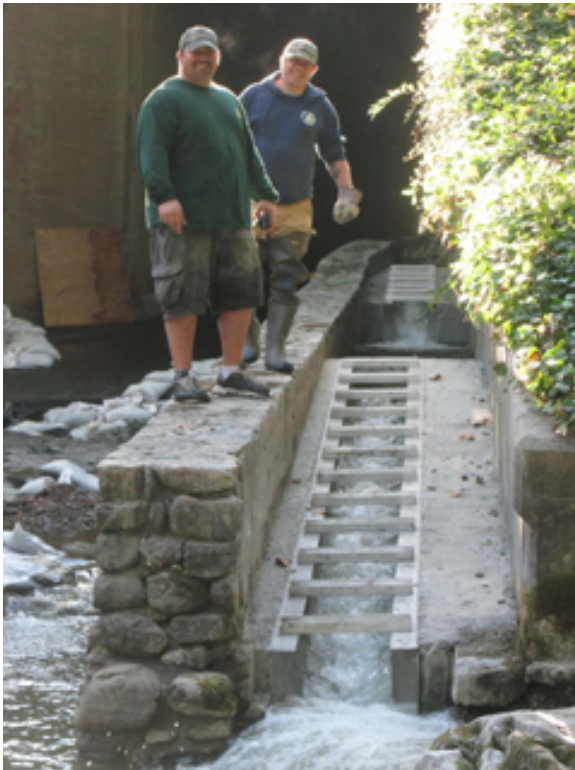
Figure 11. Completed fishway
