# FISHERIES CONSIDERATIONS IN DOT PROJECTS – A COLLABORATIVE APPROACH CASE STUDY

# FISH PASSAGE RESTORATION - MARLBOROUGH

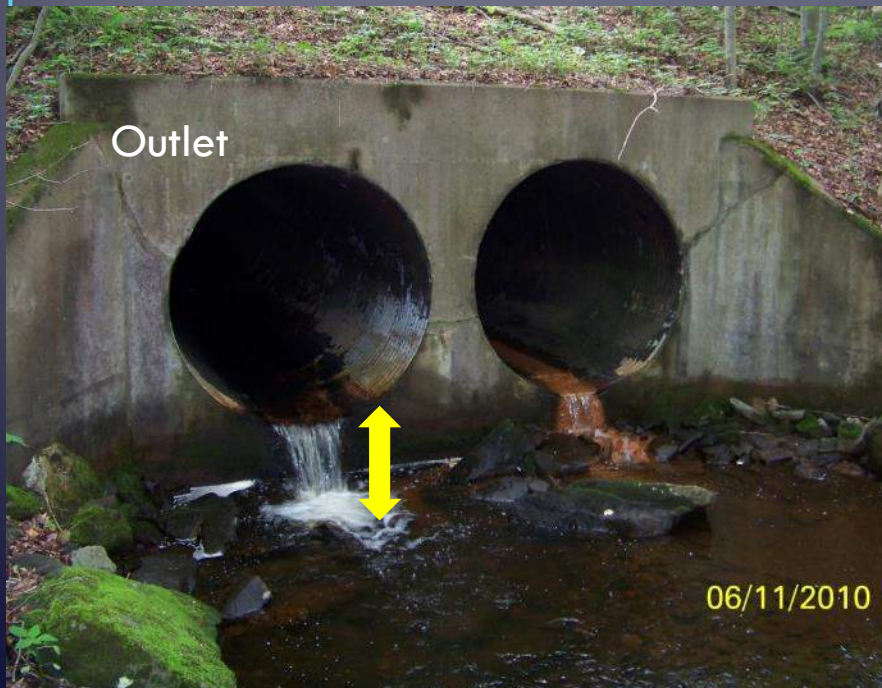
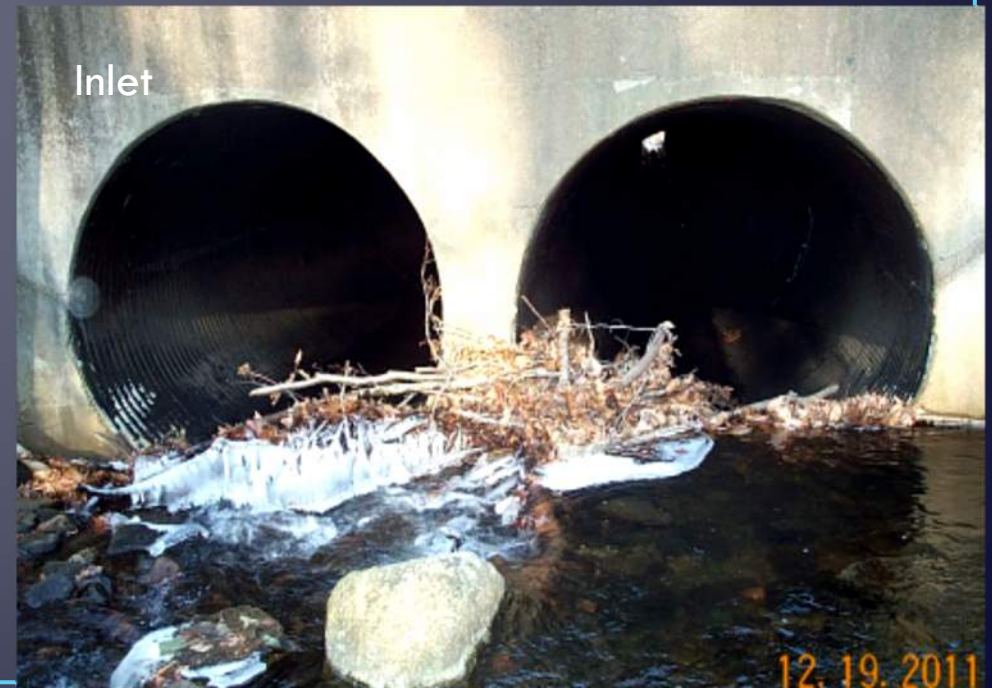
Twin - 6 ft. CMPs: 262 FT. at 4.5% slope under Route 2

- Outlet: Barrier due to drop/perch of 1½ ft.
- Inlet: Prone to clogging with woody debris.
- In-culvert issues: Seasonal excessive water velocities, shallow water, lack of roughness & velocity refugia.

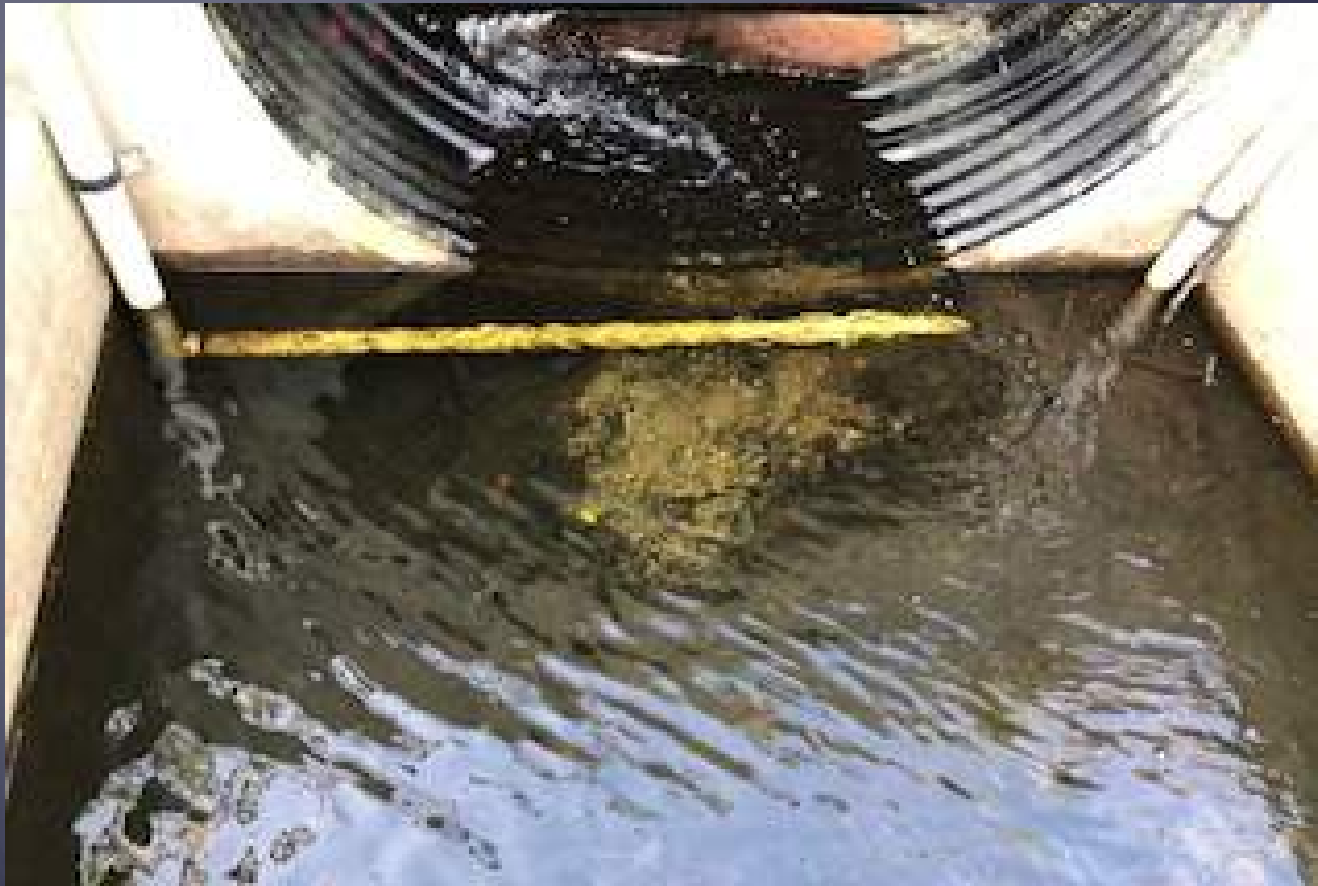
NEST DISCOVERED OCTOBER 20, 2017 AT FISHWAY POOL #6  
FISH #302 & 486 (WATER TEMP. 52 F)
