Photographic Simulations

TRUMBULL SE 4
60 COMMERCE DRIVE
TRUMBULL, CT 06611

*Prepared in February 2014 by:
All-Points Technology Corporation, P.C.
3 Saddlebrook Drive
Killingworth, CT 06141*

Prepared for Verizon Wireless

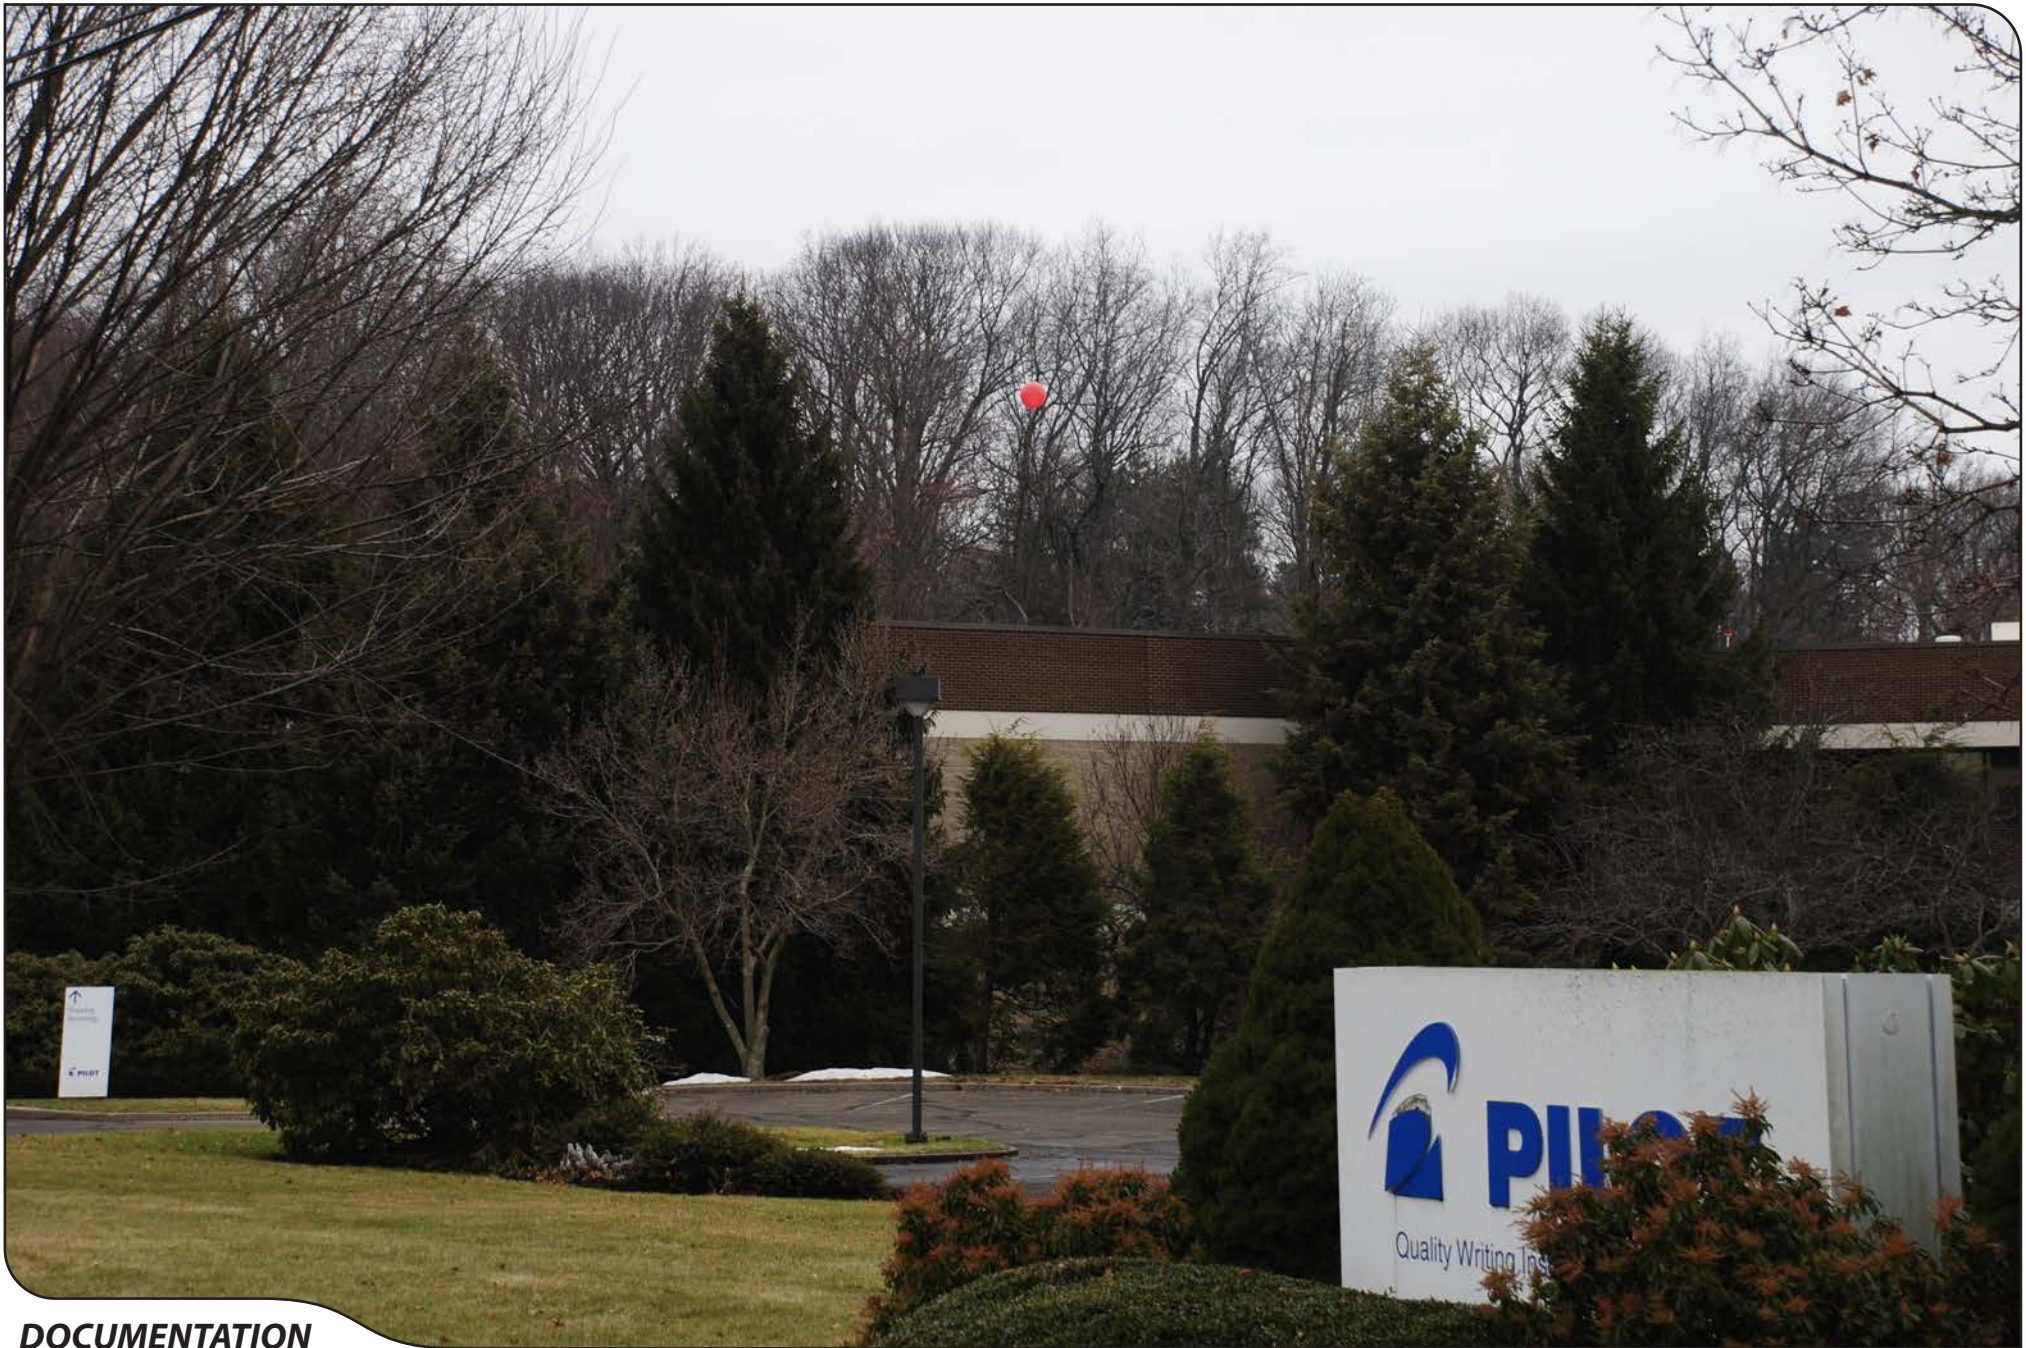
PHOTO	LOCATION	ORIENTATION	DISTANCE TO SITE	VISIBILITY
1	ENTRANCE TO PILOT PEN PROPERTY	NORTHEAST	+/- 0.10 MILE	YEAR ROUND

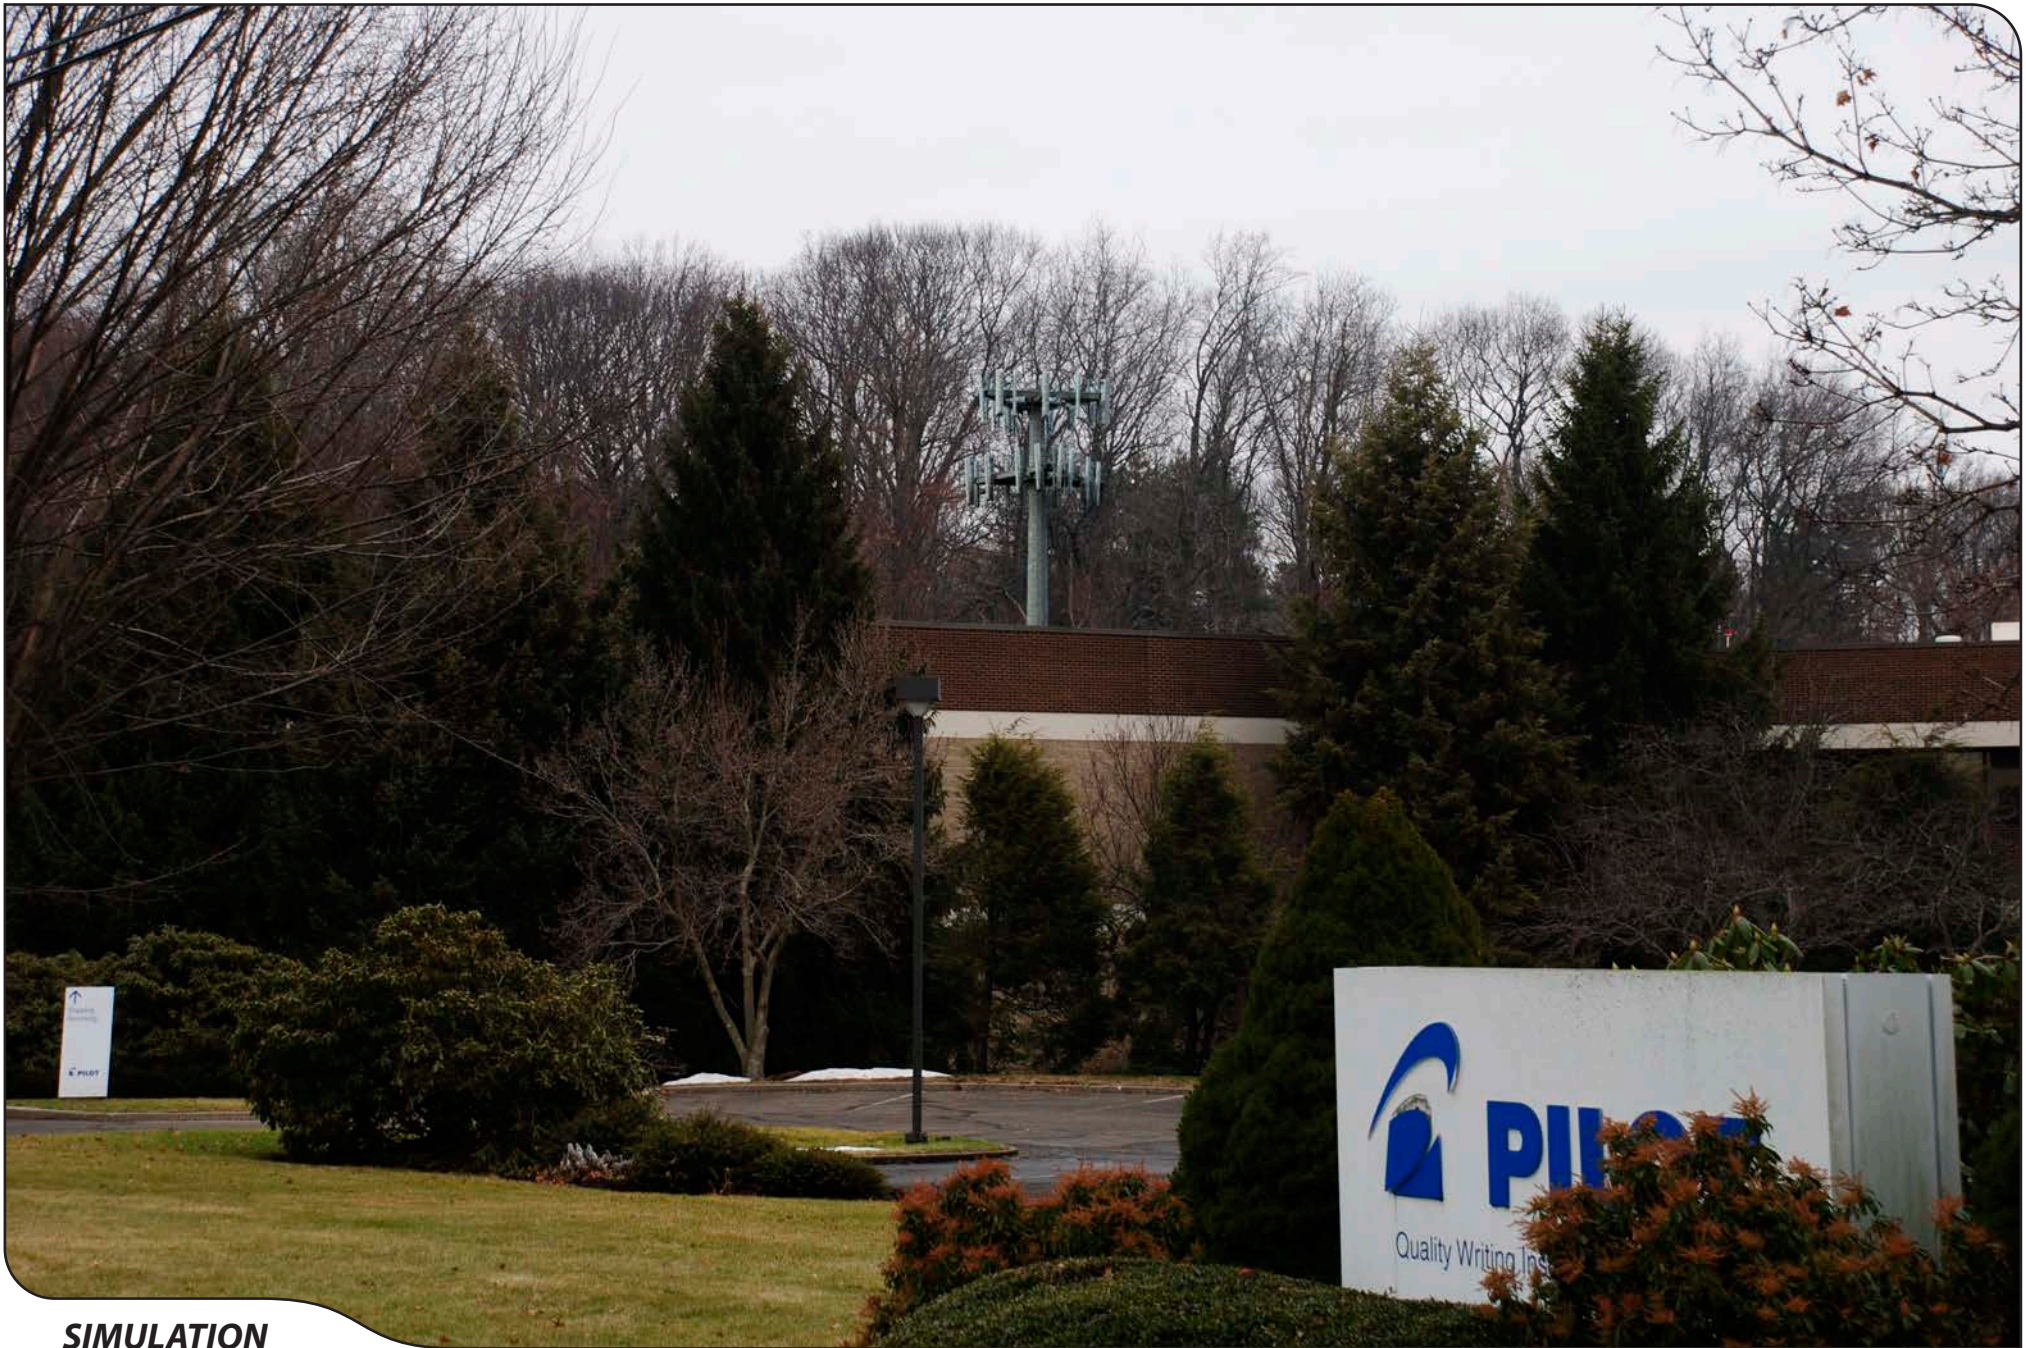
PHOTO	LOCATION	ORIENTATION	DISTANCE TO SITE	VISIBILITY
1	ENTRANCE TO PILOT PEN PROPERTY	NORTHEAST	+/- 0.10 MILE	YEAR ROUND

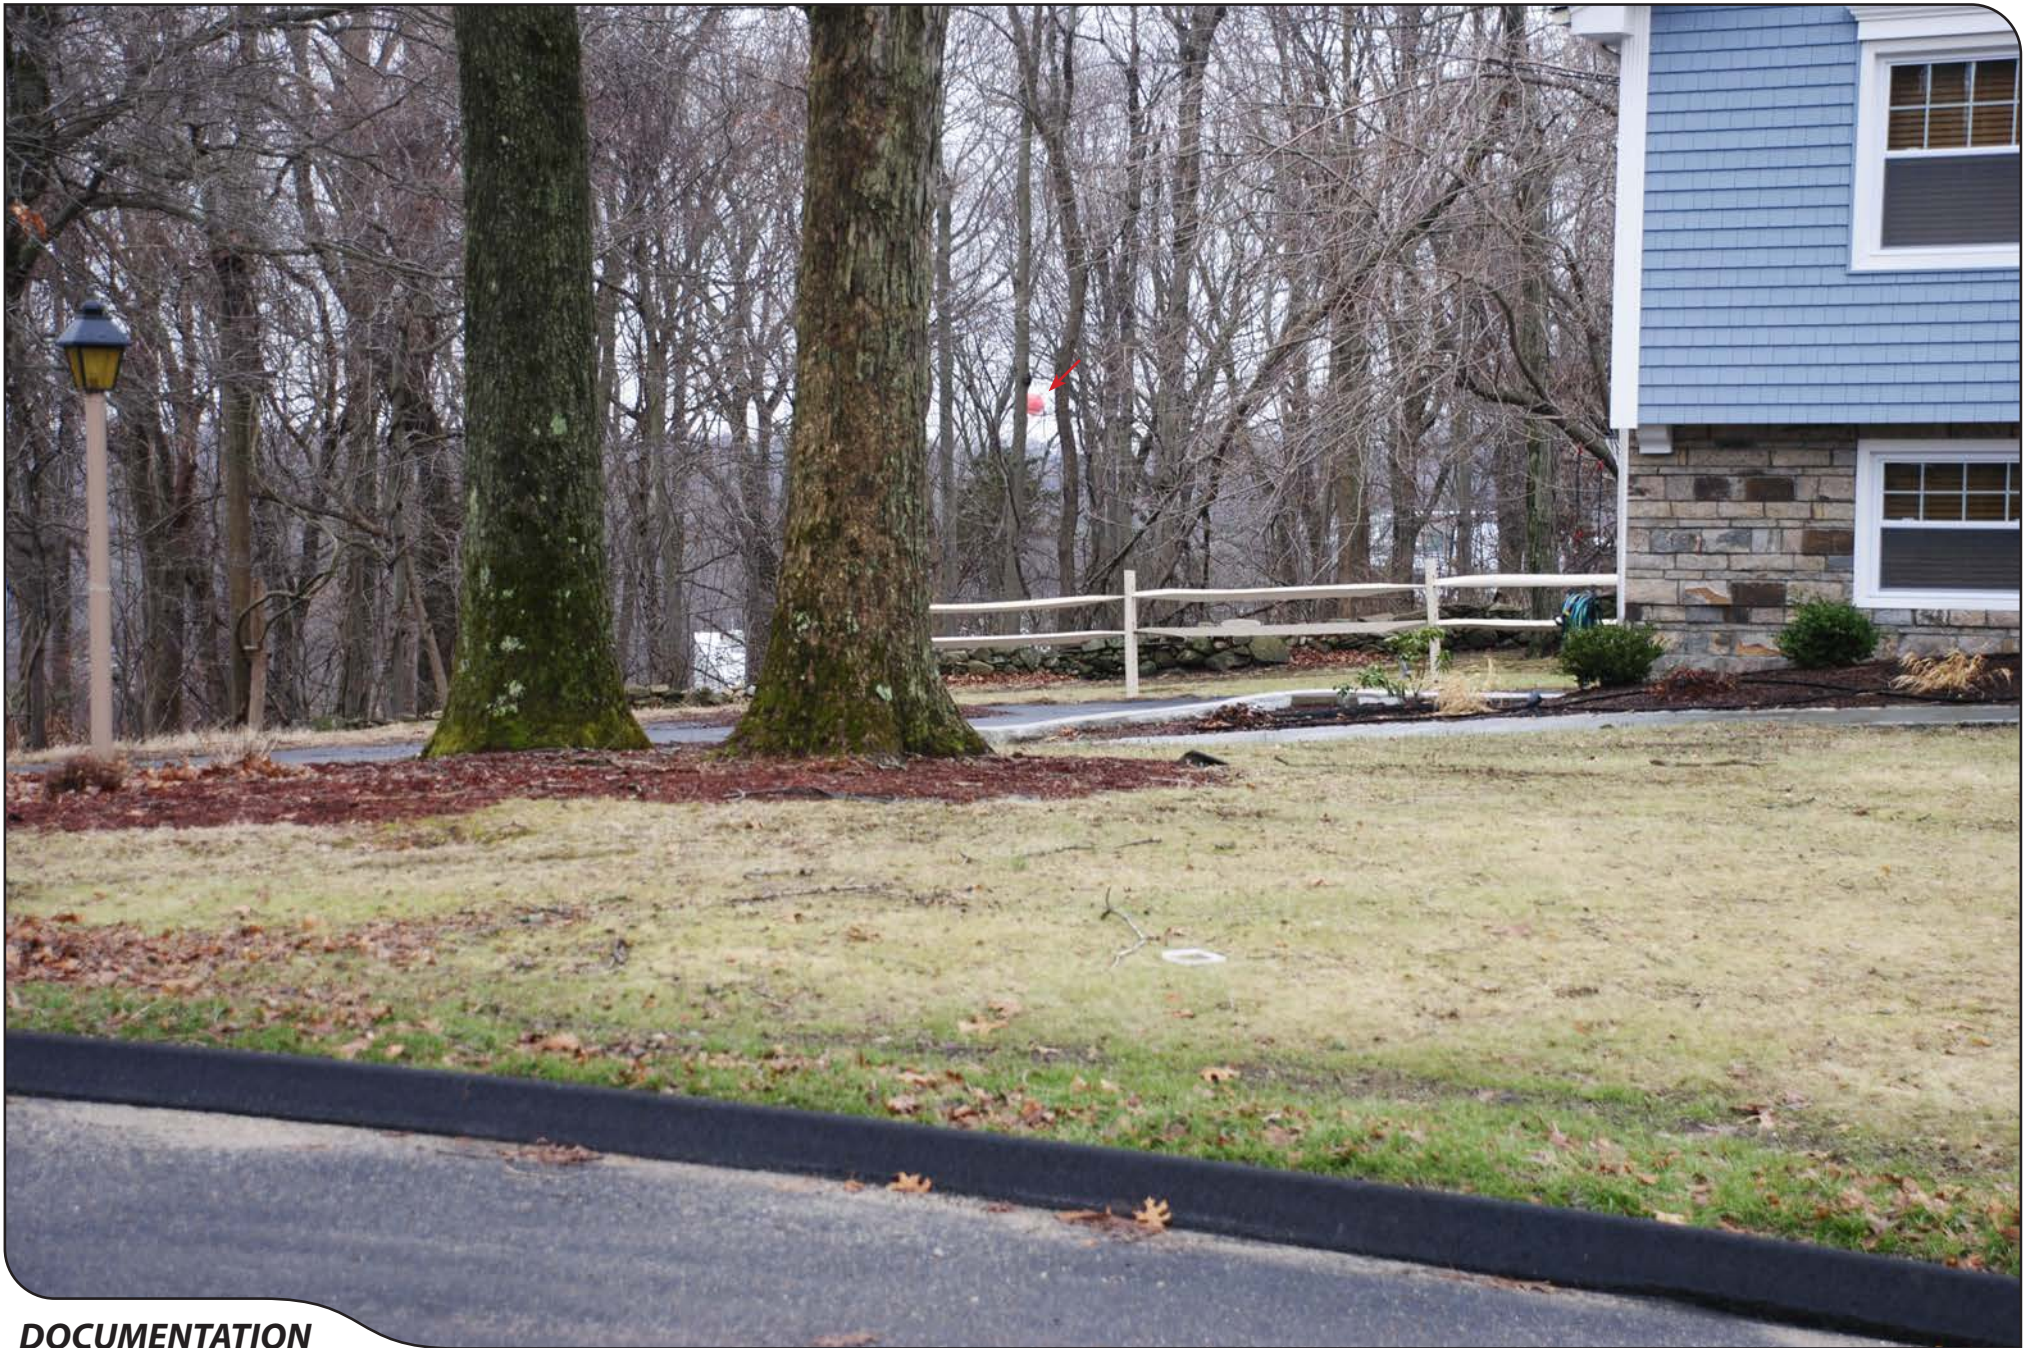
PHOTO	LOCATION	ORIENTATION	DISTANCE TO SITE	VISIBILITY
2	ADJACENT TO #16 TWIN CIRCLE DRIVE	SOUTH	+/- 0.12 MILE	YEAR ROUND

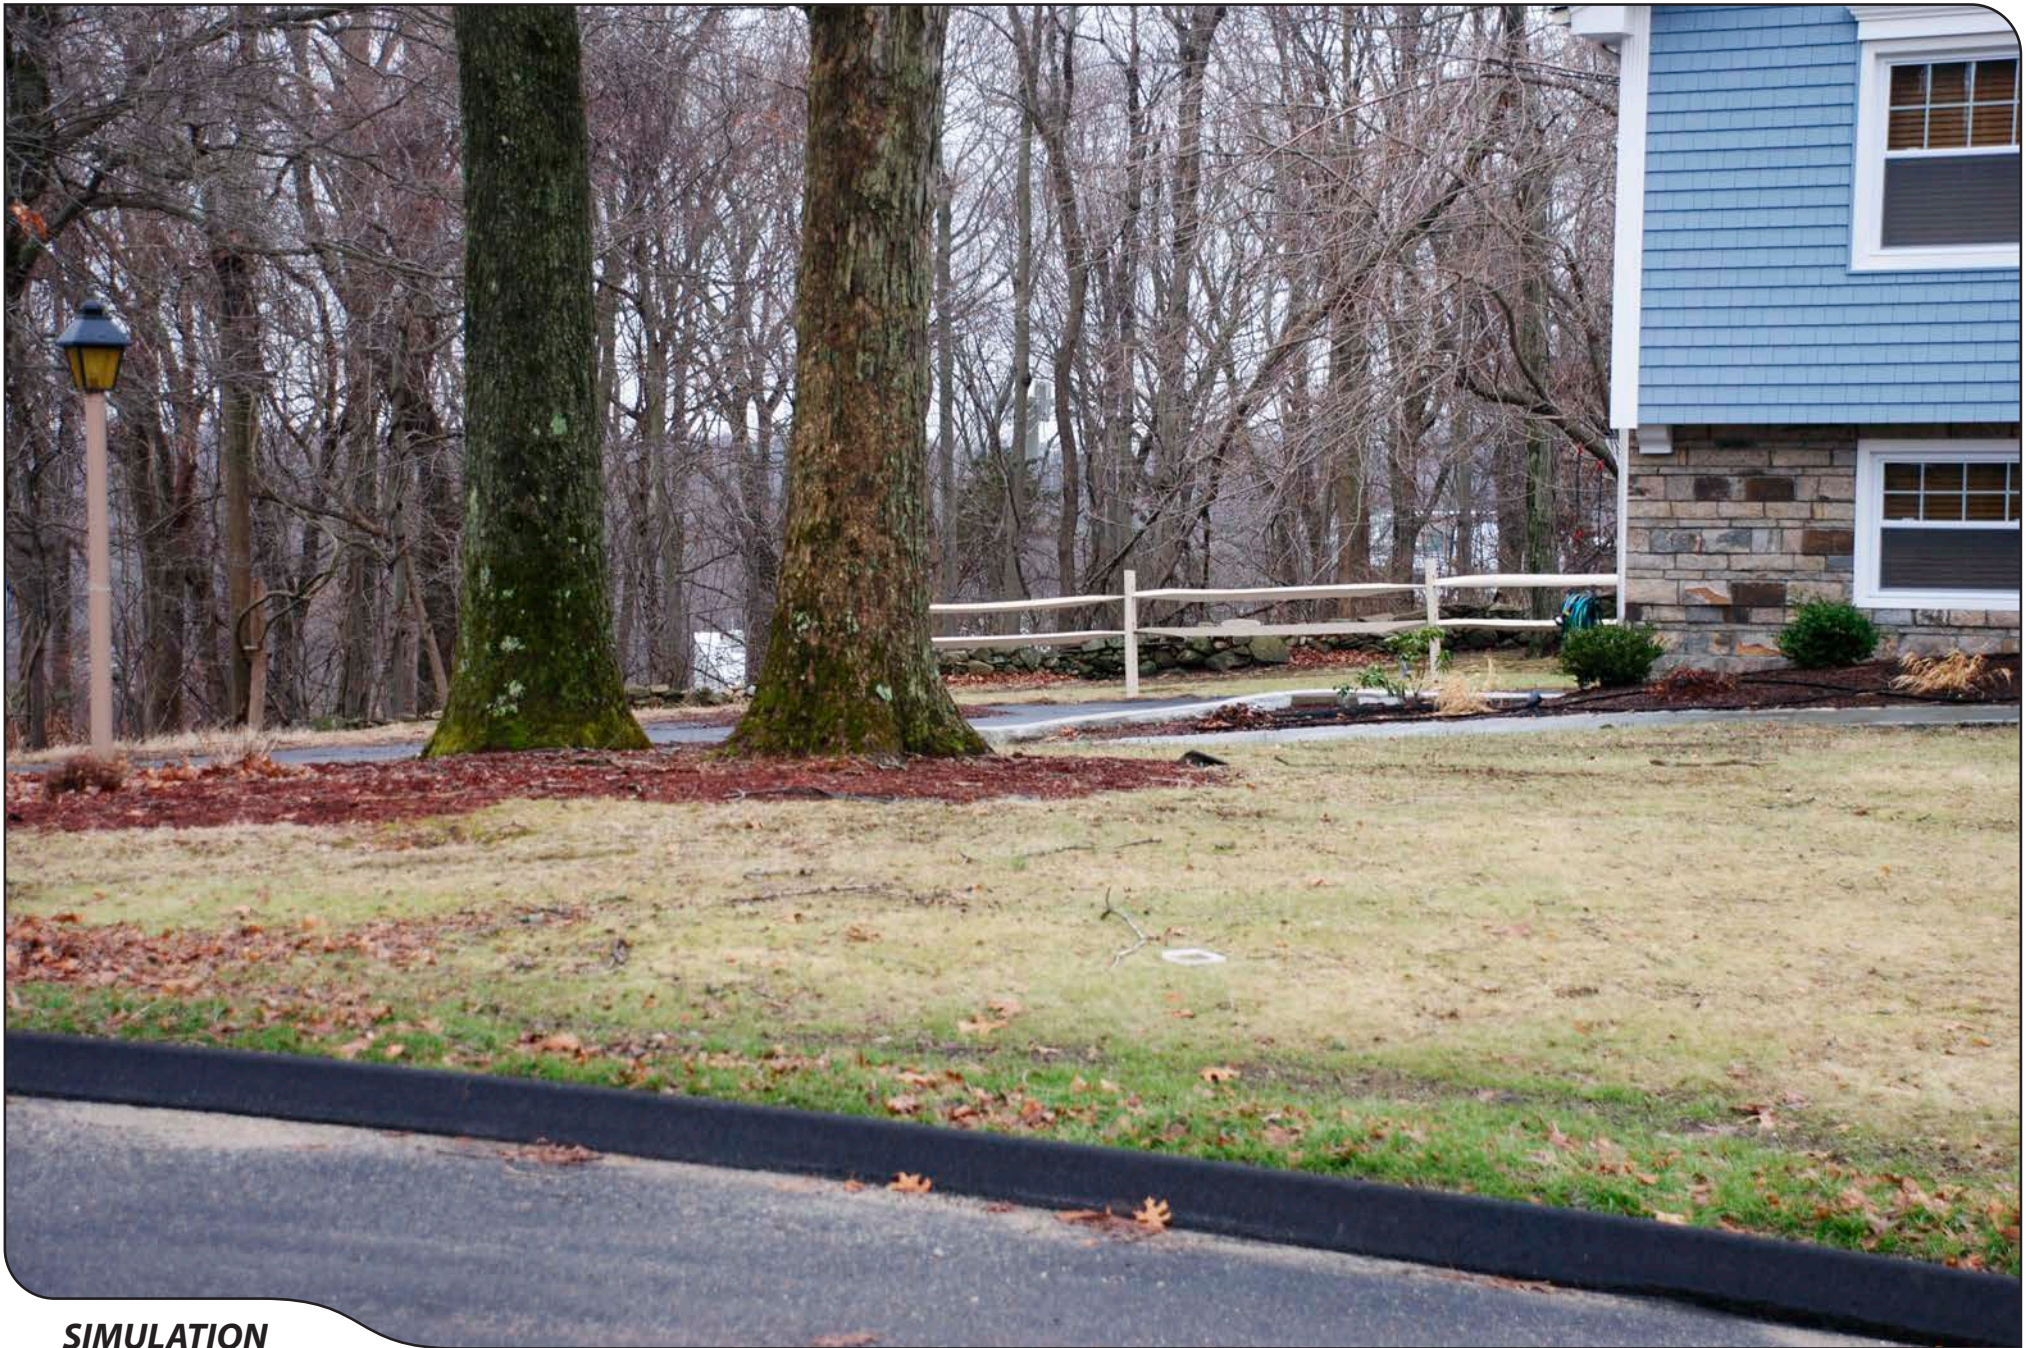
PHOTO	LOCATION	ORIENTATION	DISTANCE TO SITE	VISIBILITY
2	ADJACENT TO #16 TWIN CIRCLE DRIVE	SOUTH	+/- 0.12 MILE	YEAR ROUND

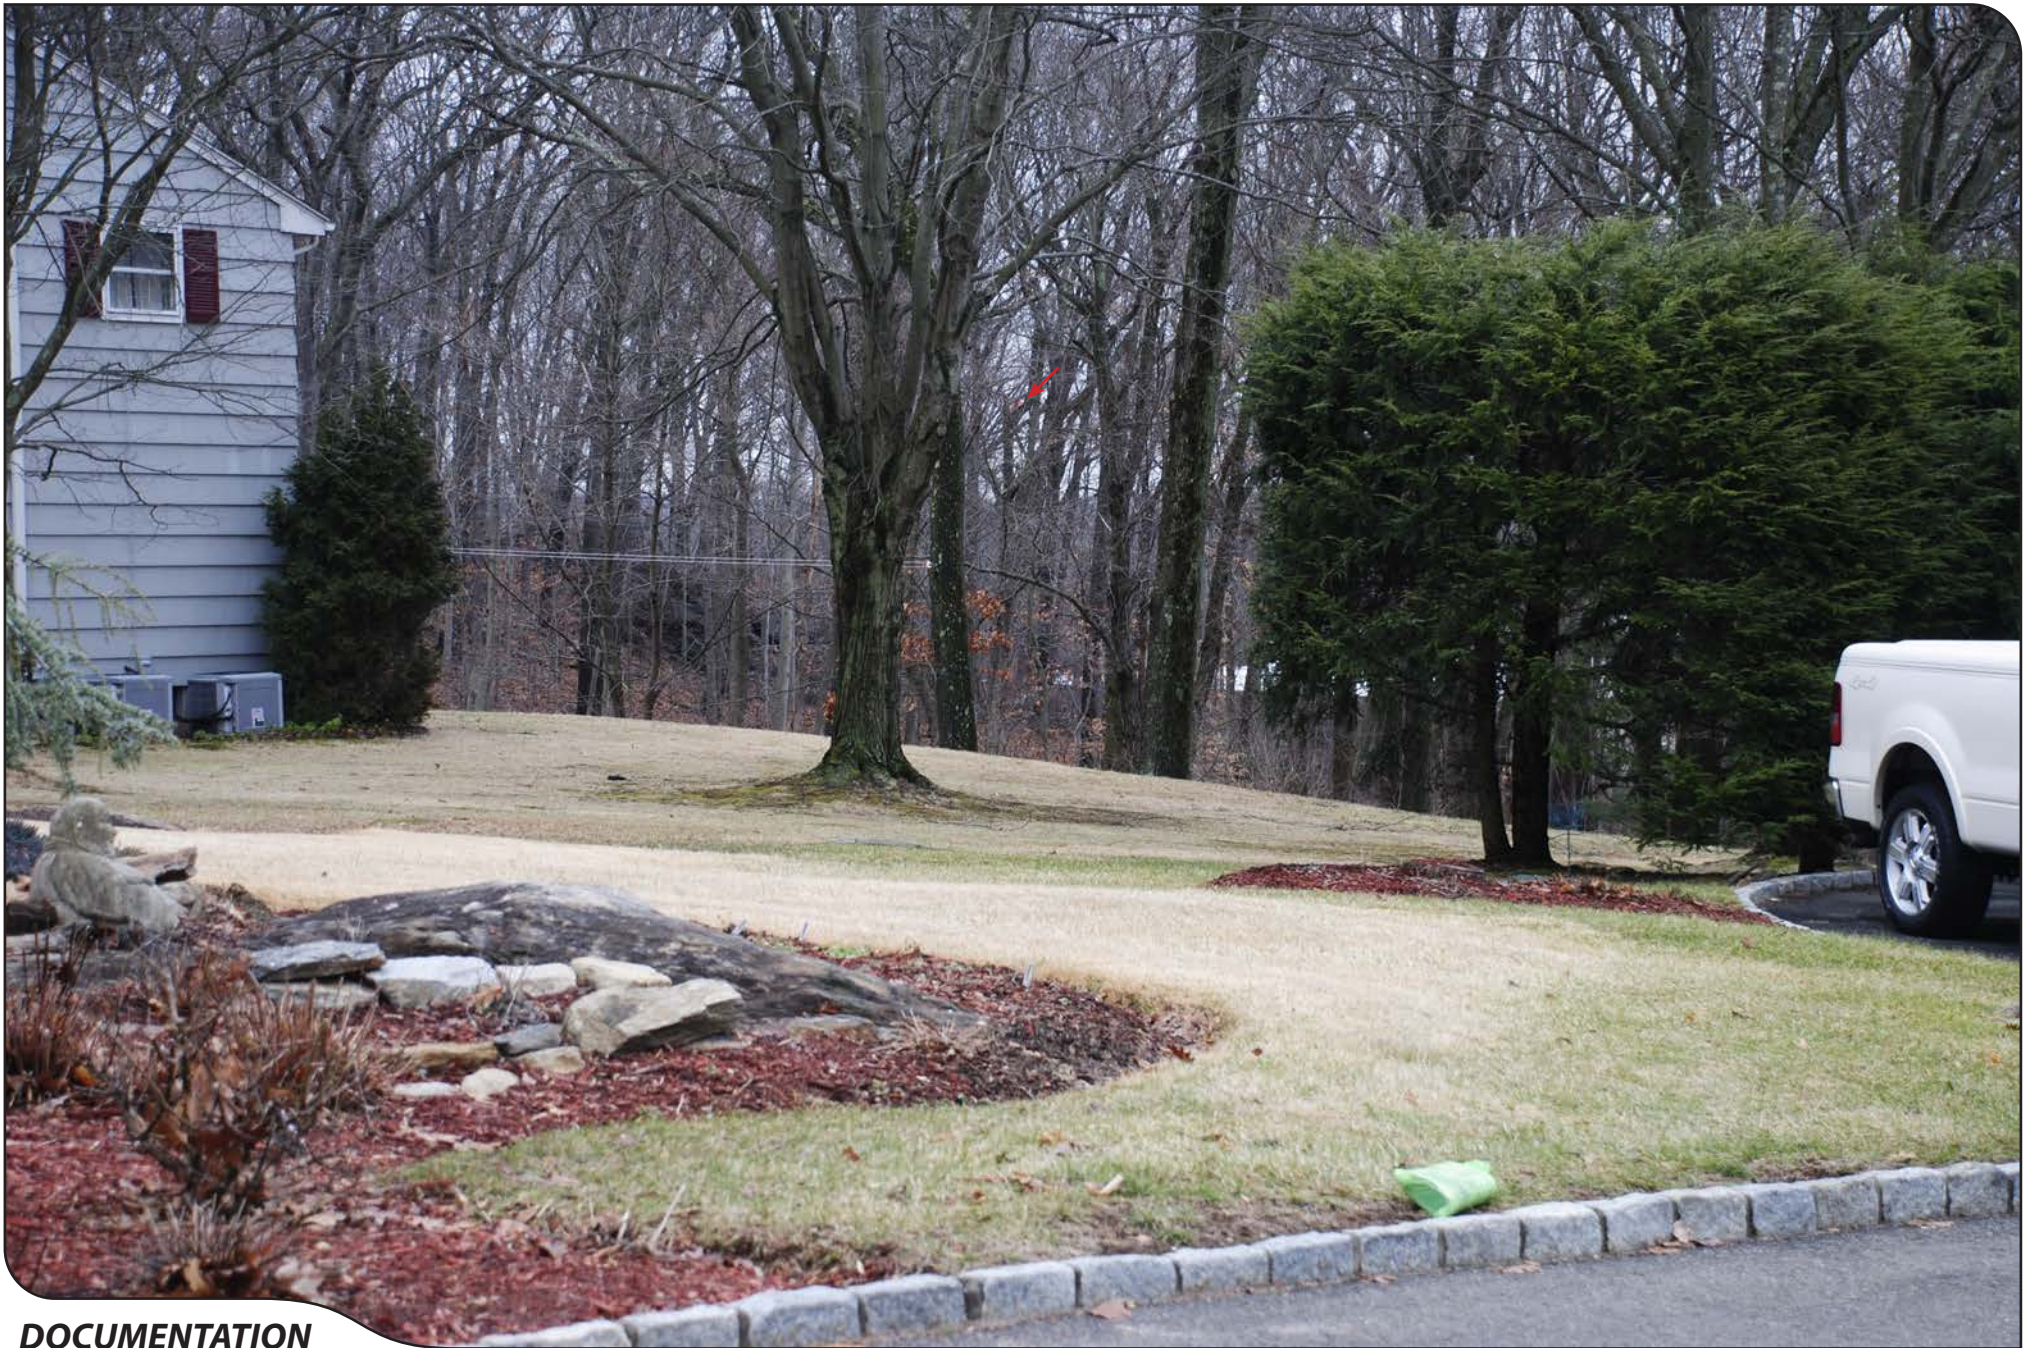
PHOTO	LOCATION	ORIENTATION	DISTANCE TO SITE	VISIBILITY
3	ADJACENT TO #41 TWIN CIRCLE DRIVE	SOUTHEAST	+/- 0.17 MILE	SEASONAL

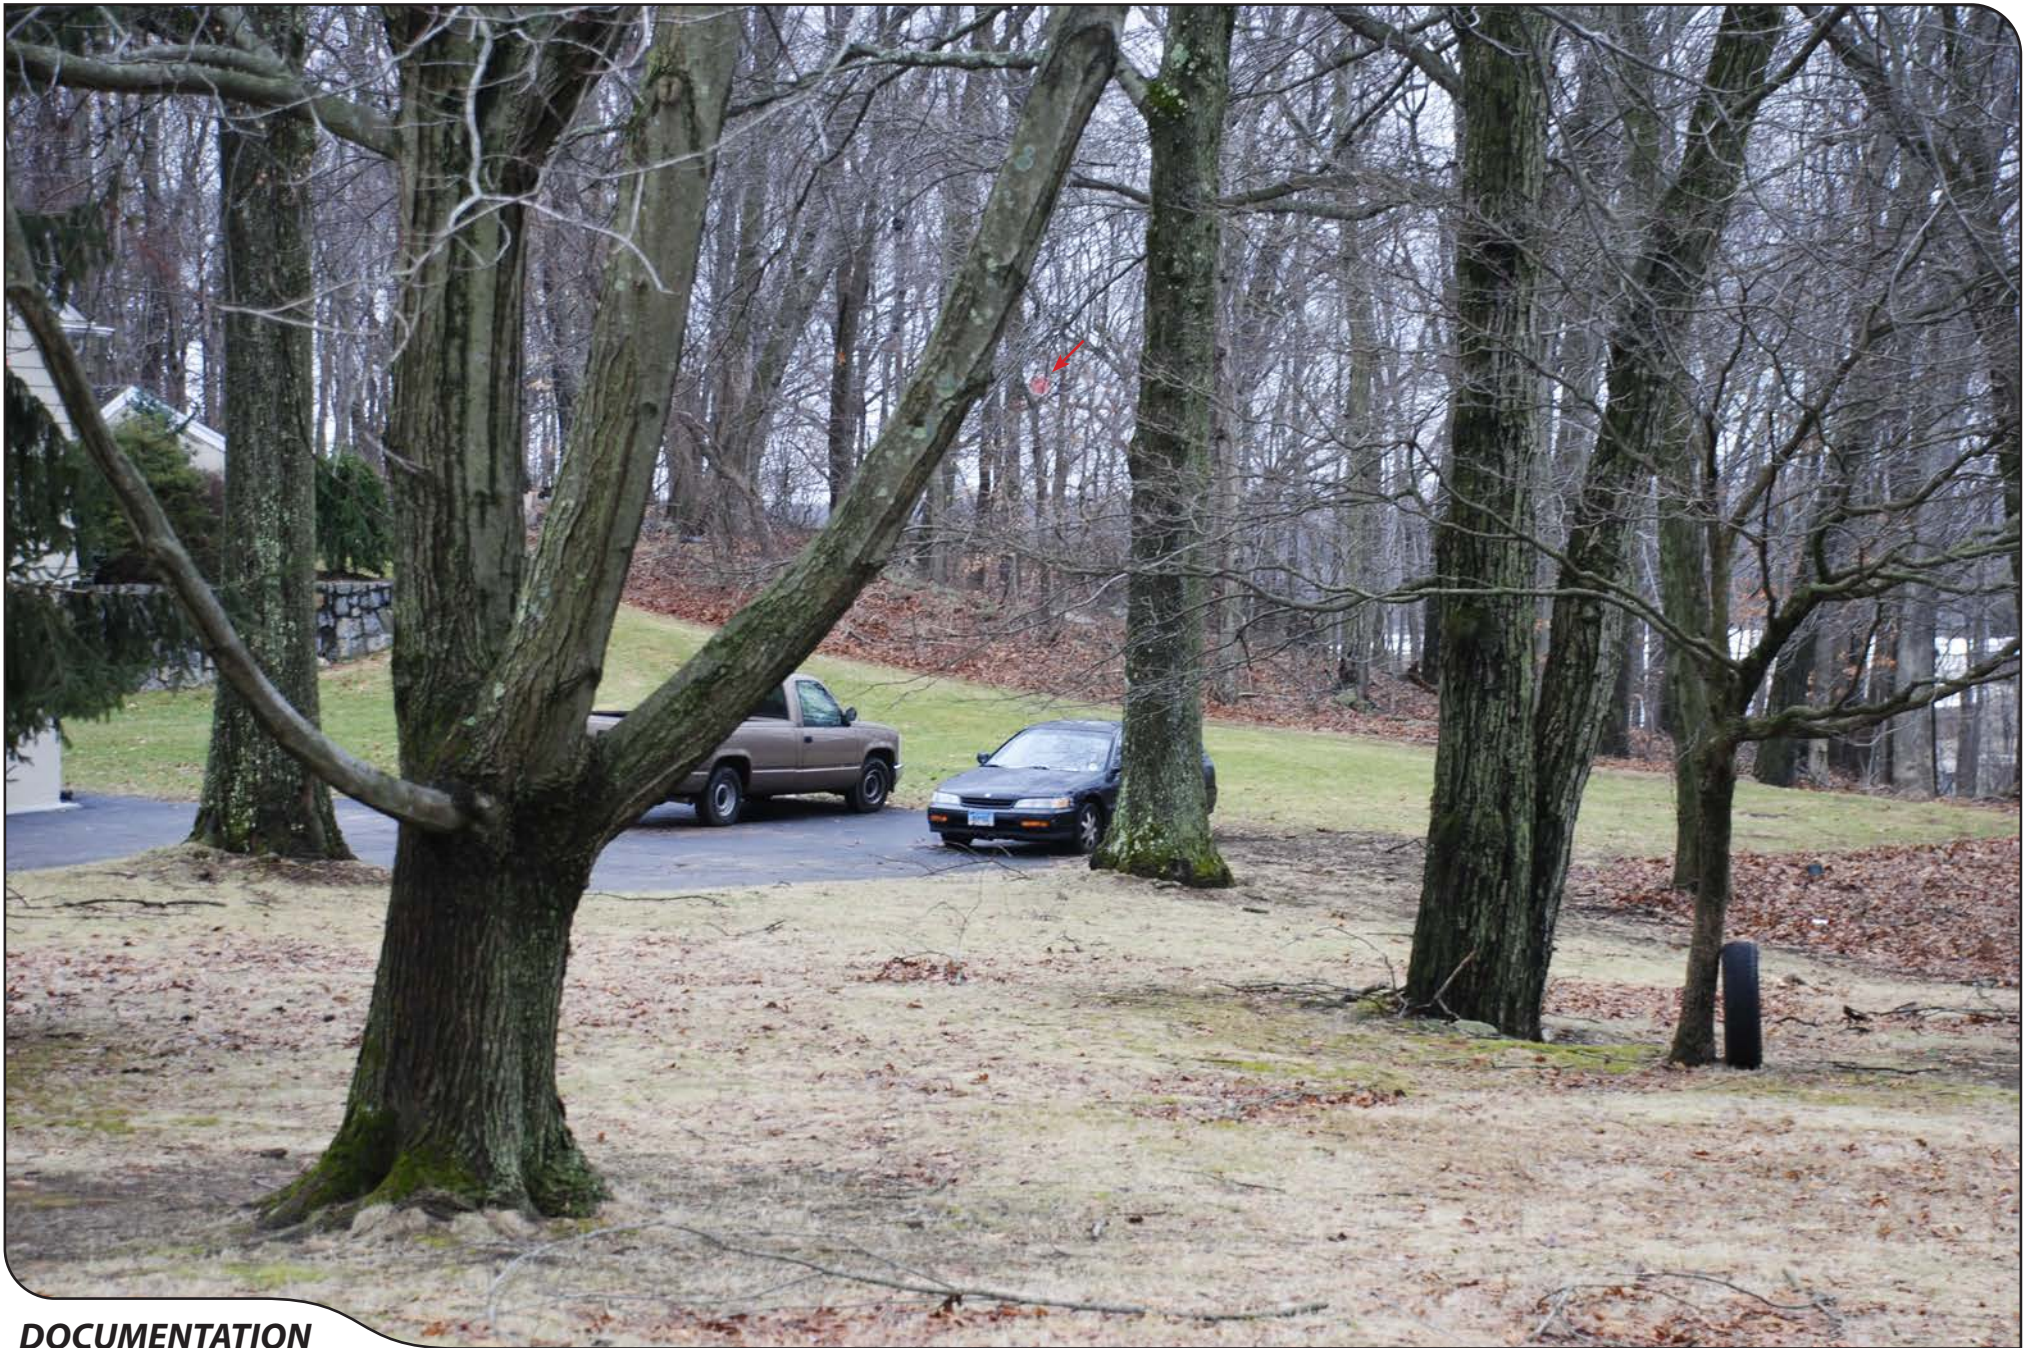
PHOTO	LOCATION	ORIENTATION	DISTANCE TO SITE	VISIBILITY
4	ADJACENT TO #27 TWIN CIRCLE DRIVE	SOUTHEAST	+/- 0.15 MILE	SEASONAL

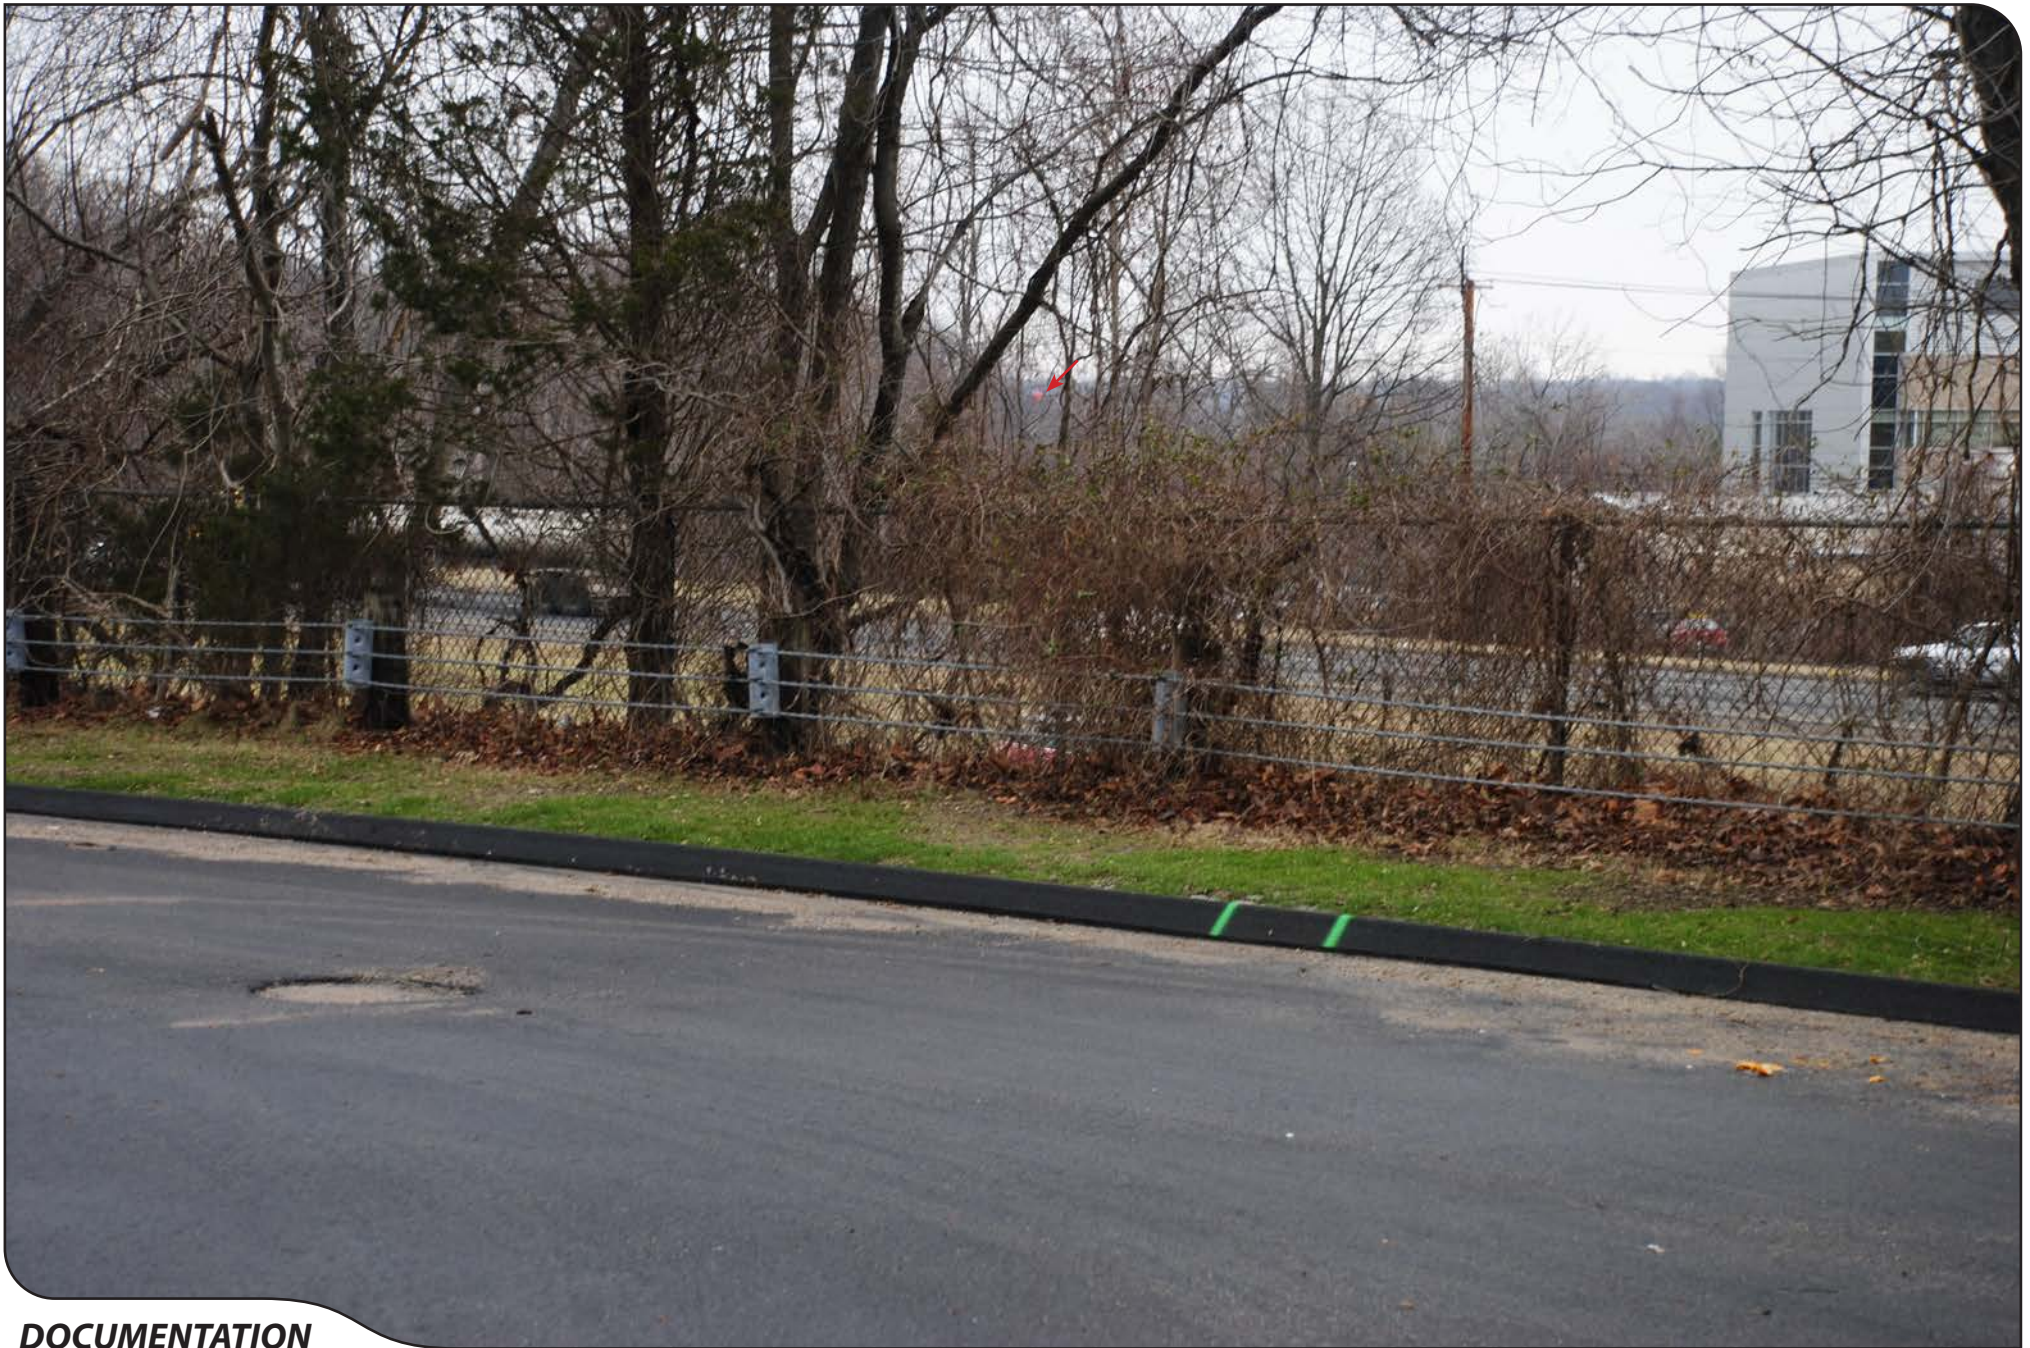
PHOTO	LOCATION	ORIENTATION	DISTANCE TO SITE	VISIBILITY
5	ST. JOHNS DRIVE	NORTHEAST	+/- 0.38 MILE	YEAR ROUND

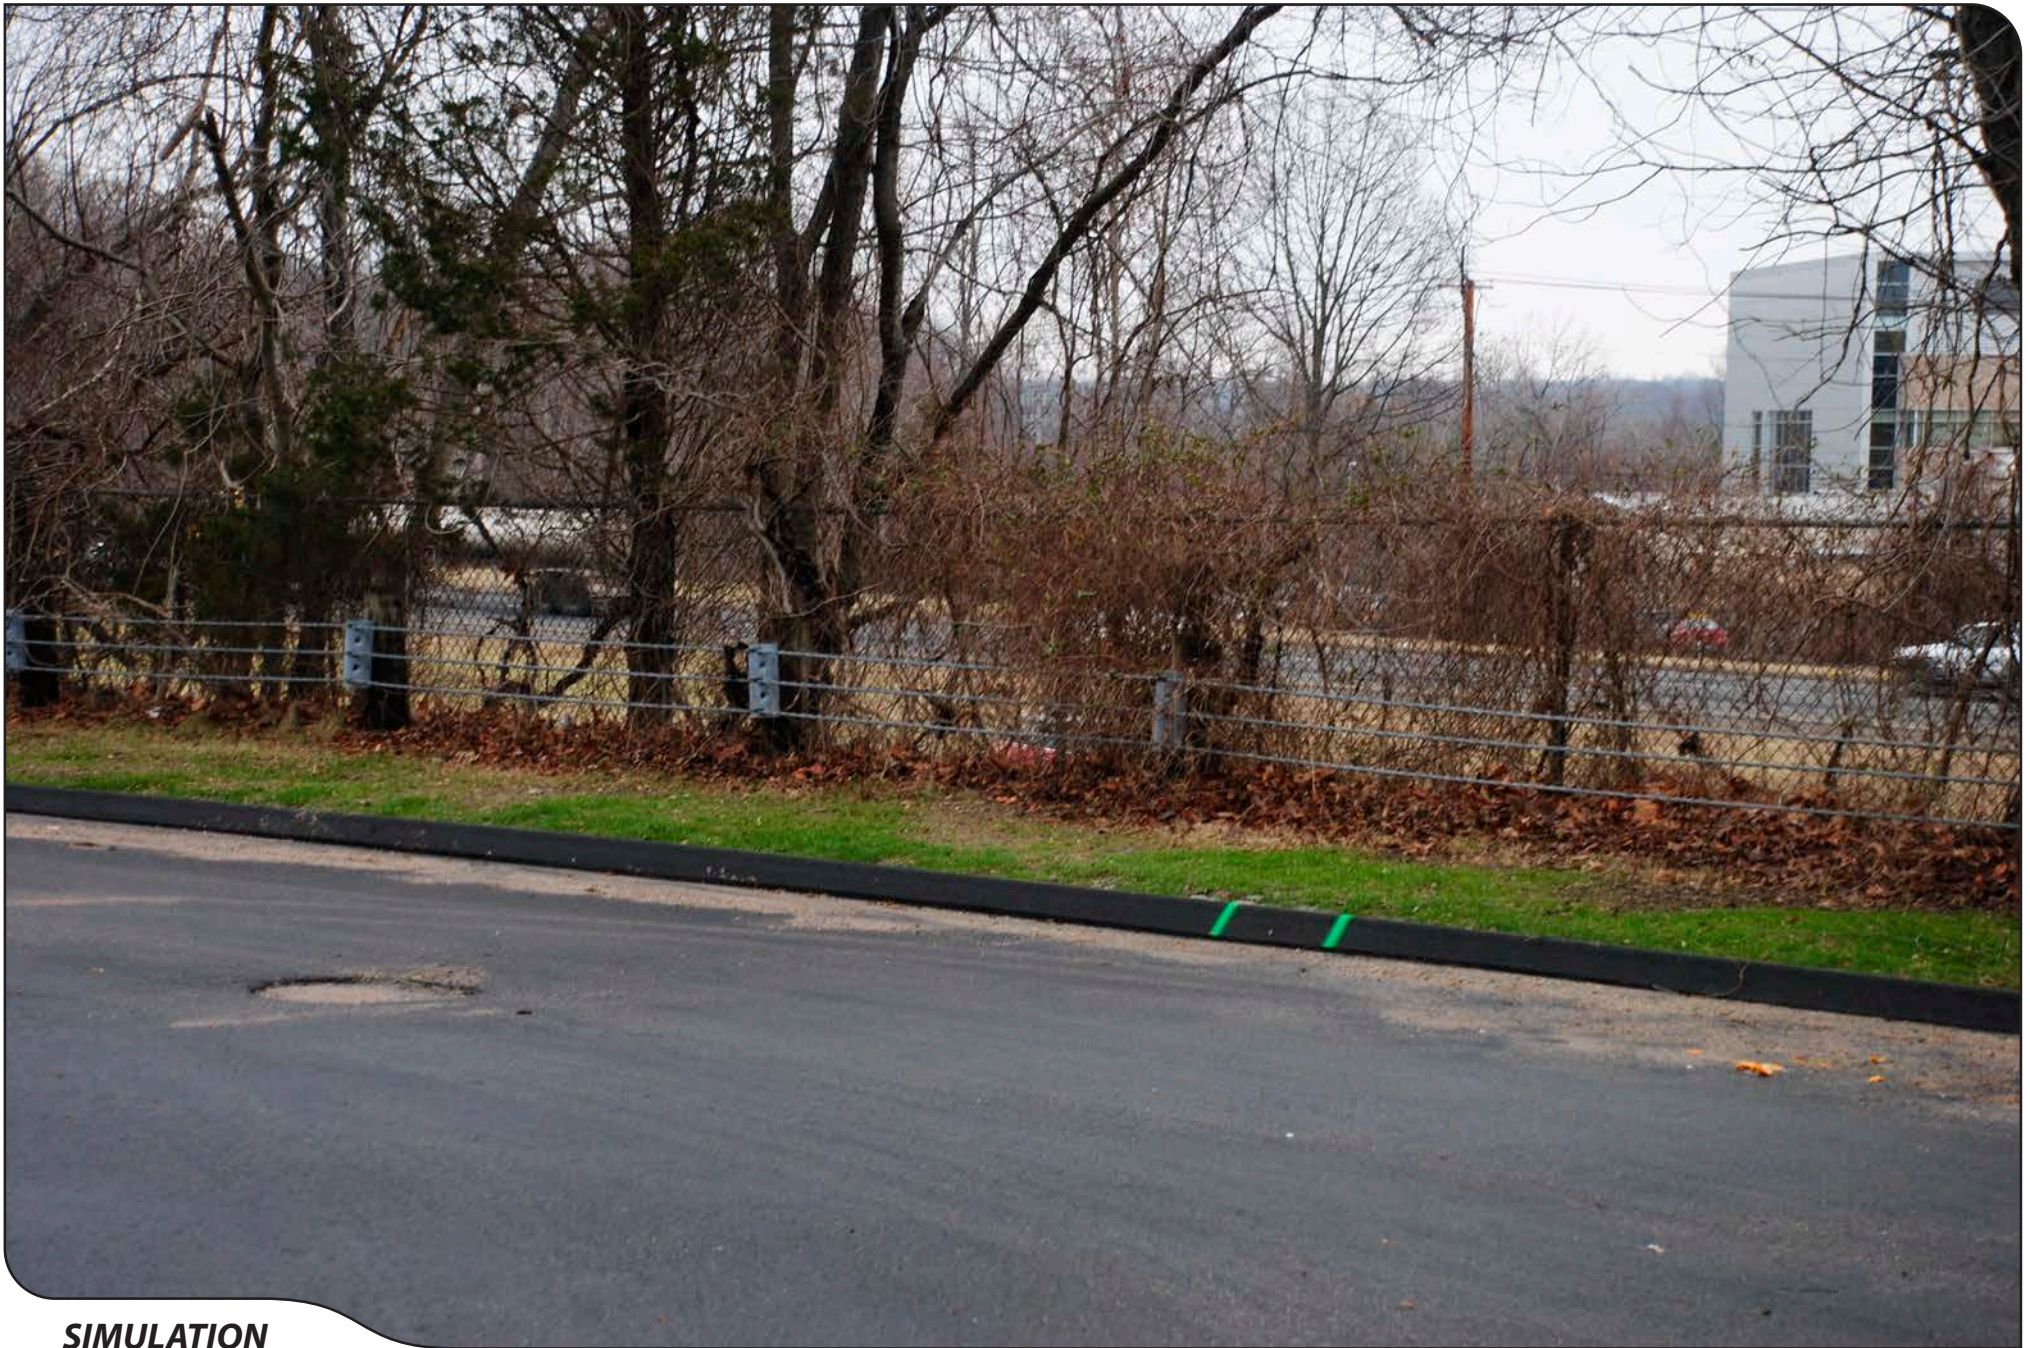
PHOTO	LOCATION	ORIENTATION	DISTANCE TO SITE	VISIBILITY
5	ST. JOHNS DRIVE	NORTHEAST	+/- 0.38 MILE	YEAR ROUND
