Photographic Simulations

TRUMBULL SE 4
60 COMMERCE DRIVE
TRUMBULL, CT 06611

*Prepared in February 2014 by:
All-Points Technology Corporation, P.C.
3 Saddlebrook Drive
Killingworth, CT 06141*

Prepared for Verizon Wireless

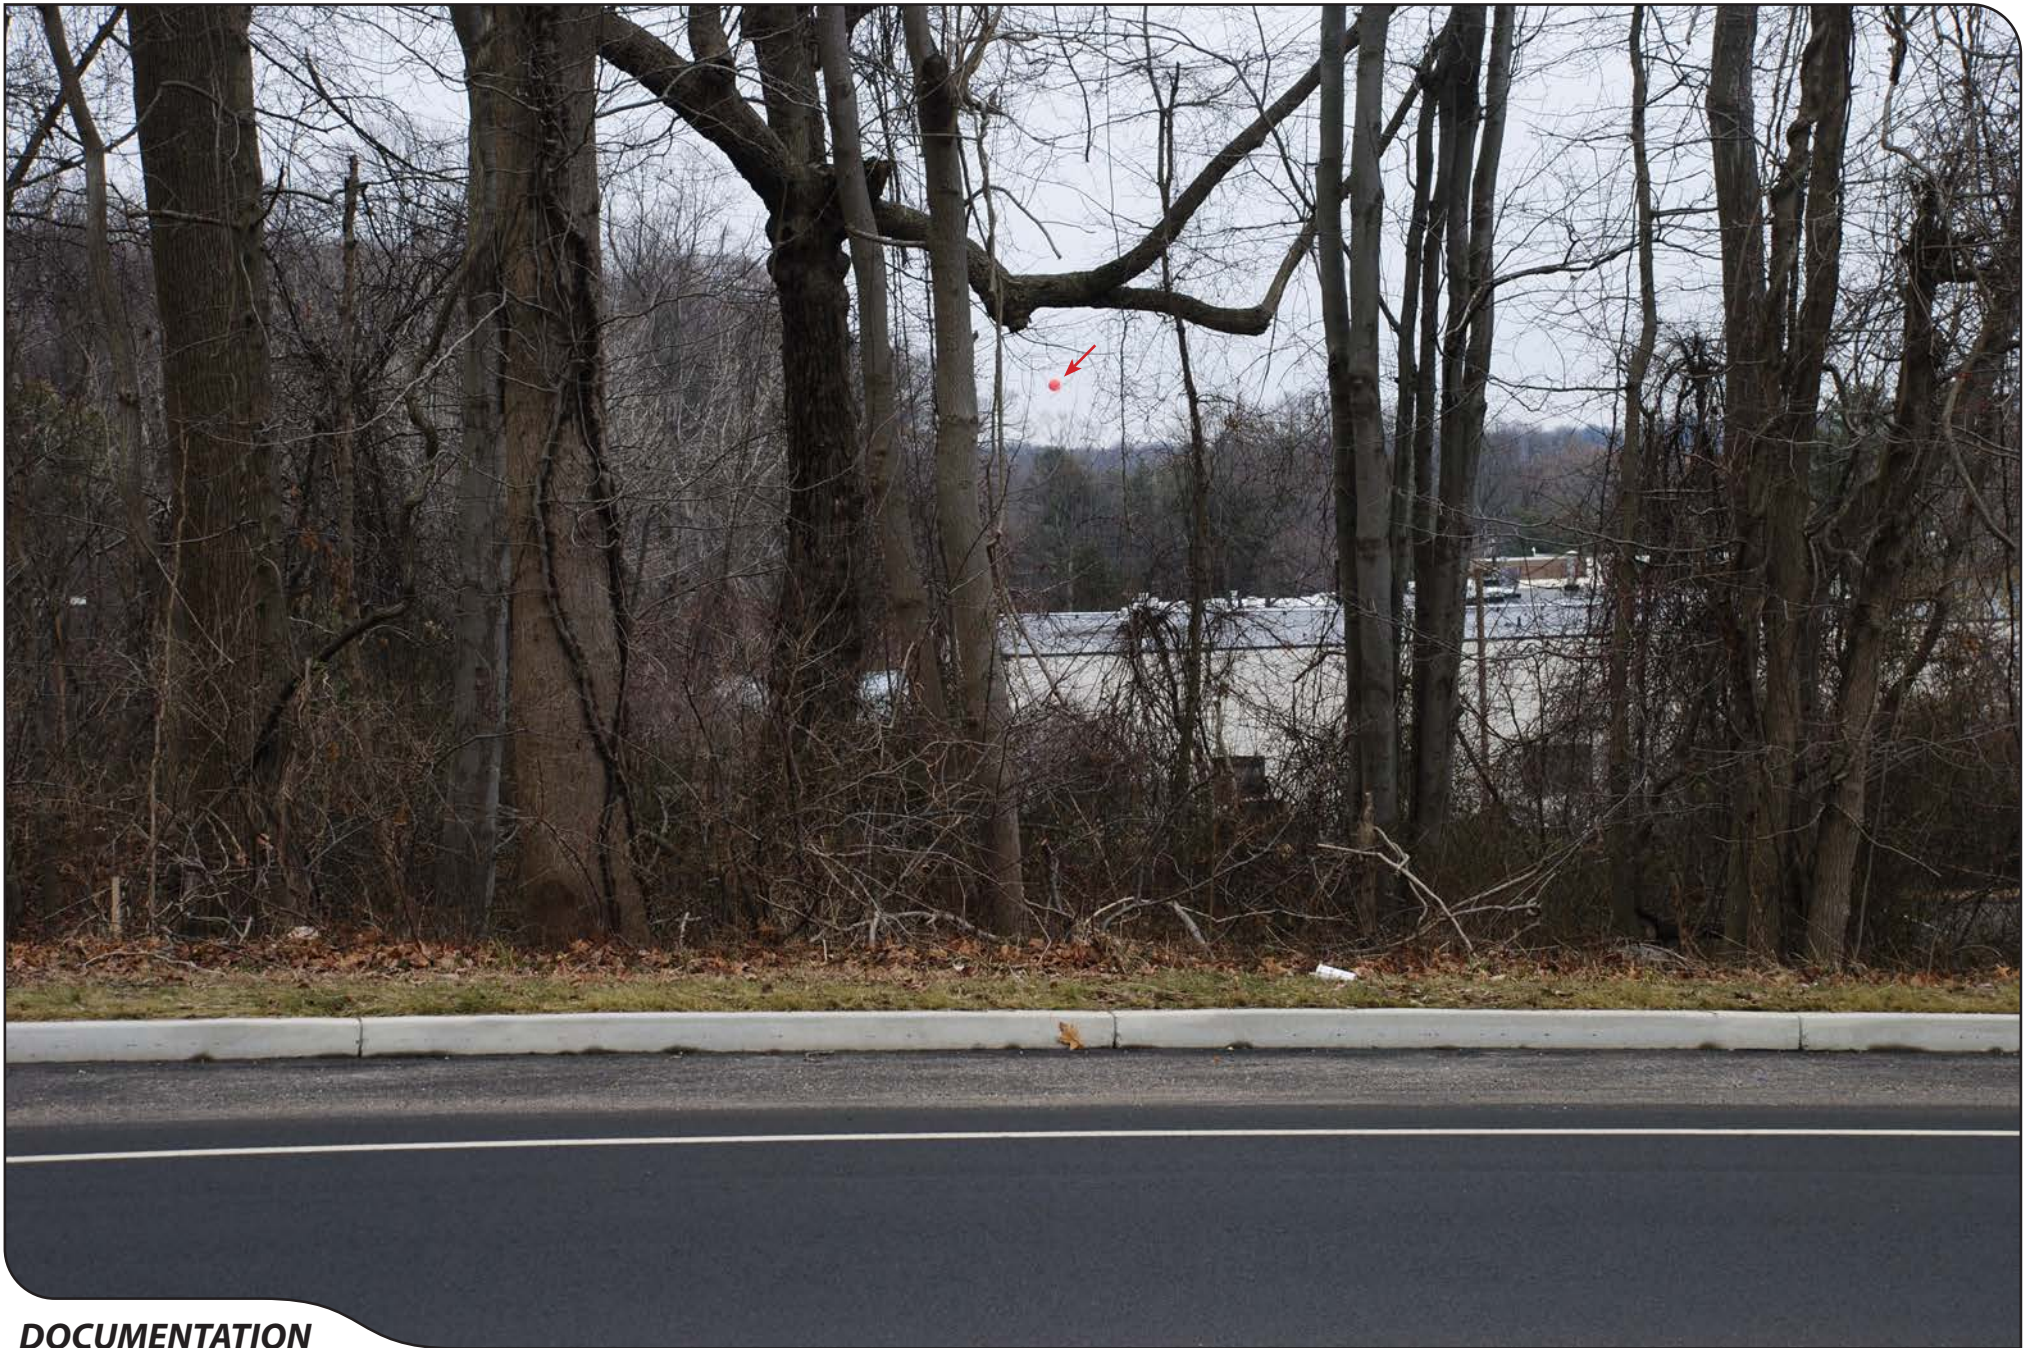
PHOTO	LOCATION	ORIENTATION	DISTANCE TO SITE	VISIBILITY
6	MERRITT BOULEVARD	NORTHEAST	+/- 0.21 MILE	YEAR ROUND

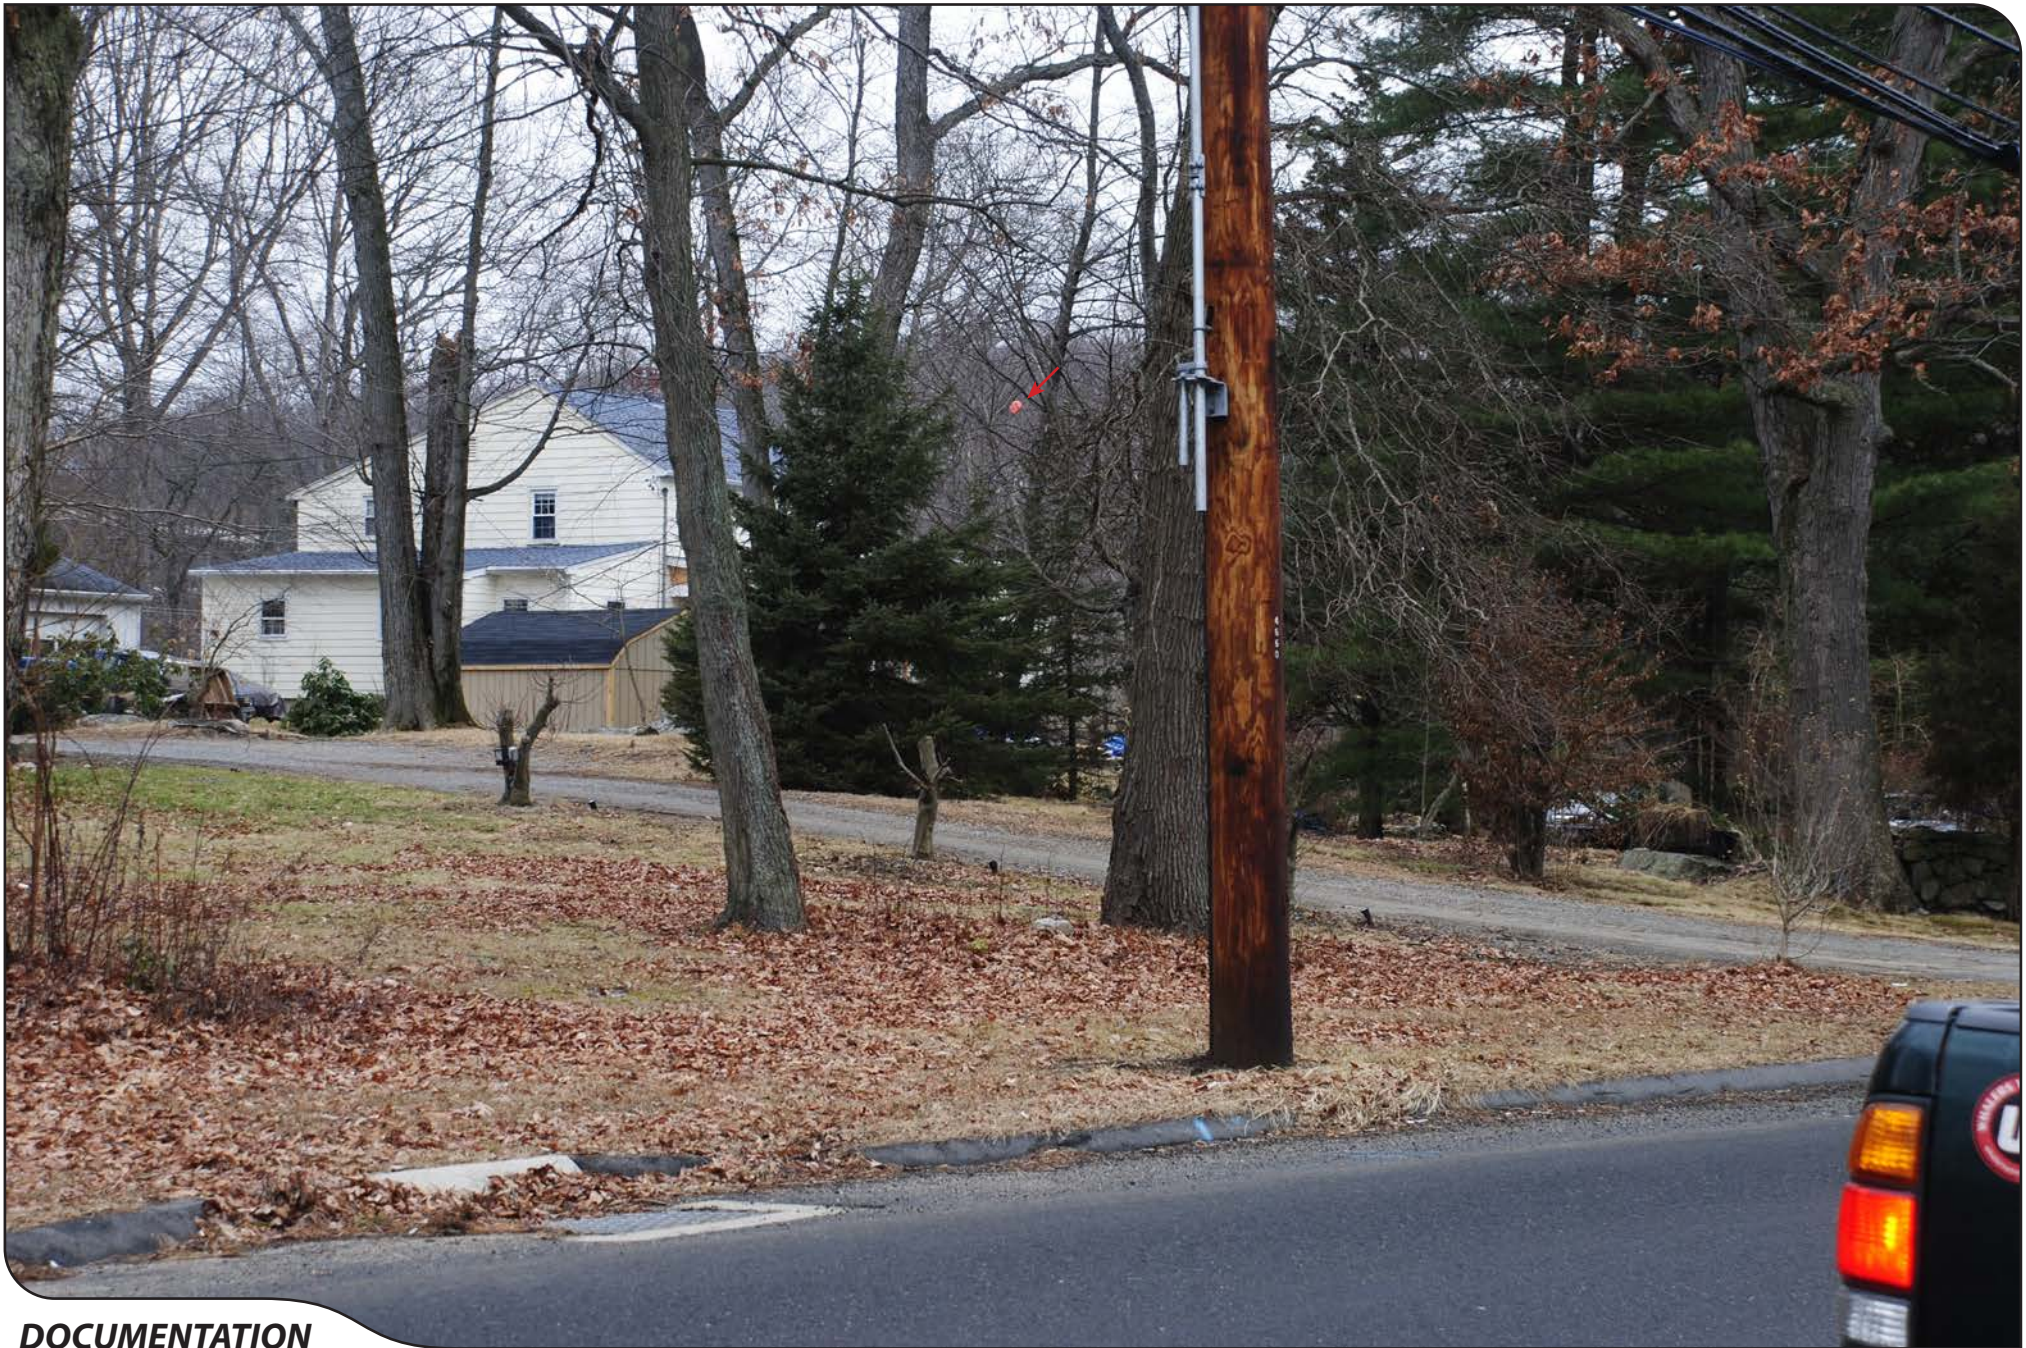
PHOTO	LOCATION	ORIENTATION	DISTANCE TO SITE	VISIBILITY
7	ADJACENT TO #2771 HUNTINGTON ROAD	NORTHWEST	+/- 0.22 MILE	SEASONAL

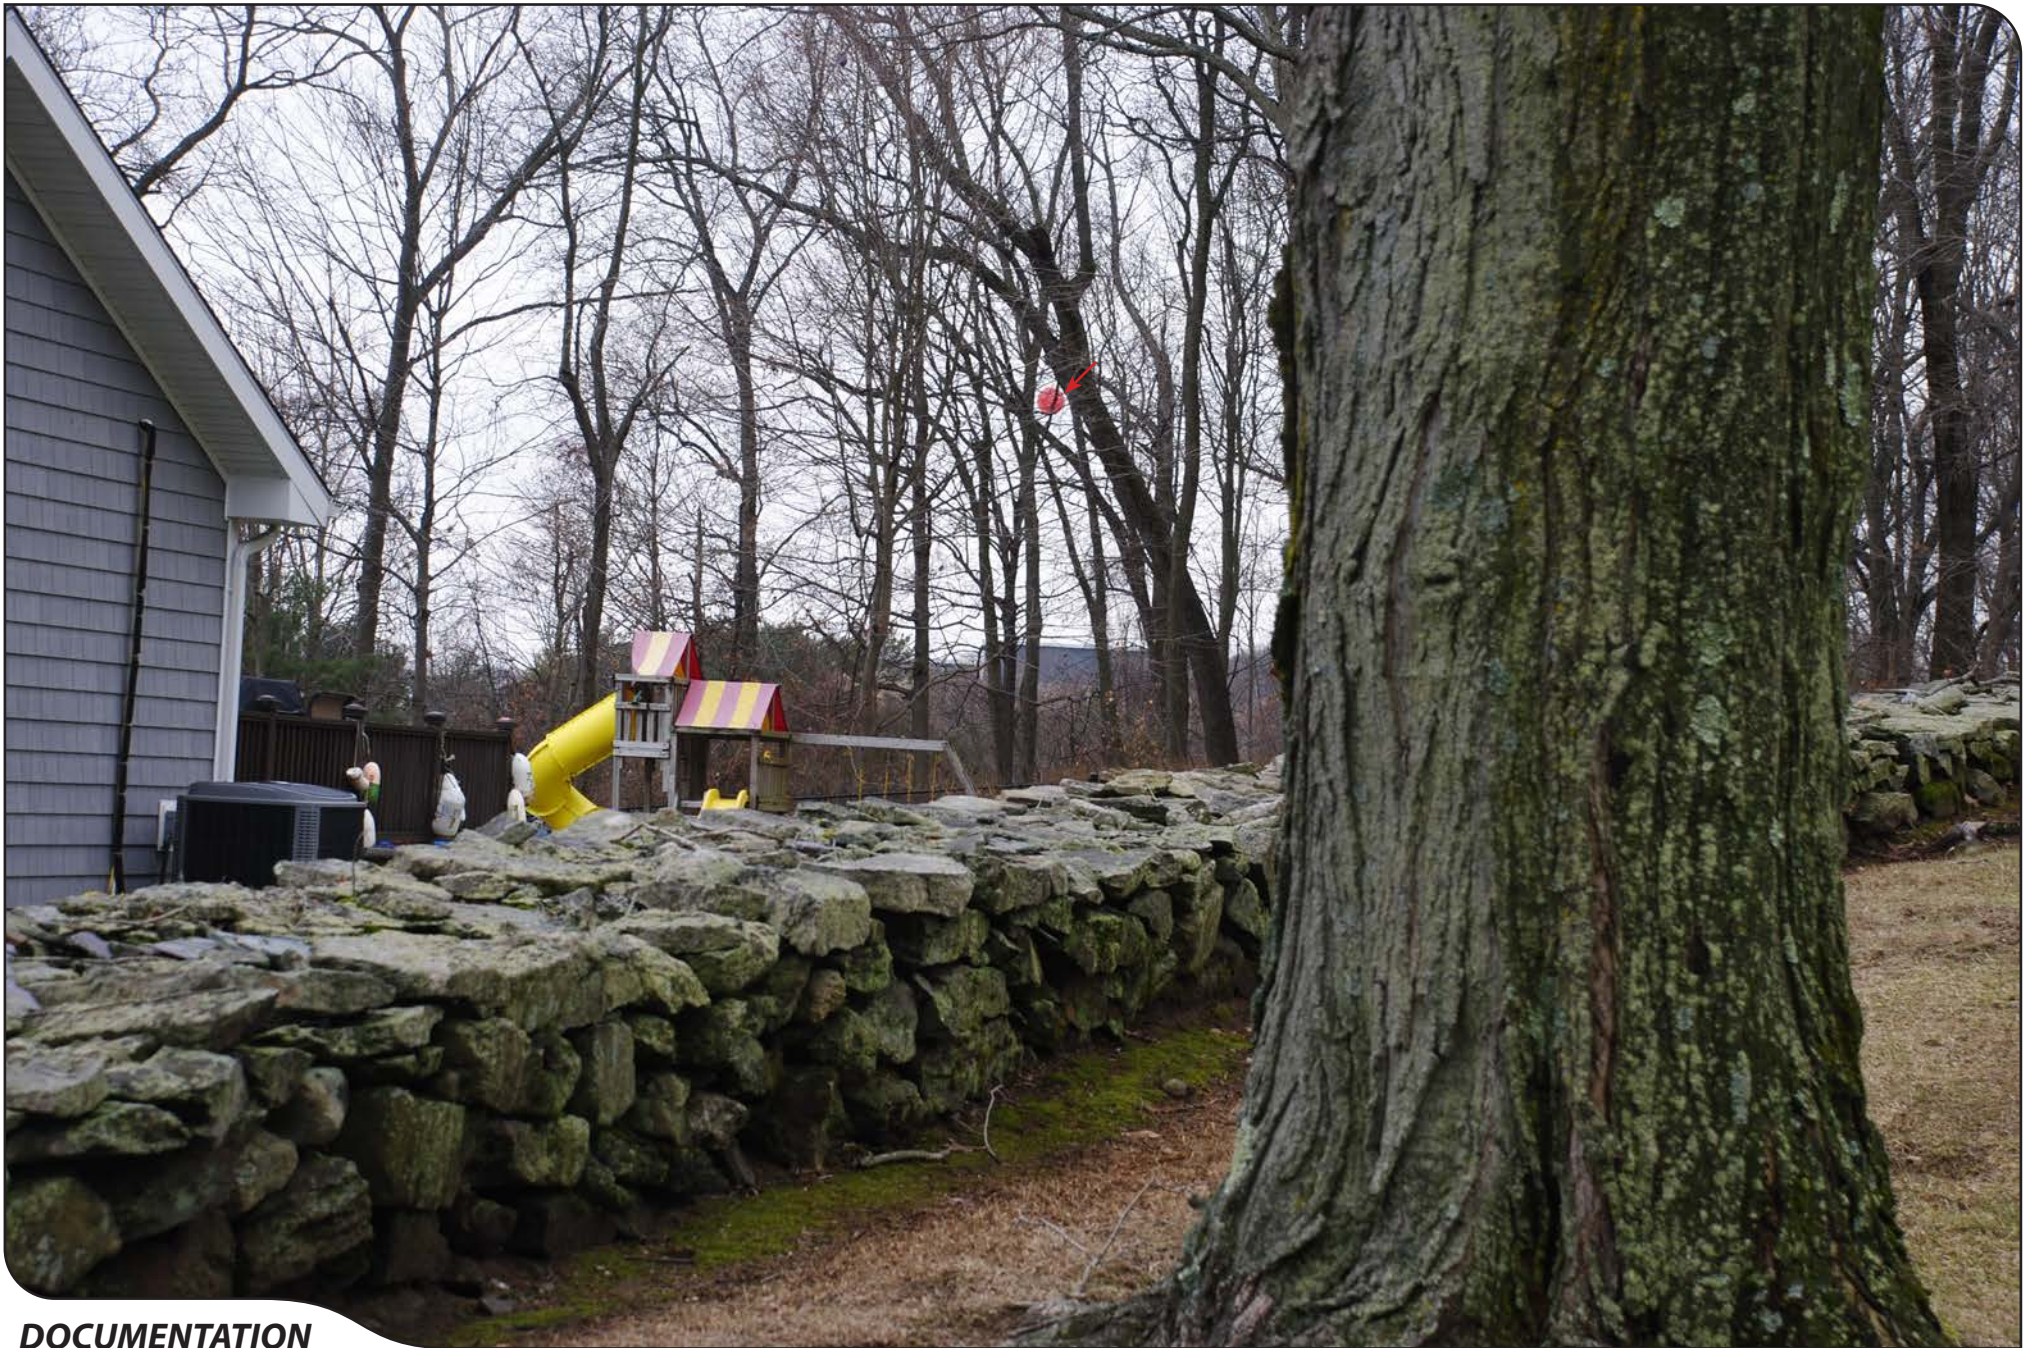
PHOTO	LOCATION	ORIENTATION	DISTANCE TO SITE	VISIBILITY
8	ADJACENT TO #2975 HUNTINGTON ROAD	SOUTHWEST	+/- 0.09 MILE	YEAR ROUND

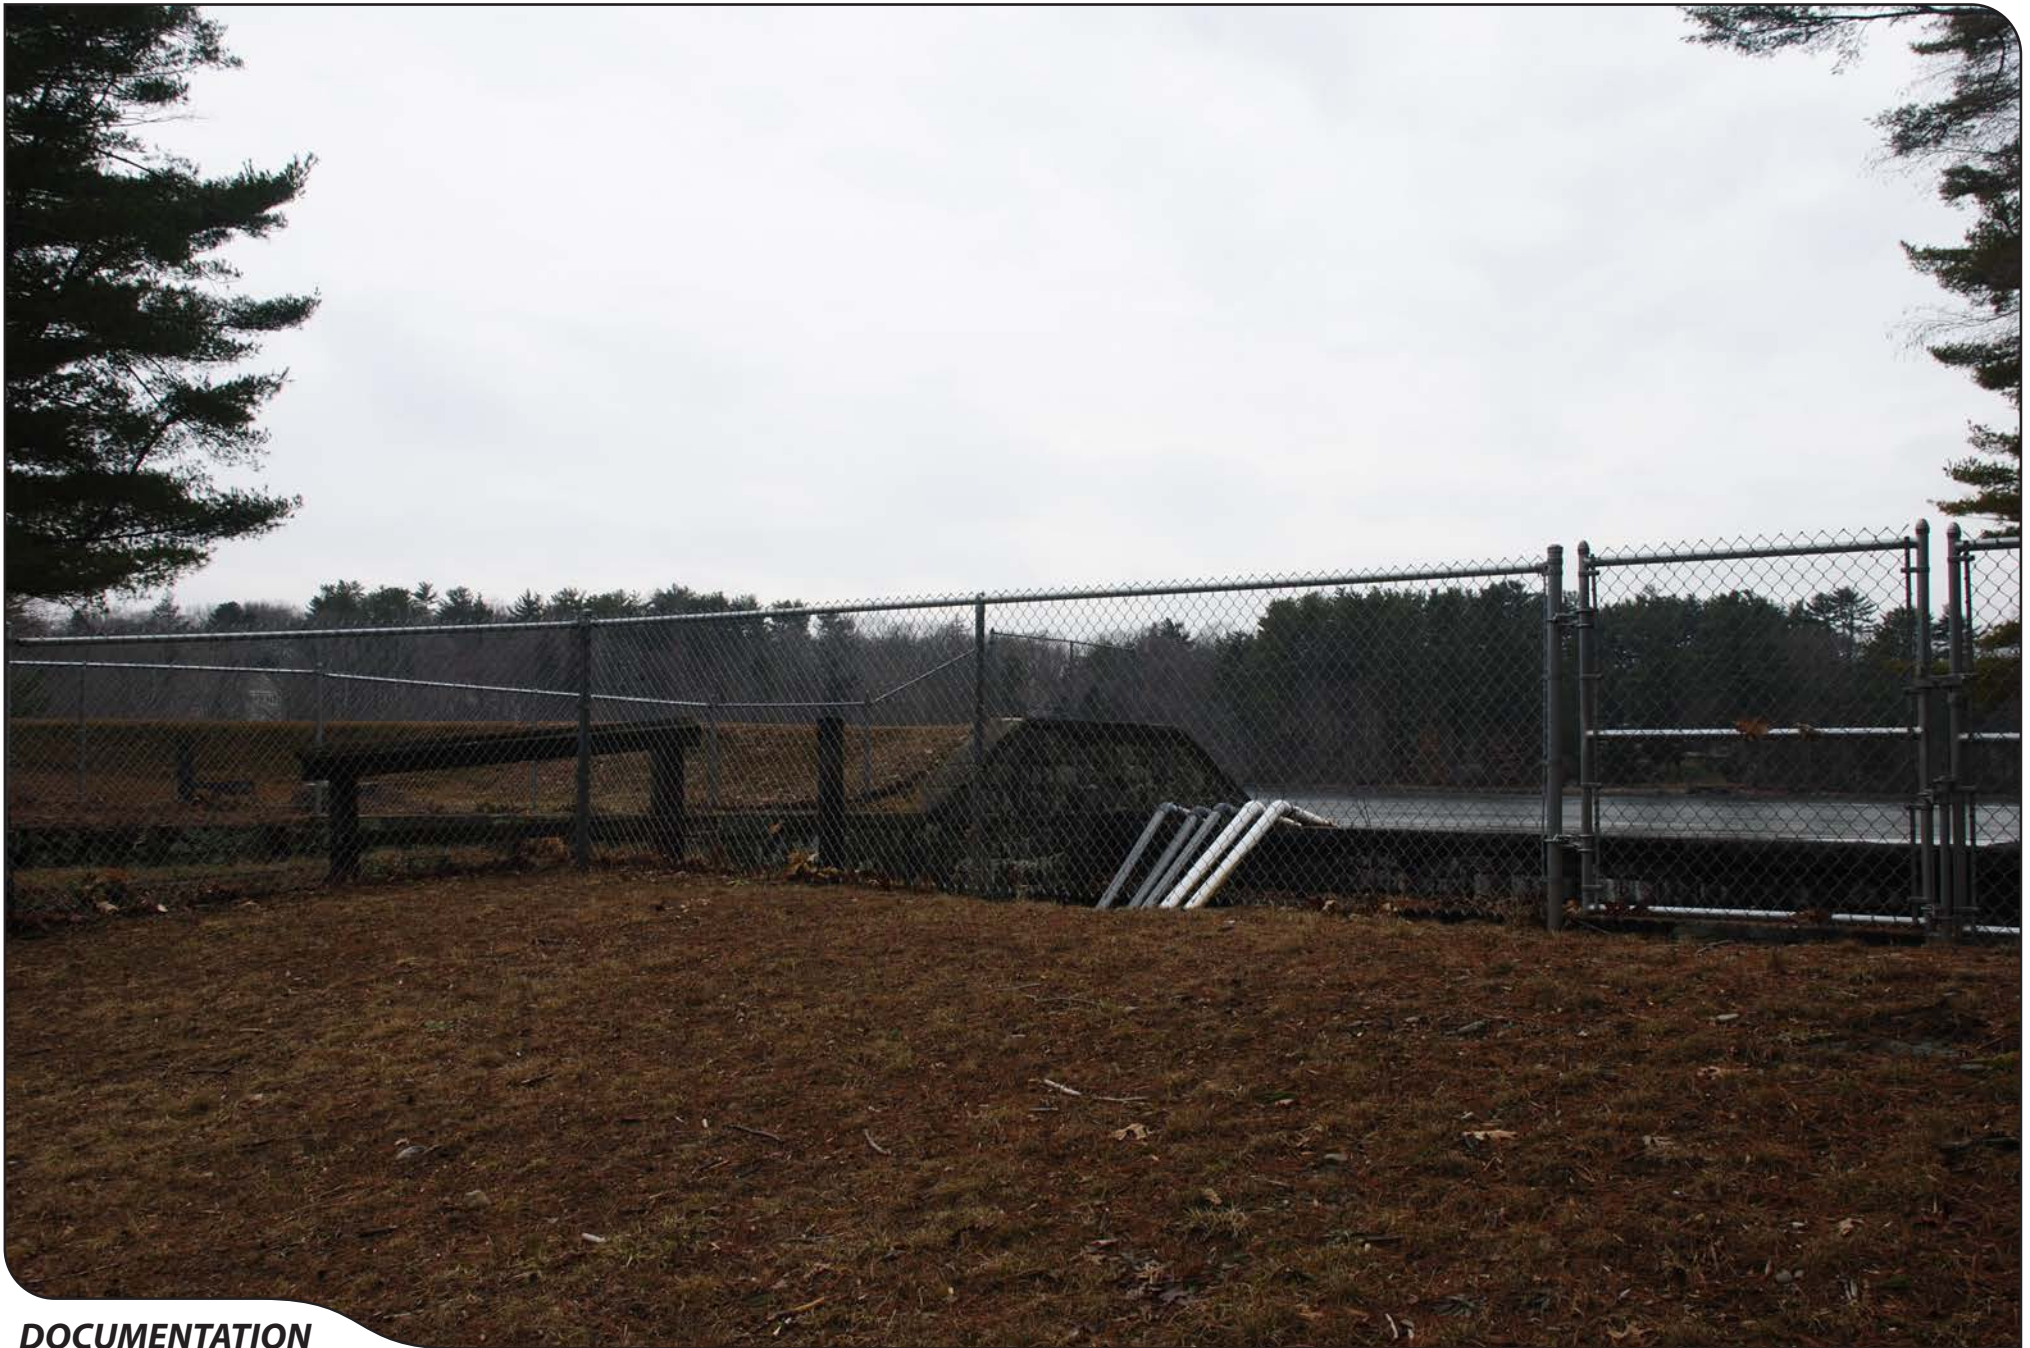
PHOTO	LOCATION	ORIENTATION	DISTANCE TO SITE	VISIBILITY
9	BEAVER DAM ROAD	SOUTHWEST	+/- 0.43 MILE	NOT VISIBLE

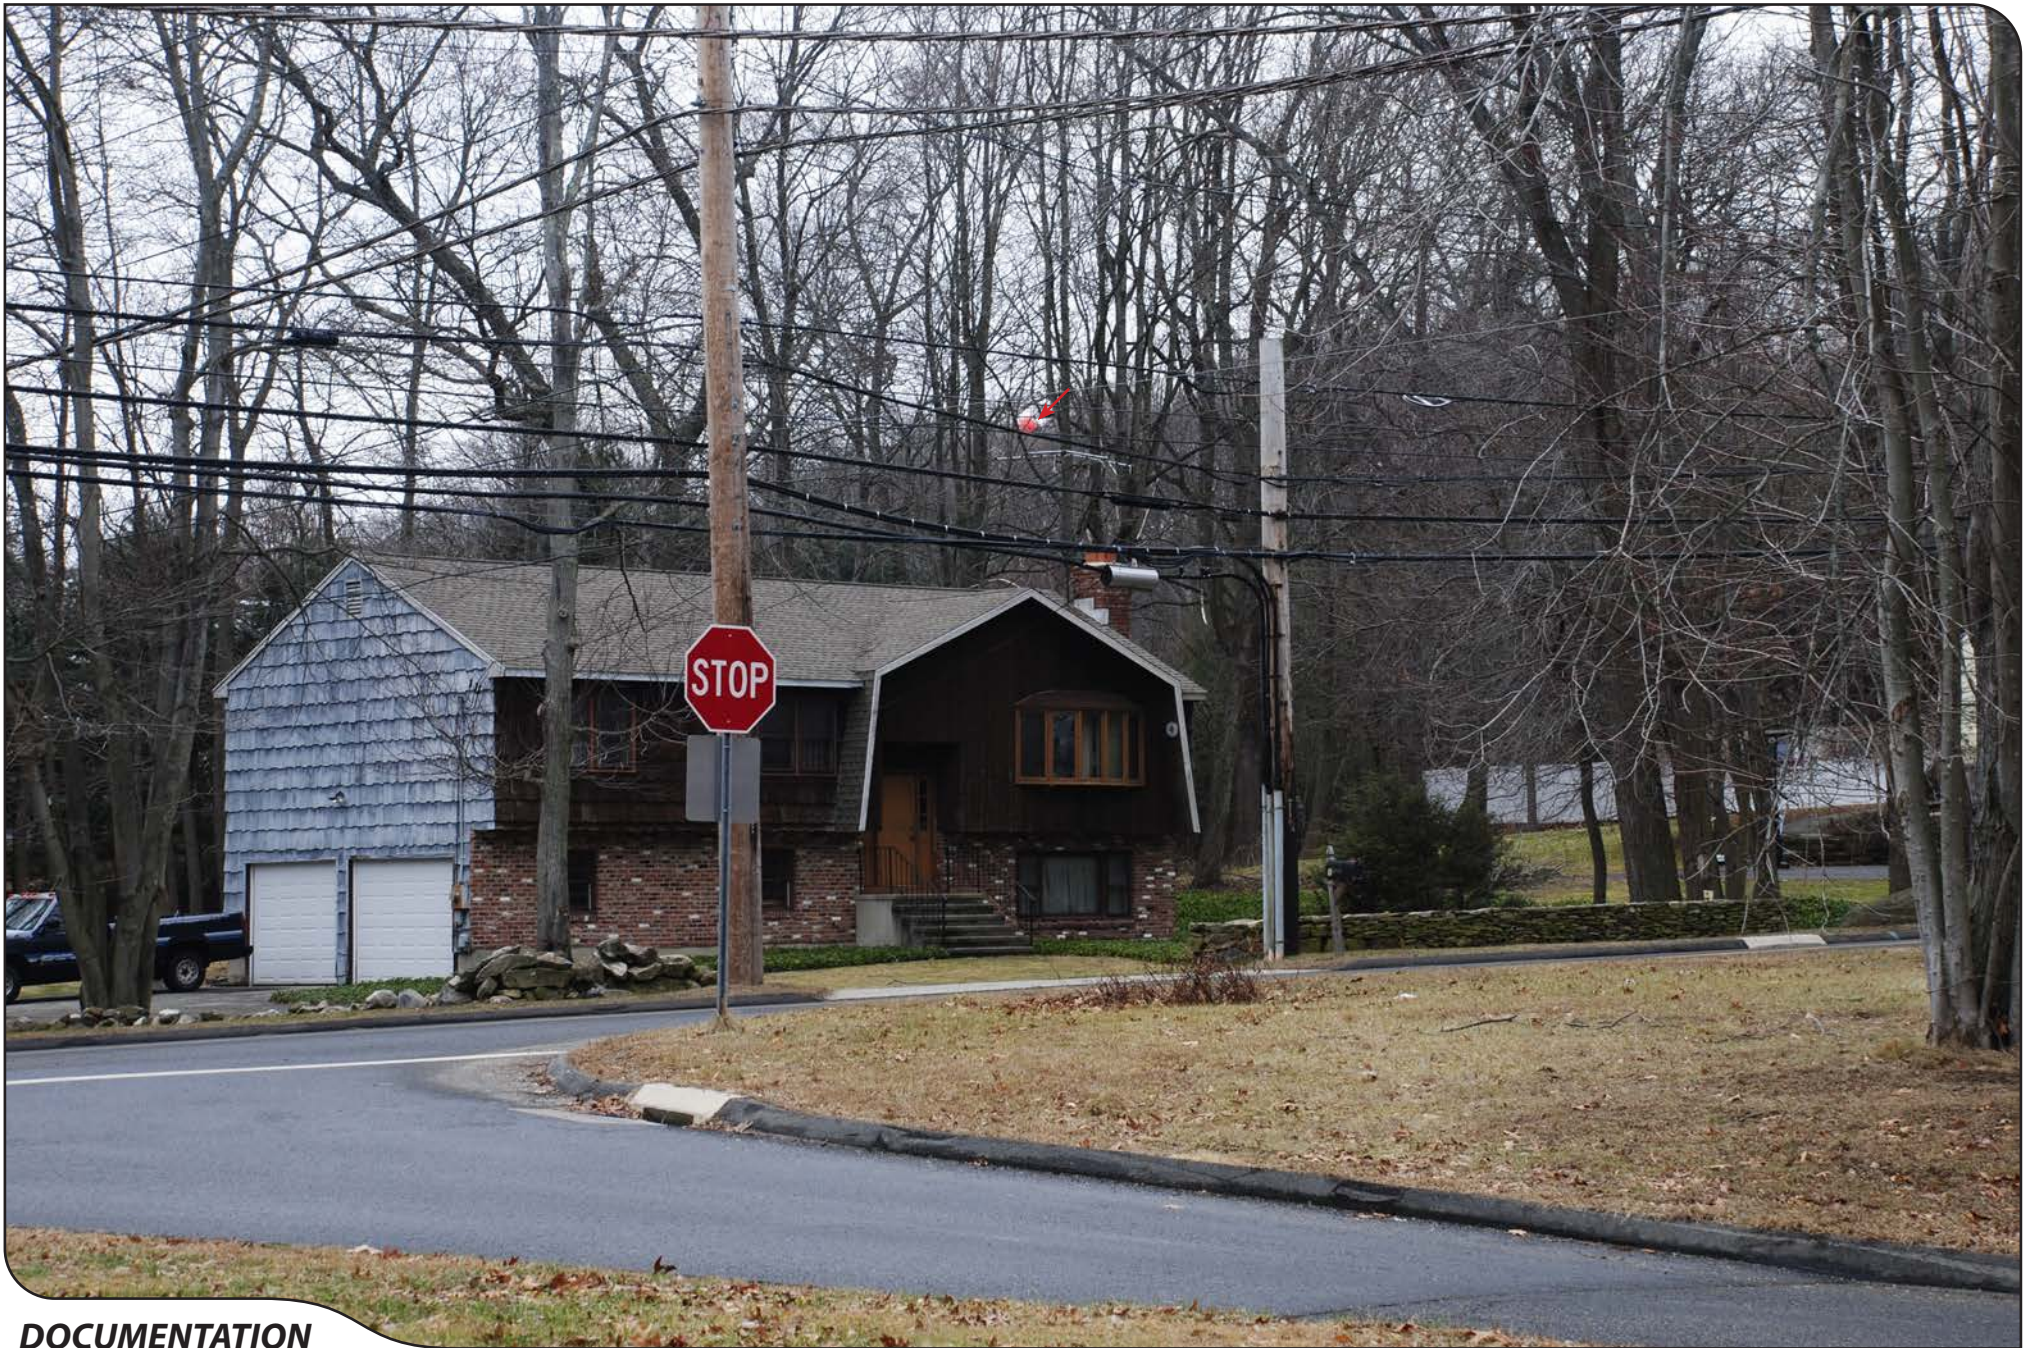
PHOTO	LOCATION	ORIENTATION	DISTANCE TO SITE	VISIBILITY
10	BEAVER DAM ROAD AT INTERSECTION WITH HUNTINGTON ROAD	NORTHWEST	+/- 0.15 MILE	SEASONAL

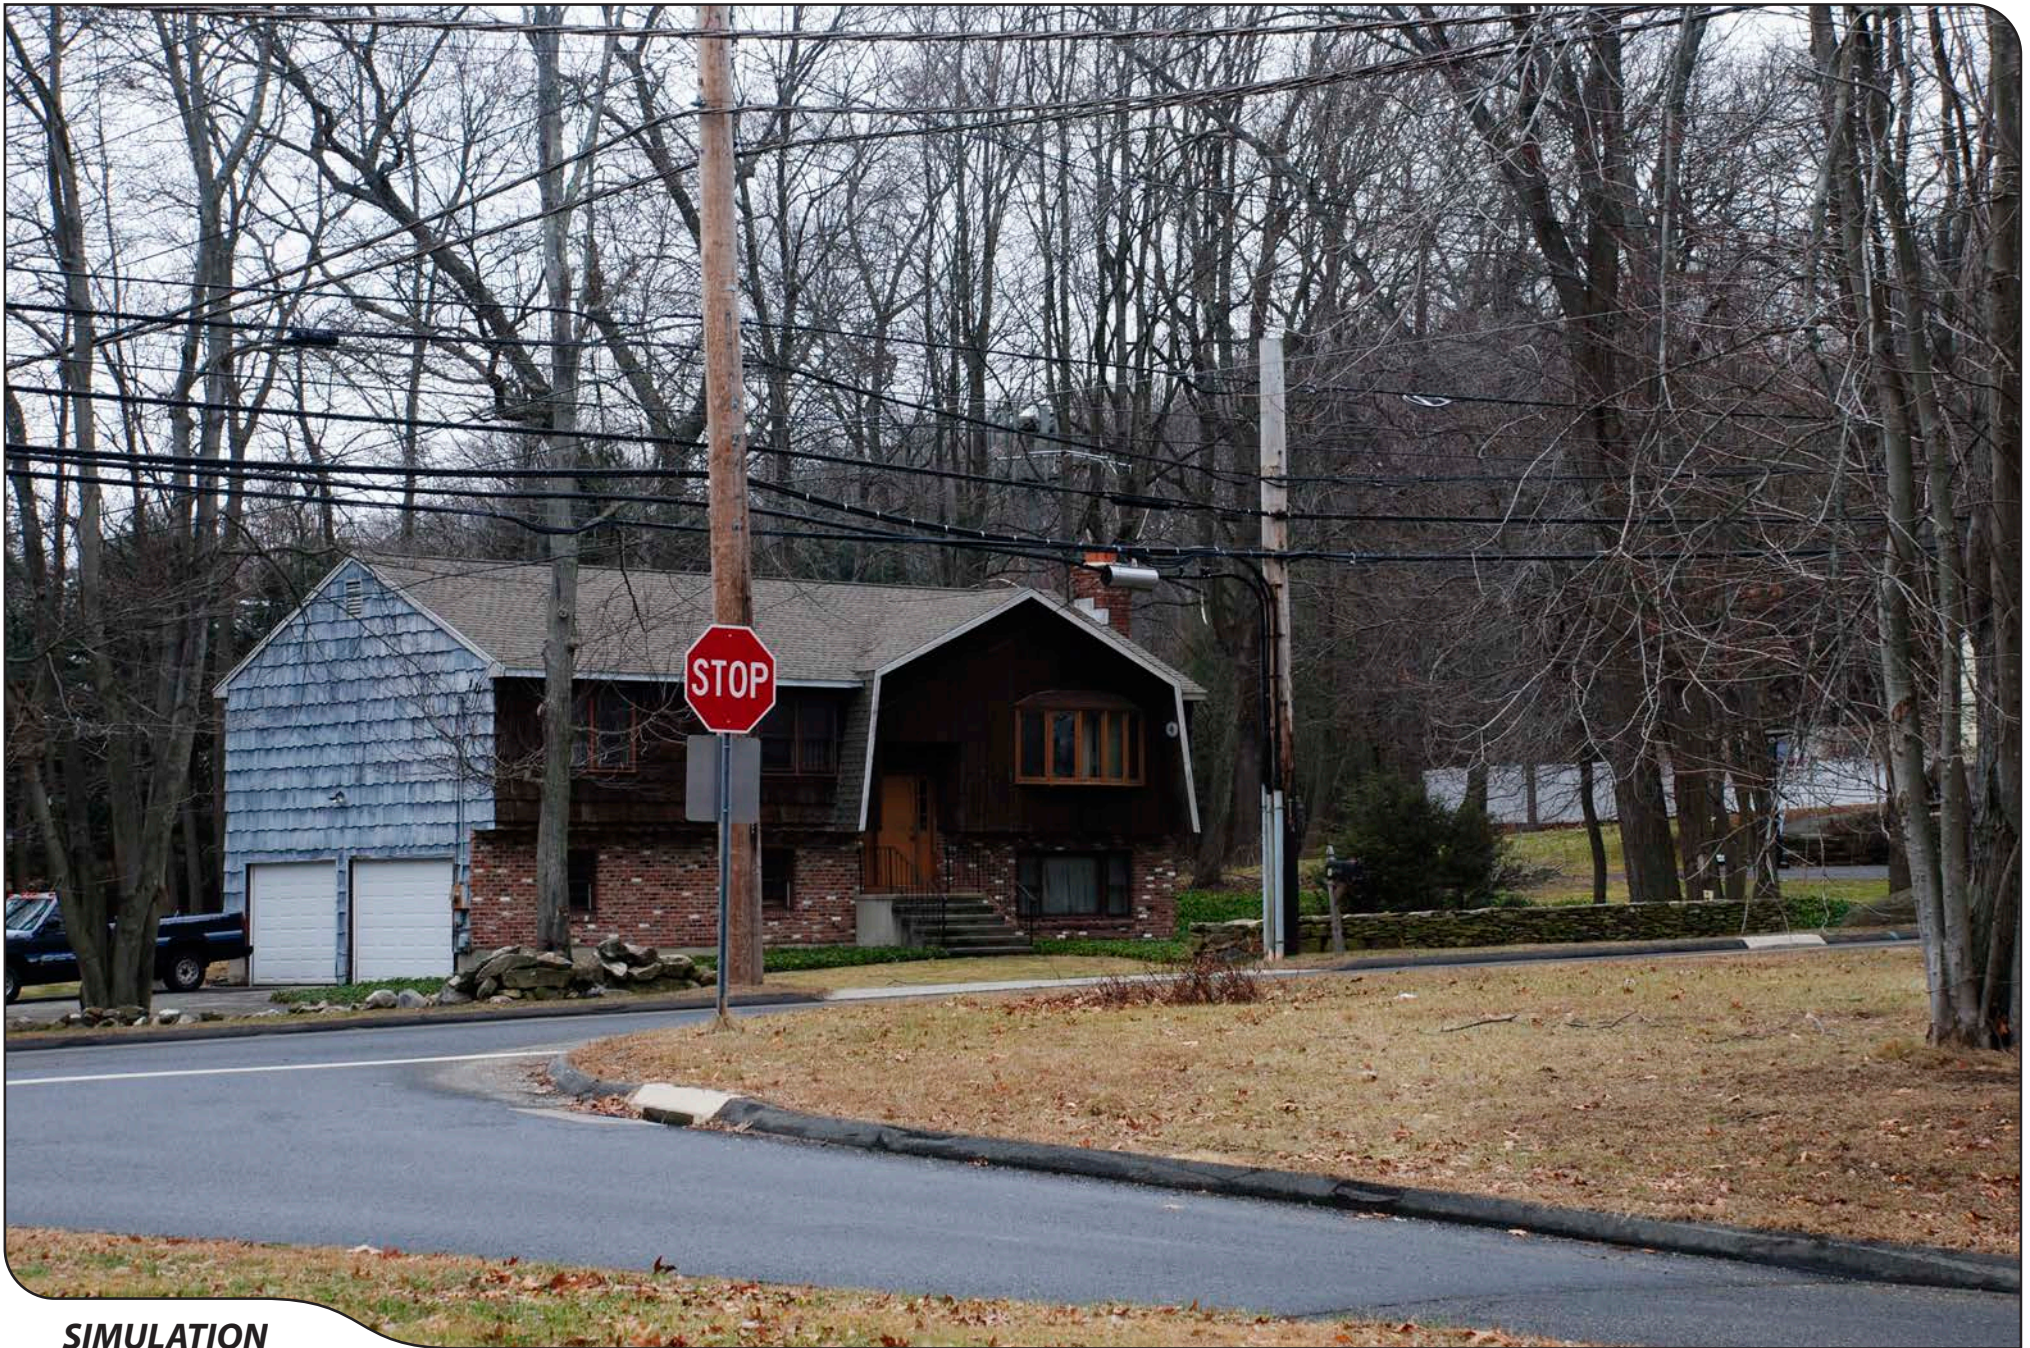
PHOTO	LOCATION	ORIENTATION	DISTANCE TO SITE	VISIBILITY
10	BEAVER DAM ROAD AT INTERSECTION WITH HUNTINGTON ROAD	NORTHWEST	+/- 0.15 MILE	SEASONAL

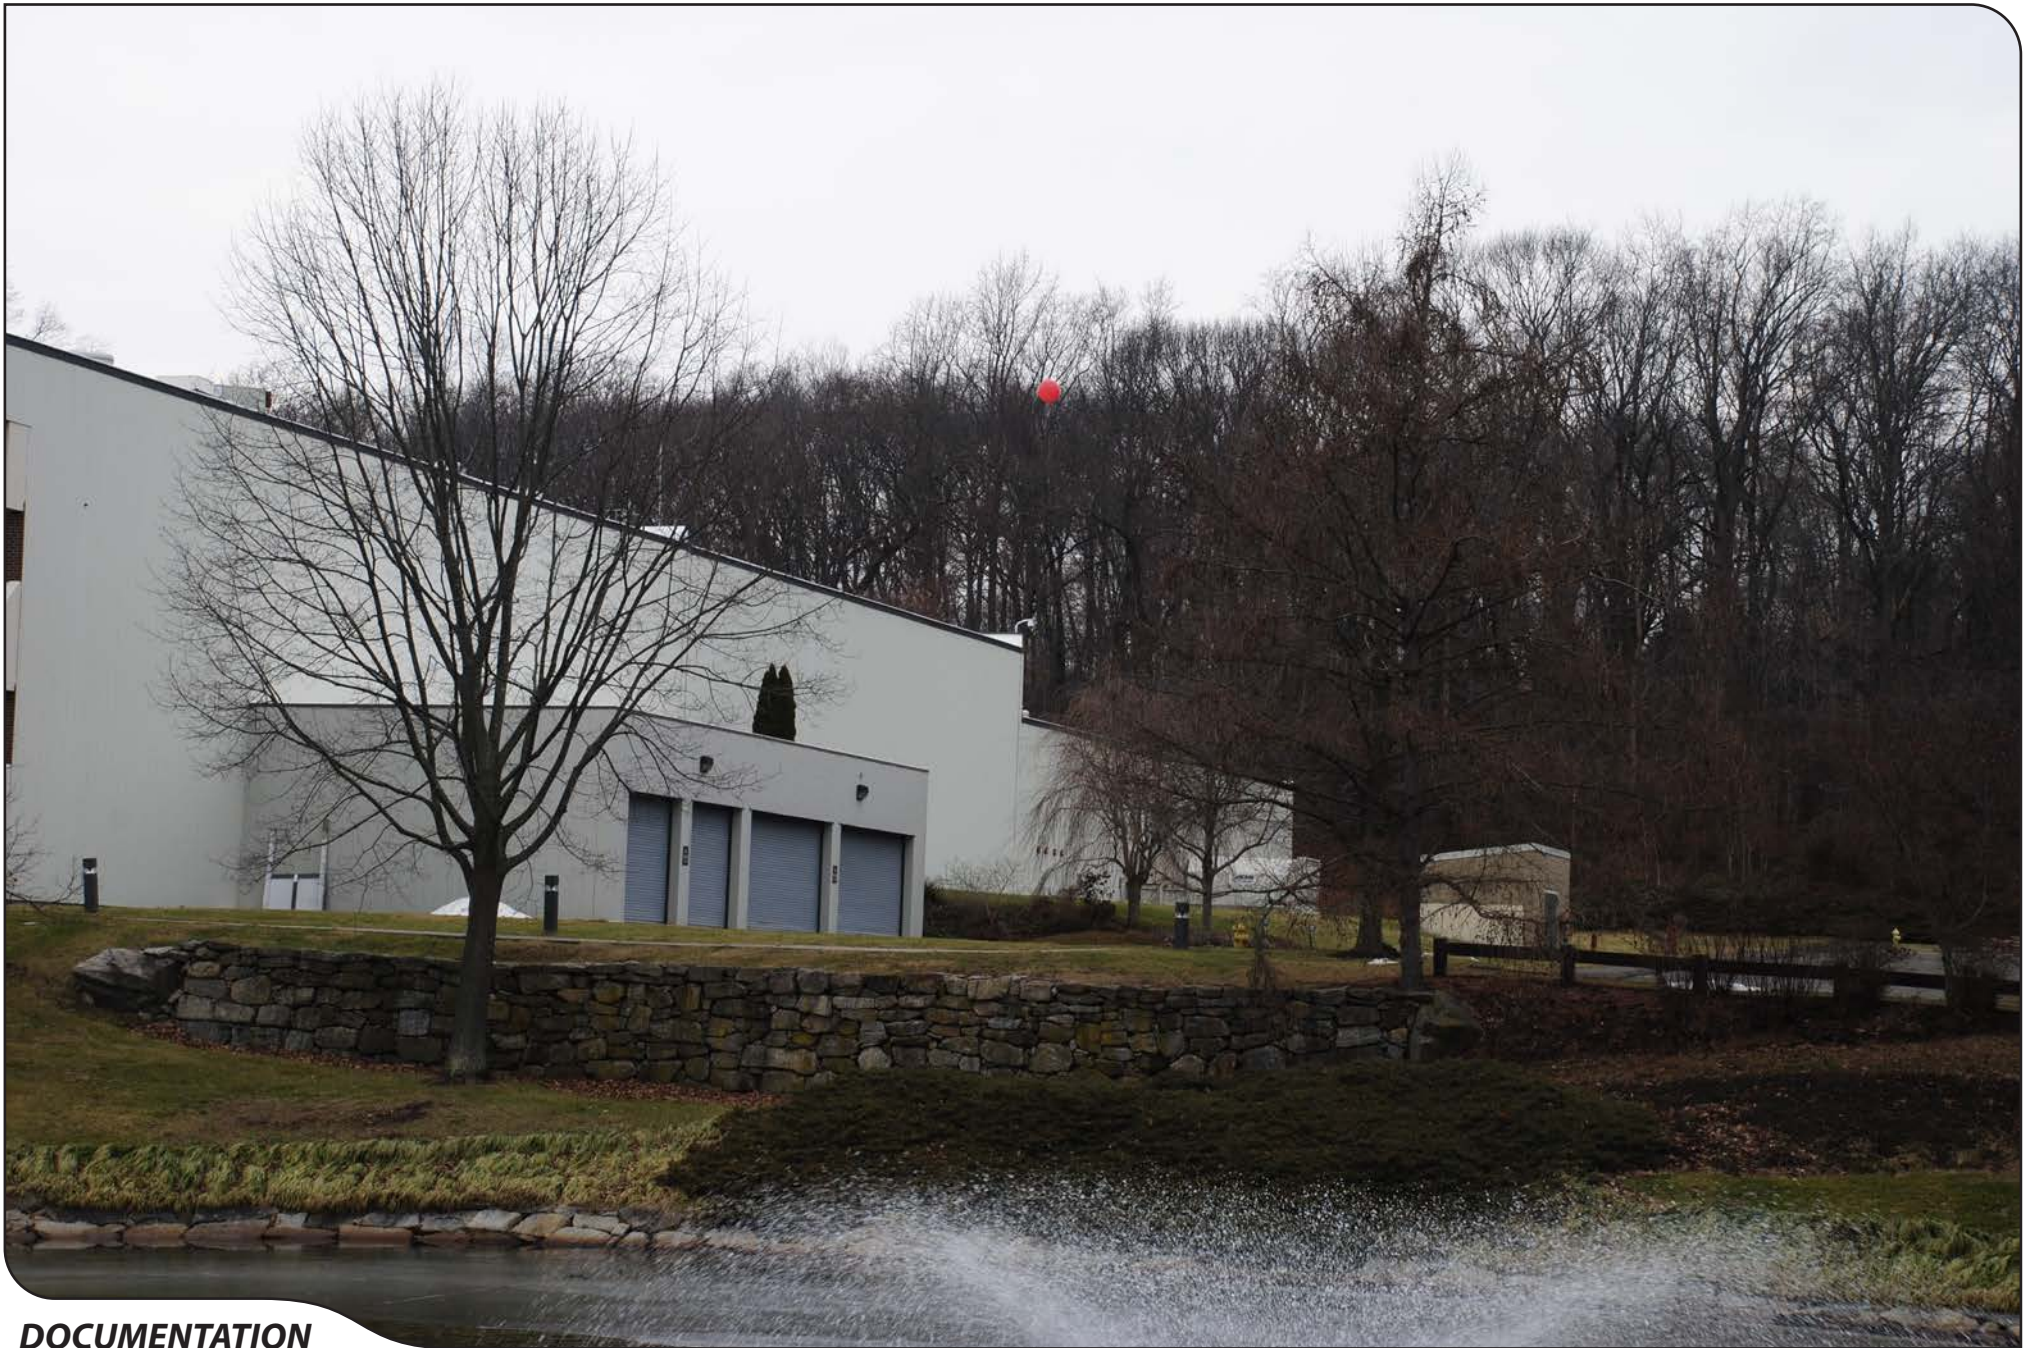
PHOTO	LOCATION	ORIENTATION	DISTANCE TO SITE	VISIBILITY
11	HOST PROPERTY	NORTHWEST	+/- 0.12 MILE	YEAR ROUND

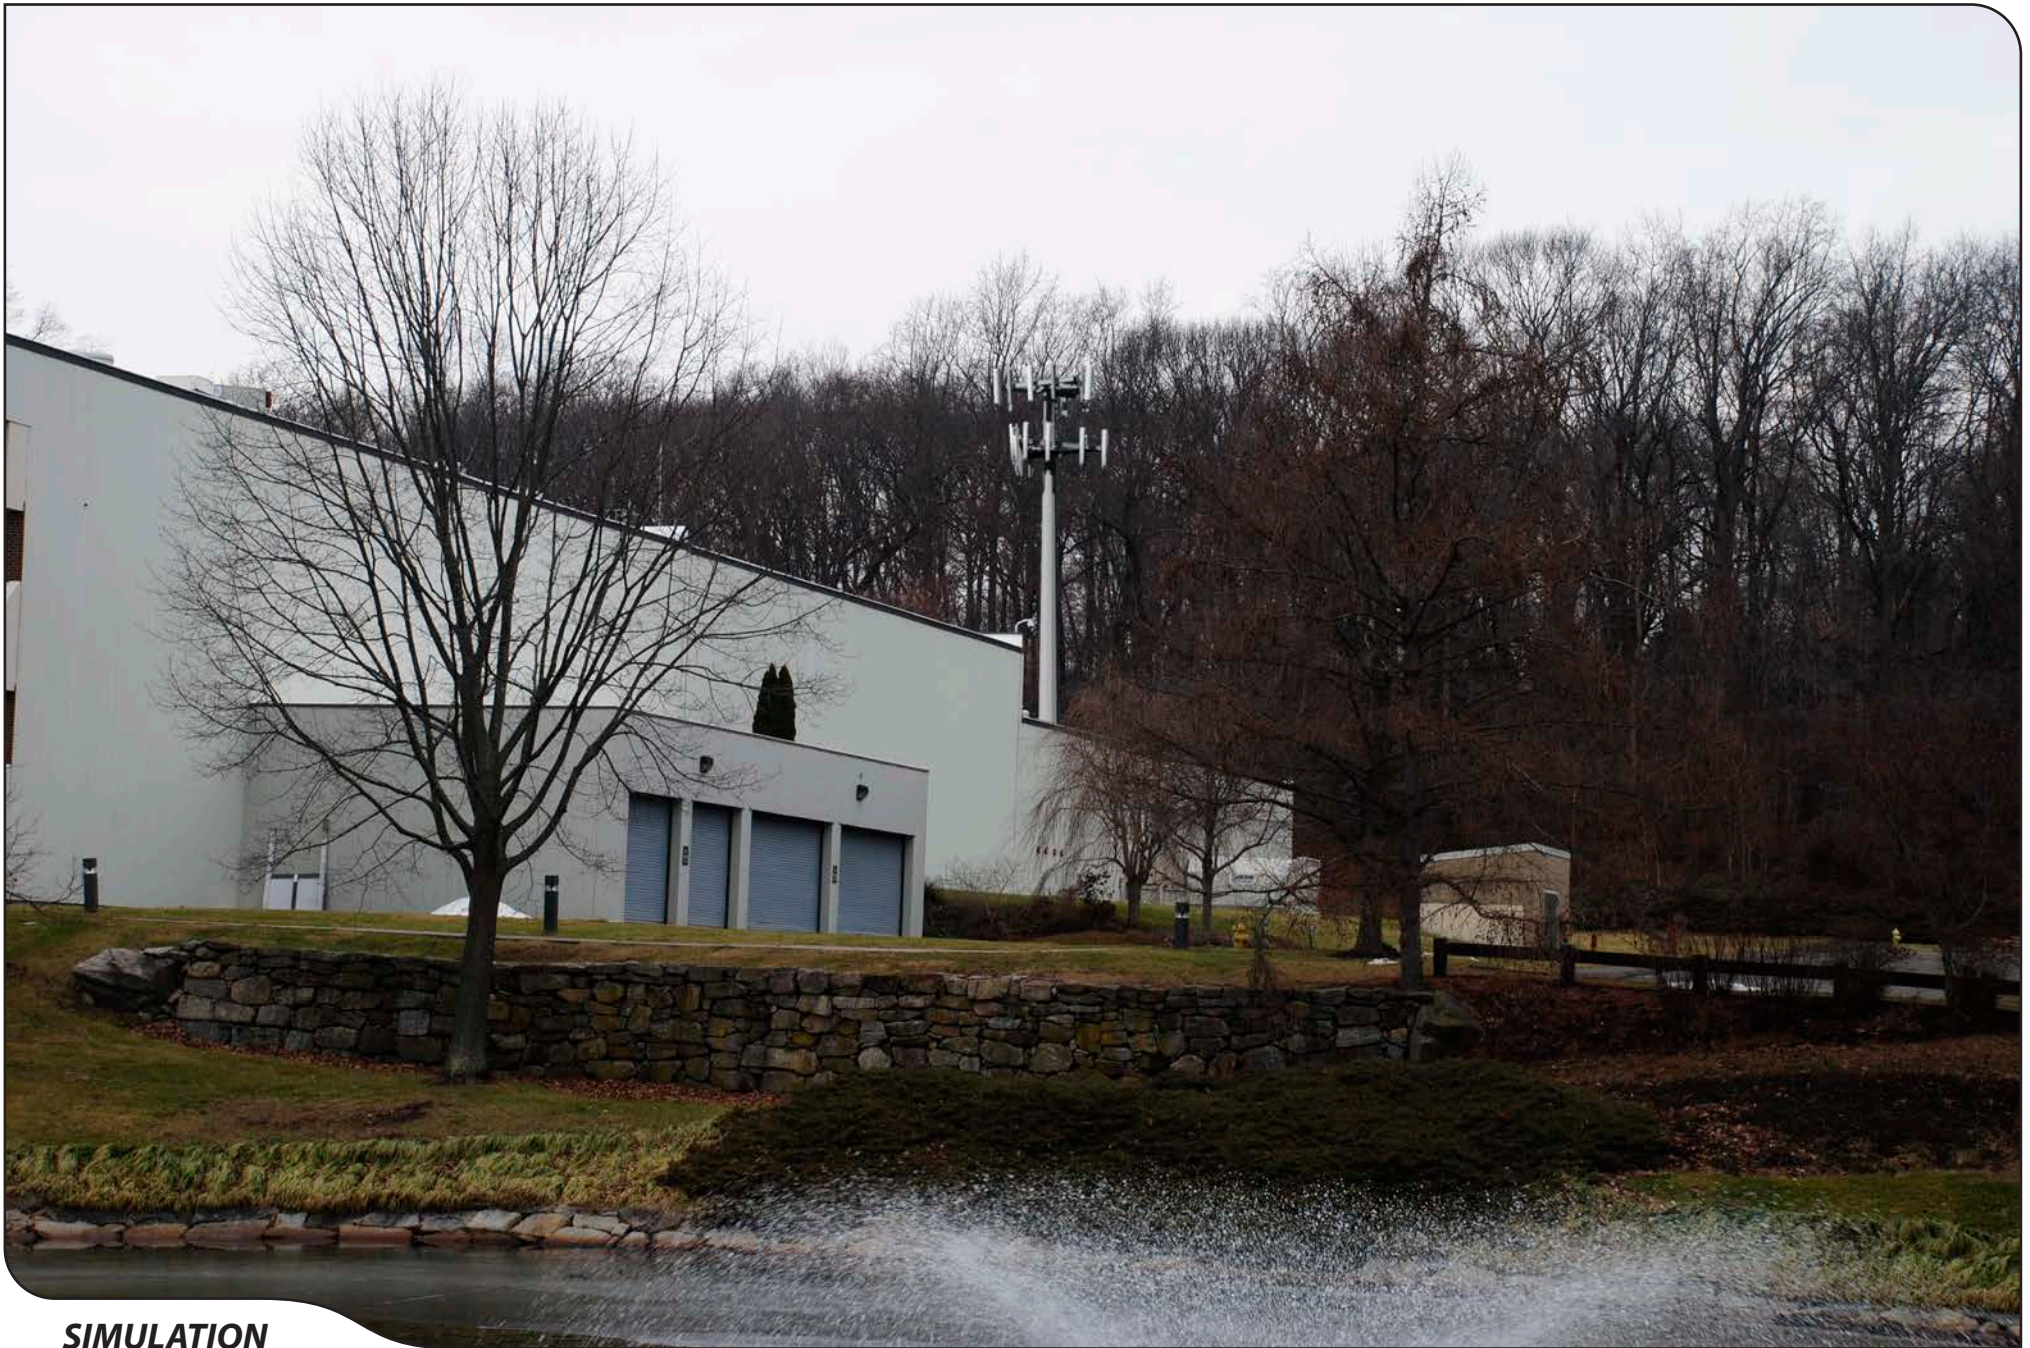
PHOTO	LOCATION	ORIENTATION	DISTANCE TO SITE	VISIBILITY
11	HOST PROPERTY	NORTHWEST	+/- 0.12 MILE	YEAR ROUND
