Photographic Simulations

TRUMBULL SE 4
60 COMMERCE DRIVE
TRUMBULL, CT 06611

*Prepared in February 2014 by:
All-Points Technology Corporation, P.C.
3 Saddlebrook Drive
Killingworth, CT 06141*

Prepared for Verizon Wireless

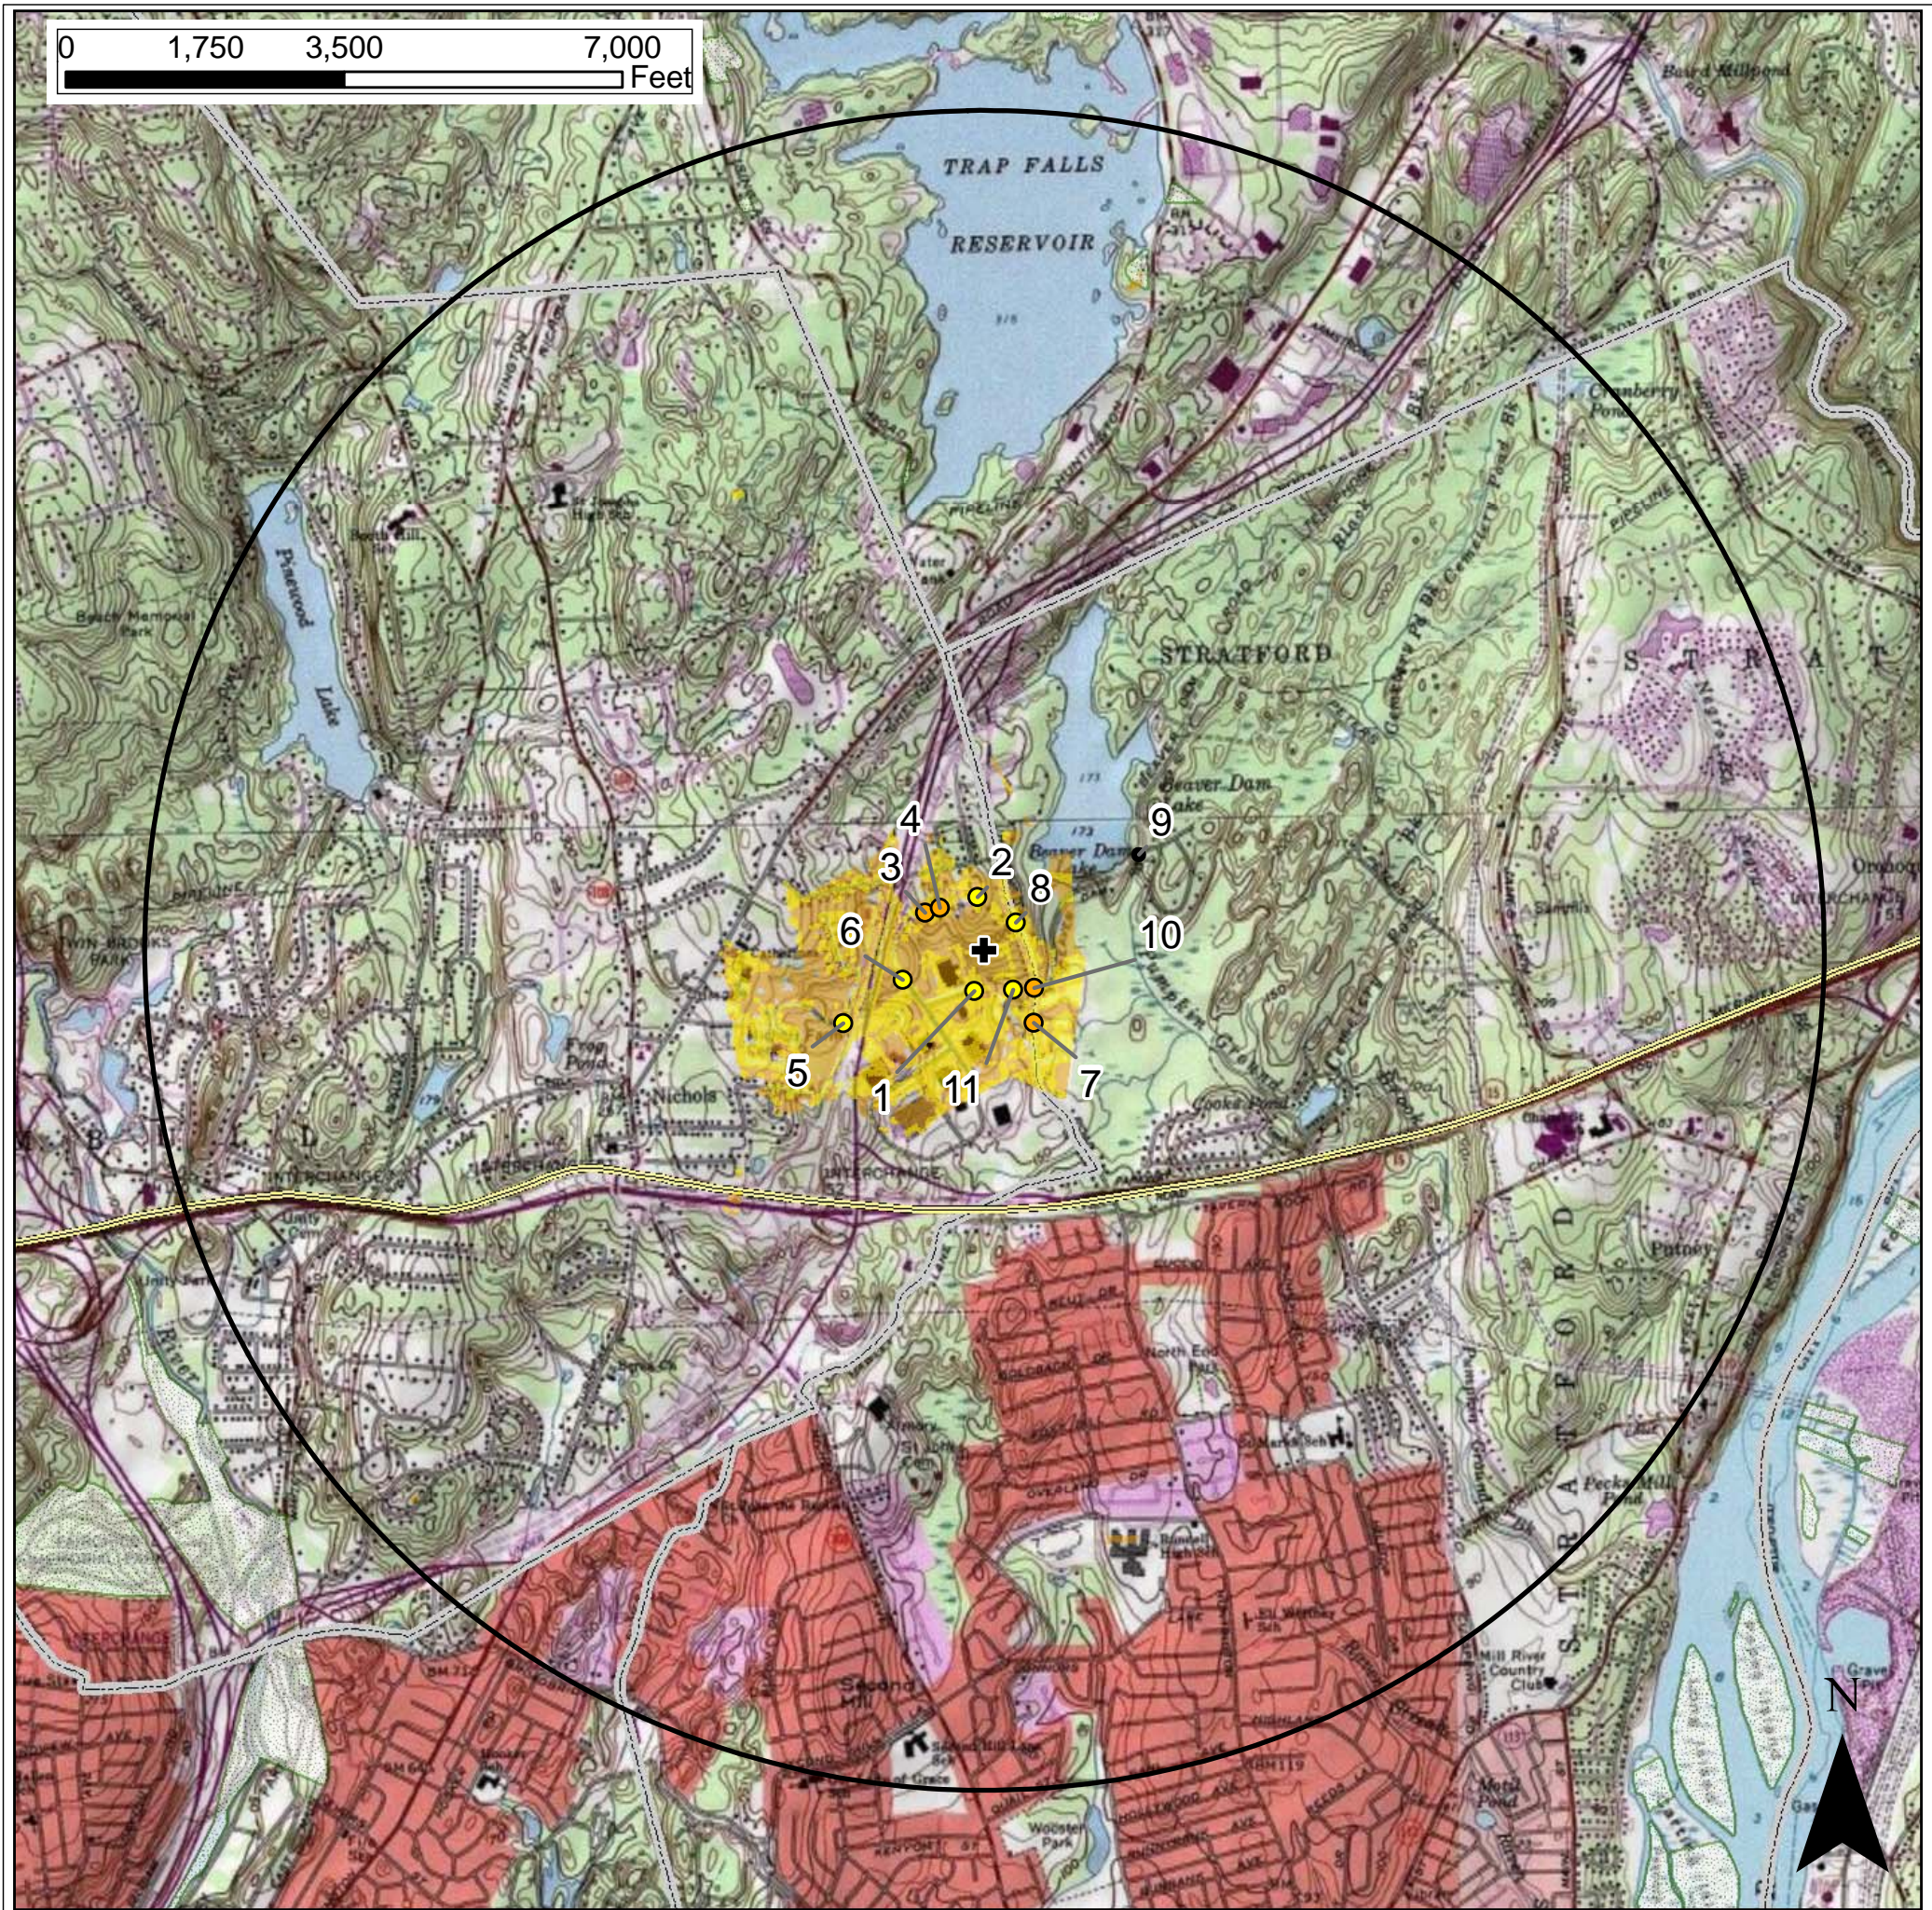
Visibility Analysis – Topo Base
 Proposed Wireless Telecommunications Facility
 Trumbull SE 4
 60 Commerce Drive, Trumbull, CT

Proposed facility height is 80 feet AGL.
 Existing tree canopy height estimated as 65 feet.
 Study area encompasses a two-mile radius and includes 8,042 acres of land.

In general, the combination of the relatively low height of the Facility, rolling terrain and mature forest results in minimizing the overall visibility throughout the Study Area, limiting views to select areas within 0.5 mile or less of the Host Property. Areas from where the proposed Facility would be visible above the tree canopy year-round comprise a total of approximately 61 acres. When the leaves are off the trees, seasonal views through intervening tree trunks and branches are anticipated to occur over an

The visibility maps presented in the attachment to this report depict areas where the proposed Facility may potentially be visible to the human eye without the aid of magnification based on a viewer eye-height of 5 feet above the ground and intervening topography and an assumed tree canopy height of 65 feet. This analysis may not necessarily account for all visible locations, as it is based on the combination of computer modeling, incorporating 2012 aerial photographs, and in-field observations from publicly-accessible locations. No access to private properties beyond the Host Property was provided to APT personnel. This analysis does not claim to depict the only areas, or all locations, where visibility may occur; it is intended to provide a representation of those areas where the Facility is likely to be seen.
