**Subject: Docket No. 466, Frost Bridge to Campville 115-kV Project
Decision and Order Condition #4 – Independent Environmental Inspector Report**

Please find enclosed the Biweekly Independent Environmental Inspector Report, Report #19, for the **August 18th** and **August 25th, 2017**, inspection events for the construction of the Eversource Frost Bridge to Campville 115-kV Project.

Frost Bridge to Campville 115kV Project

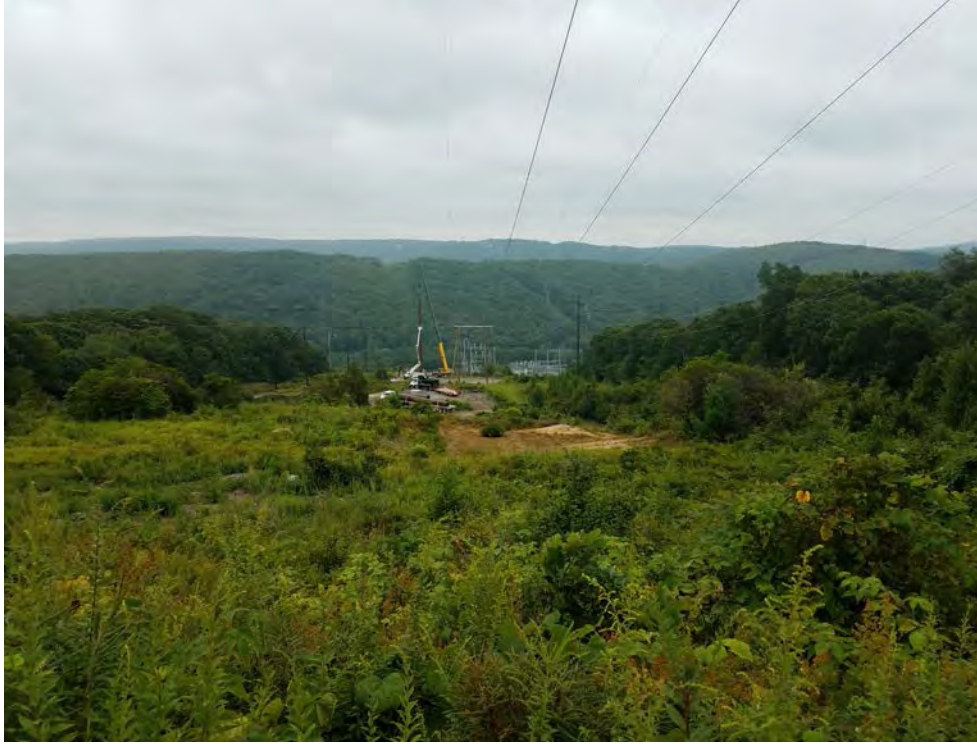
Photo 1: 08/18/17: Watertown, Map 2, Str3 and Str4 in the distance, ROW photo.

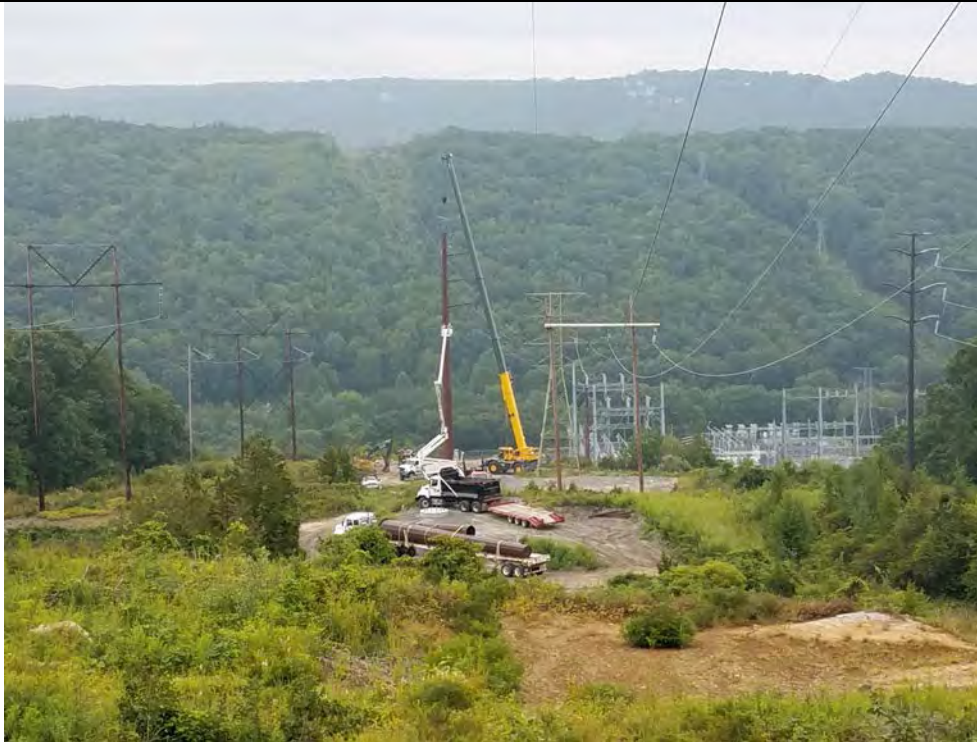
PAR is constructing a drilled shaft vertical deadend structure at Str3 and off loading steel structure sections at Str4 (Watertown, Map 2, see attached photos 1 & 2). Northern was not observed working on site today.

Photo 2: 08/18/17: Watertown, Map 2, Str3 and Str4, construction of a steel structure at Str3 and a trailer loaded with sections of a steel structure staged at Str4 waiting to be off loaded.
