WETLAND INSPECTION

APT Project No.: CT1411540

Verizon Wireless Site Name: Bridgeport NE CT

Site Address: 541 Broadbridge Road
Bridgeport, Connecticut

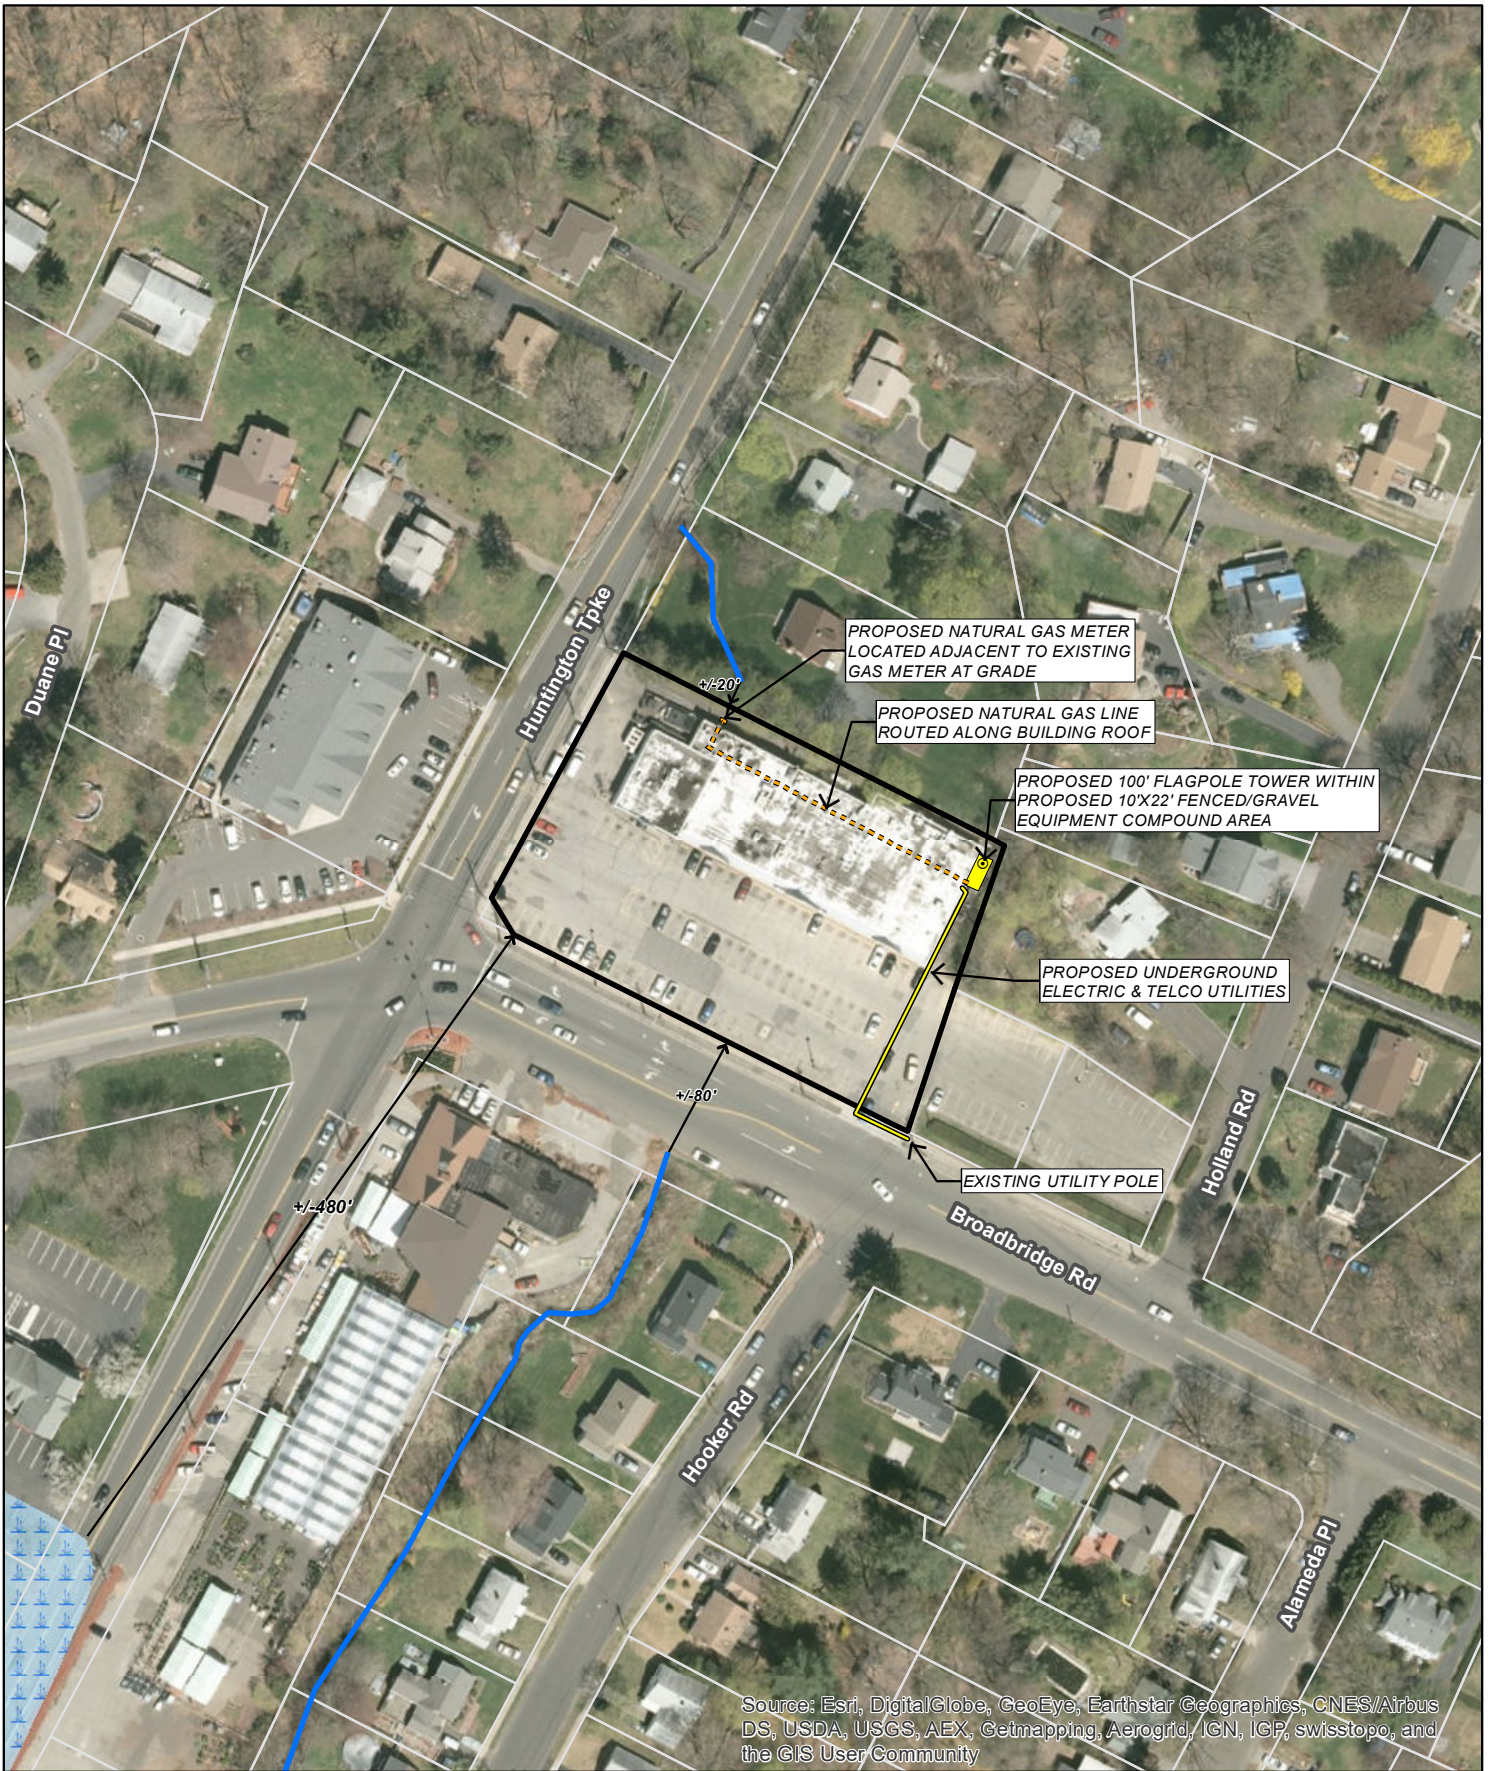
Wetland Inspection Map

The subject property is completely developed with a commercial strip plaza, hosting a number of retail businesses, and paved parking/access areas. A wooden slat fence is located along the northern property boundary. No wetlands or watercourses are located on the subject property. An unnamed intermittent watercourse apparently flows under the central portion of the subject property and daylights off site along the north property boundary and across Broadbridge Road south of the property.

The proposed flagpole facility would be located ±190 feet east of the intermittent watercourse feature, along the north property boundary in a paved and developed area. Underground utilities would be located from Broadbridge Road along the east property boundary to the proposed flagpole facility. The underground utility route would be located ±120 feet northeast of the nearest intermittent watercourse feature, across Broadbridge Road. Considering the proposed facility and associated development activities would be located within existing developed and disturbed areas that are a significant distance from the intermittent watercourse, the proposed development would not result in a likely adverse impact to this resource. This evaluation is contingent upon erosion and sedimentation controls being installed and maintained during construction in accordance with the 2002 Connecticut Guidelines for Soil Erosion and Sedimentation Control.

Map Notes:
 No wetlands or watercourses identified on the subject property
 Base Map Source: ESRI Imagery, GBRC RPIIP 2013
 Map Scale: 1 inch = 125 feet
 Map Date: September 2016
