WETLAND INSPECTION

APT Project No.: CT283190

HLT Site Name: Easton
CT 254

Site Address: 515 Morehouse Road
Easton, Connecticut

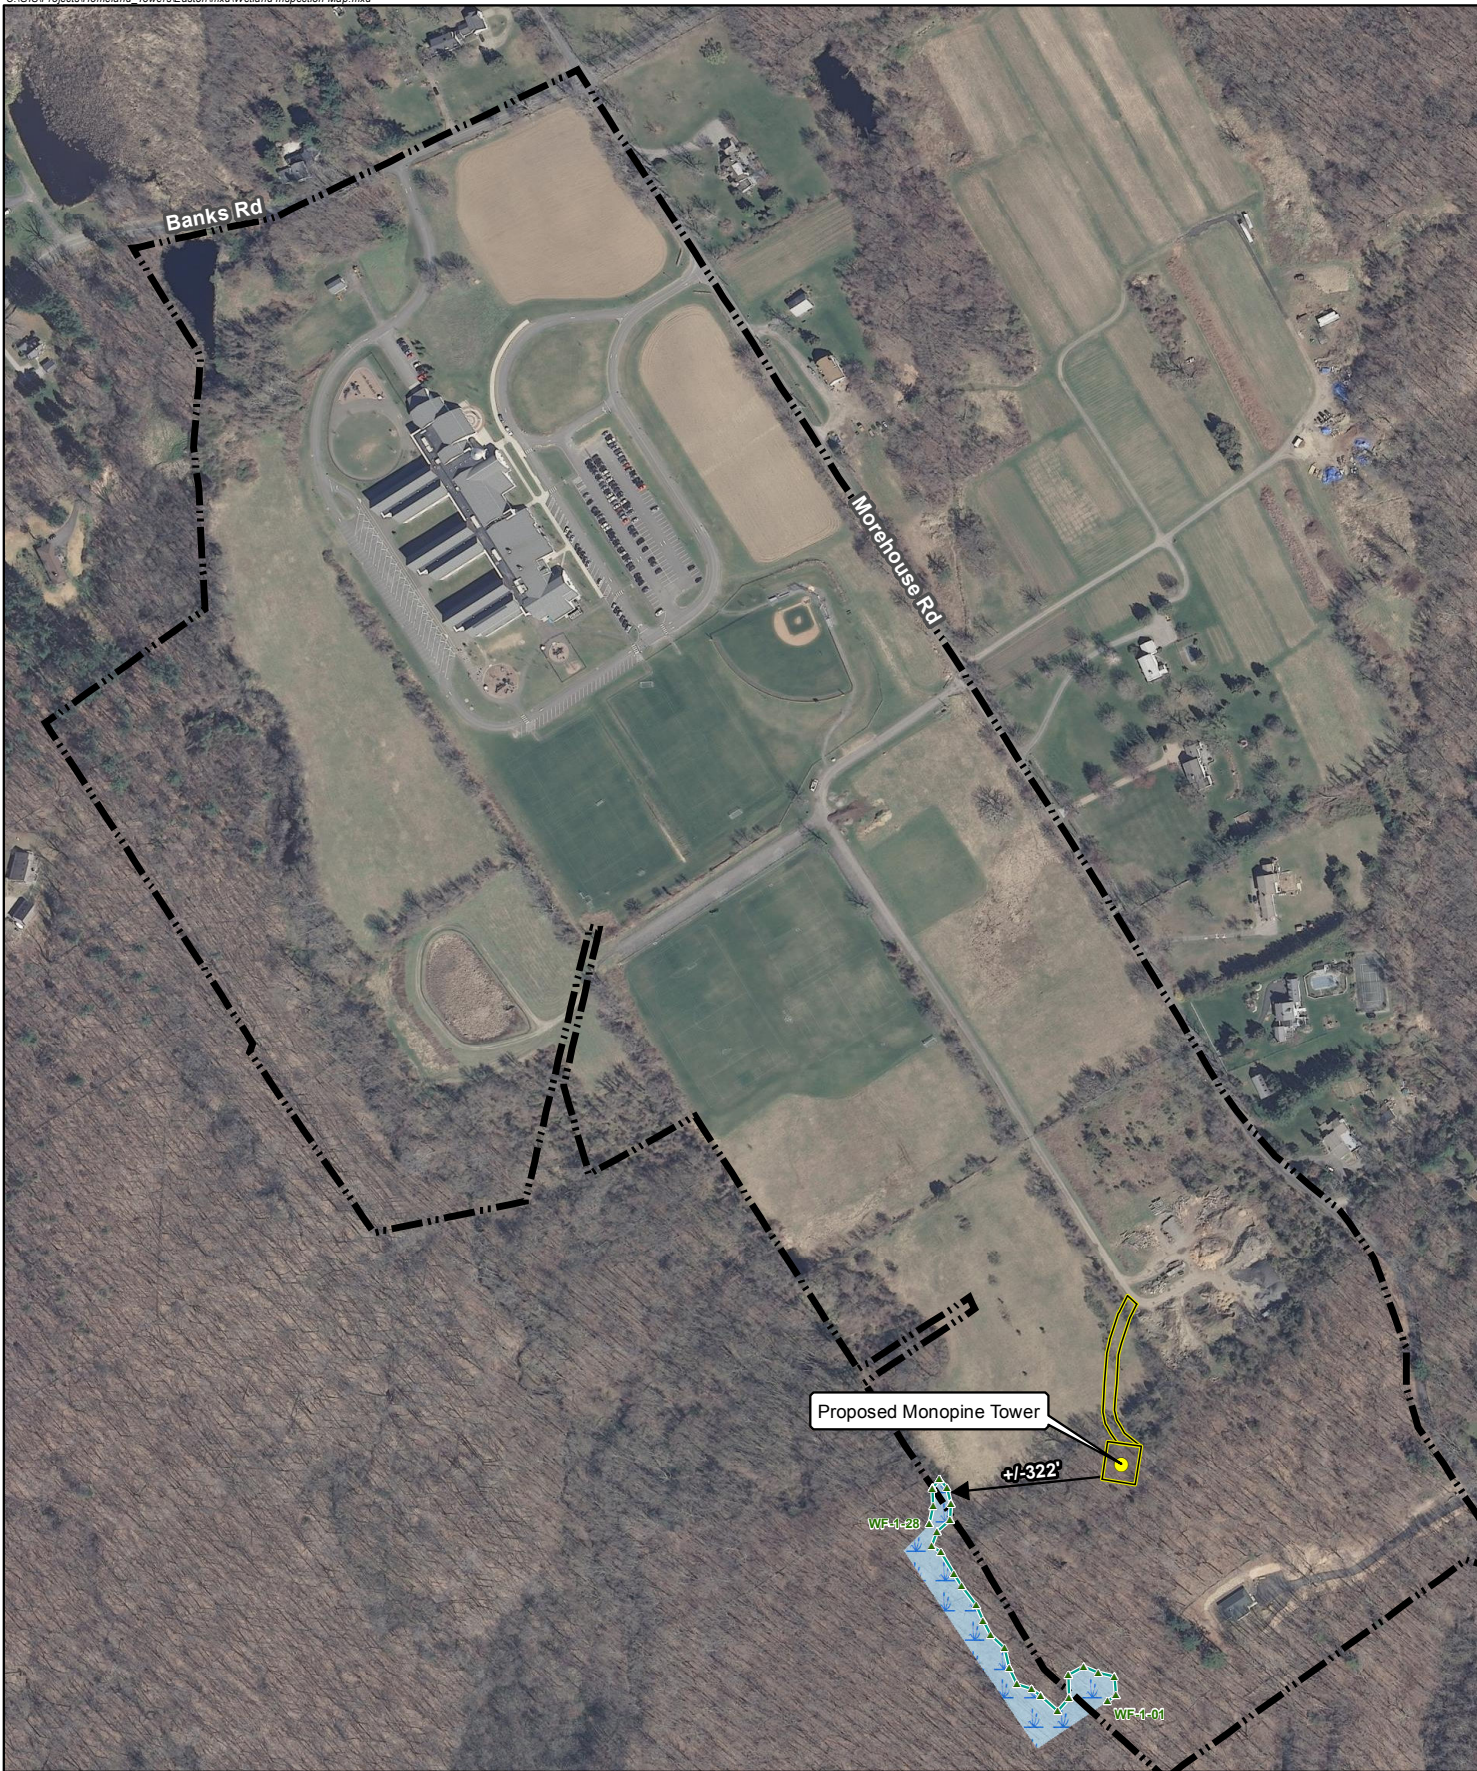
Wetland Inspection Map

Proposed Wireless
Telecommunications Facility
Easton CT
515 Morehouse Road
Easton, Connecticut

Map Notes:
Base Map Source: 2012 Aerial Photograph (CT ECO)
Map Scale: 1 inch = 400 feet
Map Date: June 2015
