WETLAND INSPECTION

APT Project No.: CT1417820

Verizon Wireless Site Name: Coventry Northwest CT

Site Address: Folly Lane, Coventry, Connecticut

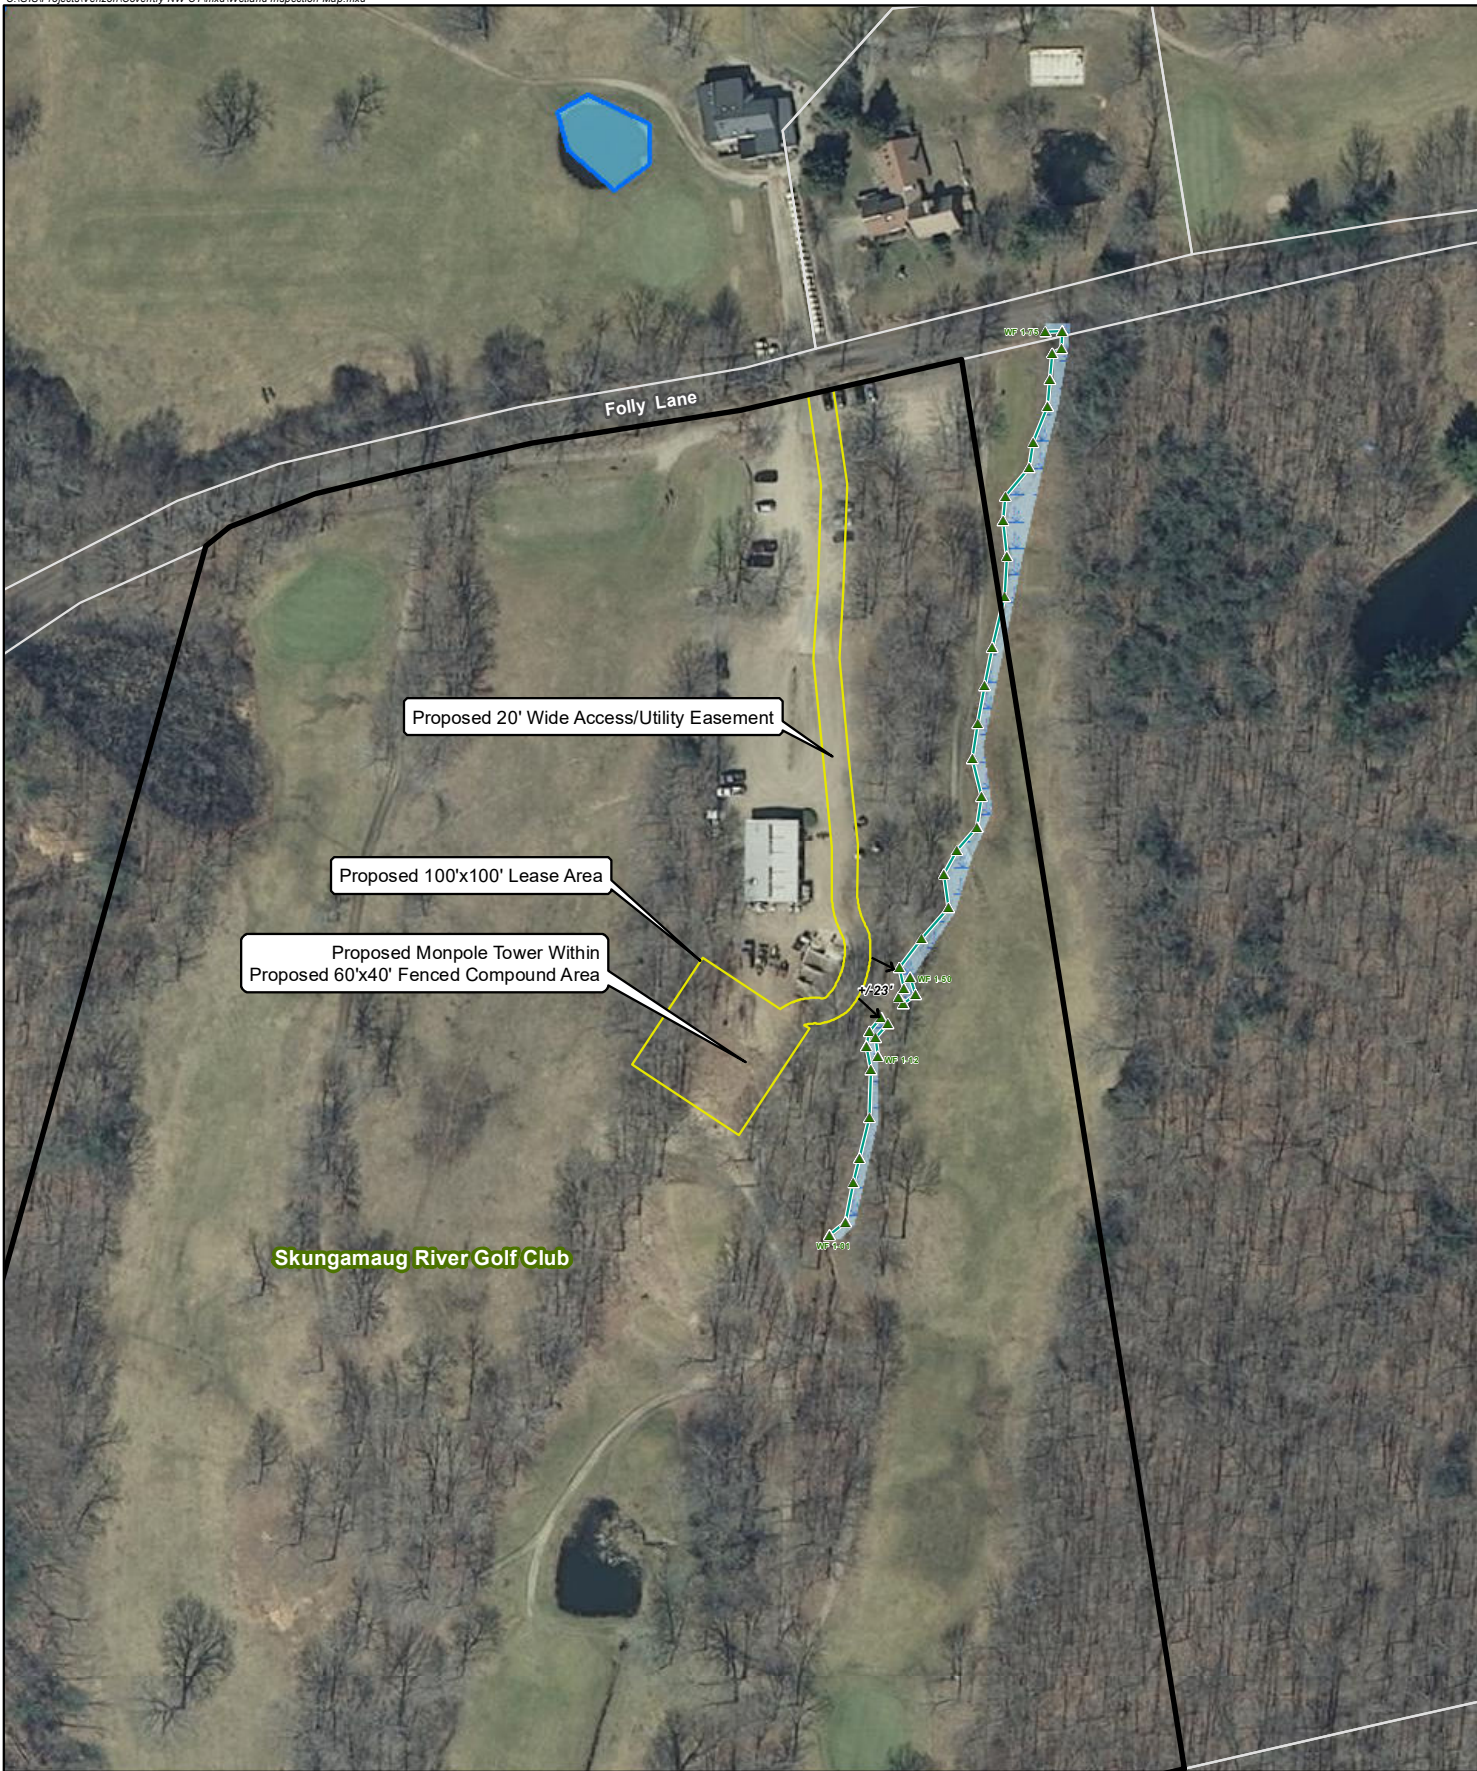
Wetland Inspection Map

Wetland 1 is a narrow, well confined intermittent stream located just east of the existing dirt/gravel road and southeast of the proposed Facility location. The banks of the stream are incised and generally maintained in various grasses and forbs as this feature flows through the 13th fairway. There are no bordering wetlands within the delineated reaches of this resource. The southern portion of the delineated section of Wetland 1 is forested with sparse mature red maple and green ash trees and cleared understory (maintained lawn).

The proposed Facility would be located ±40 feet northwest of Wetland 1 at the nearest point (wetland flag WF 1-07). The existing gravel driveway is located ±23 feet northwest of Wetland 1. Although Wetland 1 is located nearby, the proposed Facility would be located within an existing developed and disturbed area and would not require removal of mature upland vegetation between the Facility and nearby wetland. A review of site plans prepared by Hudson Design Group LLC, dated 10/21/16, reveals appropriate erosion and sedimentation controls would be installed and maintained during construction in accordance with the 2002 Connecticut Guidelines for Soil Erosion and Sedimentation Control. Therefore, considering the existing developed nature of the proposed Facility site and no direct impact to Wetland 1 or its mature bordering vegetation would occur, no likely adverse impact to wetlands would be anticipated from the proposed Verizon Wireless development.
