Baseline Watershed Assessment North Branch Park River Watershed

Connecticut Department of
Environmental Protection

July 2010

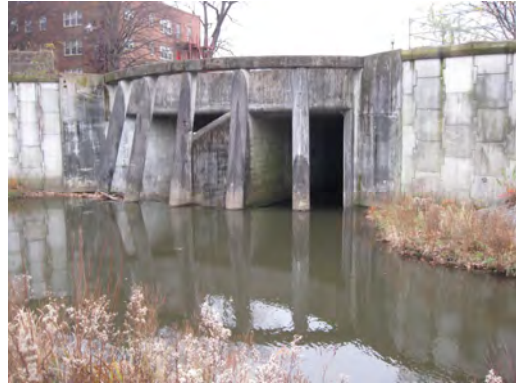
The North Branch Park River conduit entrance near Farmington Avenue.

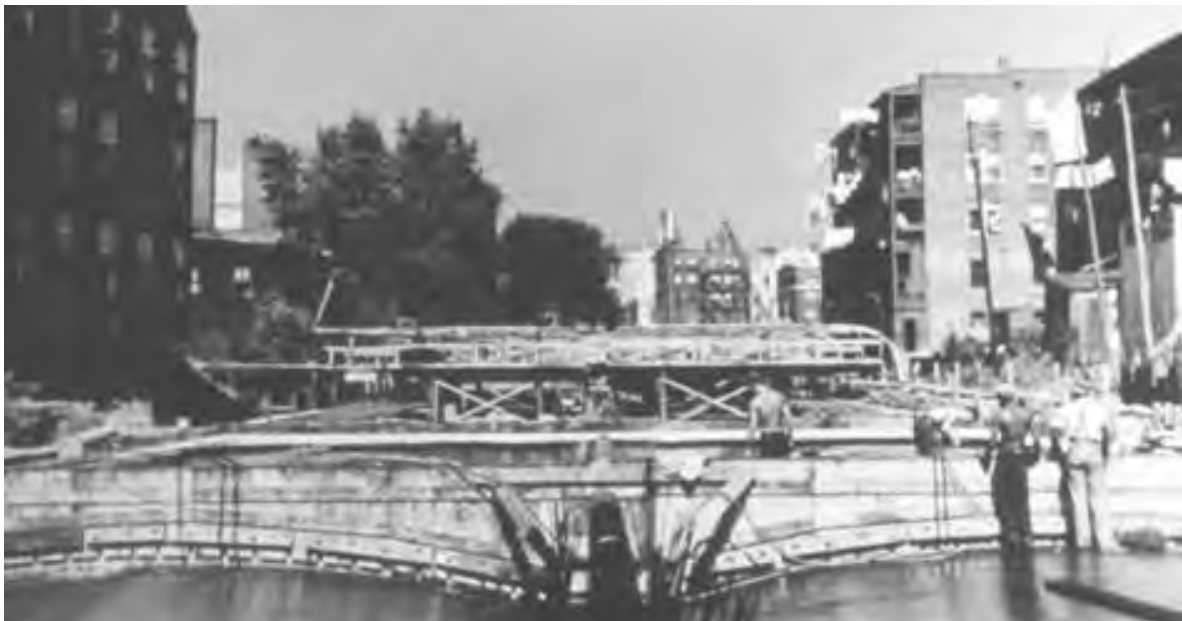
The Park River conduits during construction, circa 1942. (Hartford Collection, Hartford Public Library).

This flood control project began along the Park River in September 1940 and was completed three years later. The first phase of the conduit was just over a mile long and ended between the Capitol and Armory buildings. The majority of the flood control system was completed in 1943, although additional changes were constructed following flooding caused by Hurricane Diane in 1955, including construction of a section of the conduit from the Armory to Farmington Avenue in the early 1960s (Normen, 2008), which combined the construction of I-84 along the former stream corridor of the South Branch, with the underground conduit and flood storage system 40' – 100' below grade. This flood control system remains intact today. The system of underground conduits conveys both the North and South branches of the Park River below Hartford to an outfall on the Connecticut River. Burial of the North Branch between Capitol and Farmington Avenues was the last segment of river to be buried to accommodate an athletic field for Hartford High School and a parking lot for the Mark Twain House and Museum.

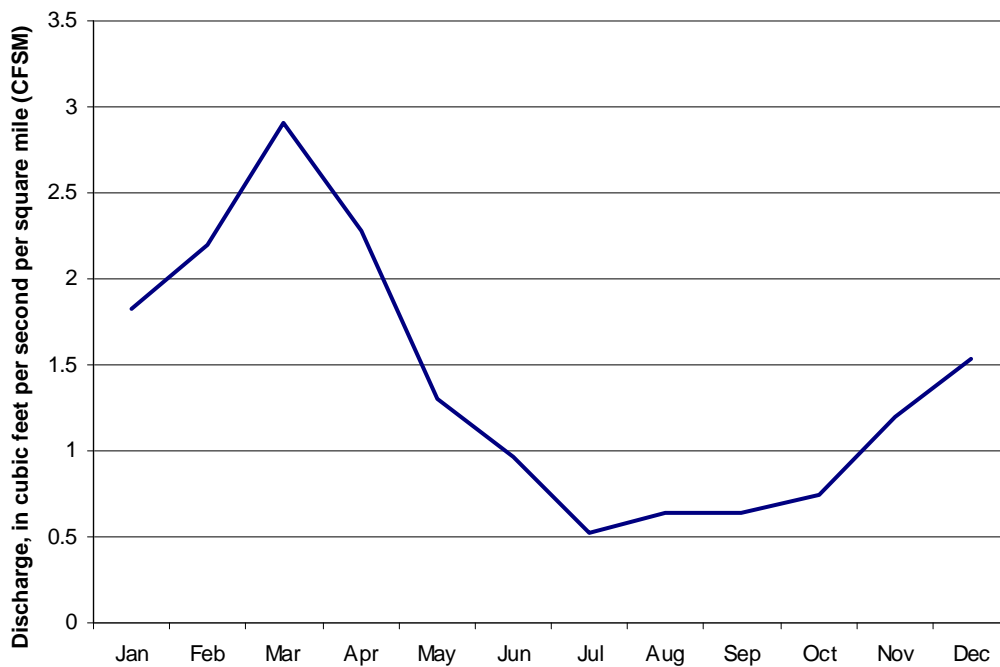
Figure 4-2. Mean Monthly Streamflow of North Branch Park River

The United States Geological Survey (USGS) has also estimated peak-flow magnitudes for 1.5-, 2-, 10-, 25-, 50-, 100- and 500-year recurrence intervals (corresponding to exceedance probabilities of 0.67, 0.50, 0.10, 0.04, 0.02, 0.01, and 0.002, respectively) based on historical streamflow measurements at the North Branch Park River stream gage location near Albany Avenue (Ahearn, 2003). *Table 4-2* summarizes peak flow frequency estimates for given recurrence intervals and the maximum known peak flow for the North Branch Park River. Beginning in 1963, flows in the North Branch Park River watershed were affected by flood control regulation resulting from the construction of the Cold Spring, Bloomfield (Tunxis), Wintonbury, and Blue Hills flood control reservoirs. Details of these flood control reservoirs are presented in Section 5.1.

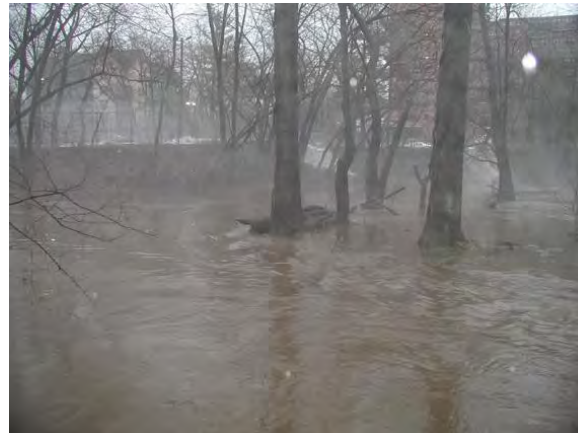
An example of flooding that is common along the lower portion of the North Branch Park River during a January 2006 storm.

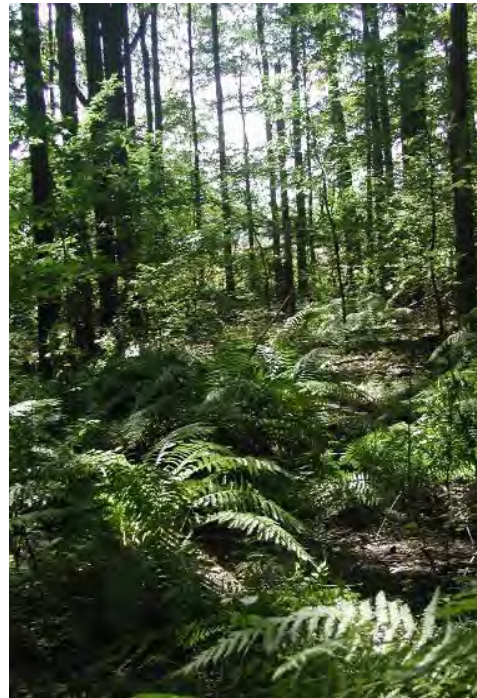
Although much of this area was altered in the past and continues to be impacted by stormwater runoff from the shopping center and other nearby impervious areas, a square-shaped wooded portion in the southeast corner of the assessment area remains relatively undisturbed. Open water and marsh dominate the northern end of this wetland. Four distinct vernal pools (breeding habitat not confirmed) are evident within the undisturbed woods. One of them held a small amount of water on the date of the assessment, while the other three were dry. Because of the large amount of water directed to these wetlands from developed areas, they provide important water quality functions.

Wooded wetland near the COPACO Shopping Center (NEE, 2009).

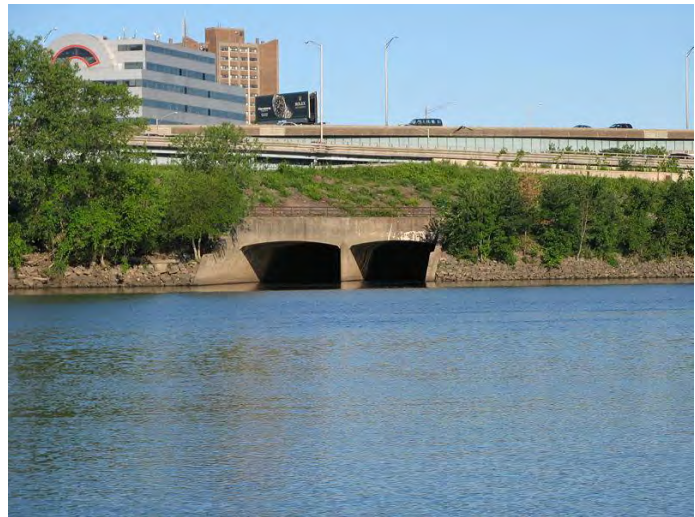
The confluence of the Park River conduit with the Connecticut River in Hartford.

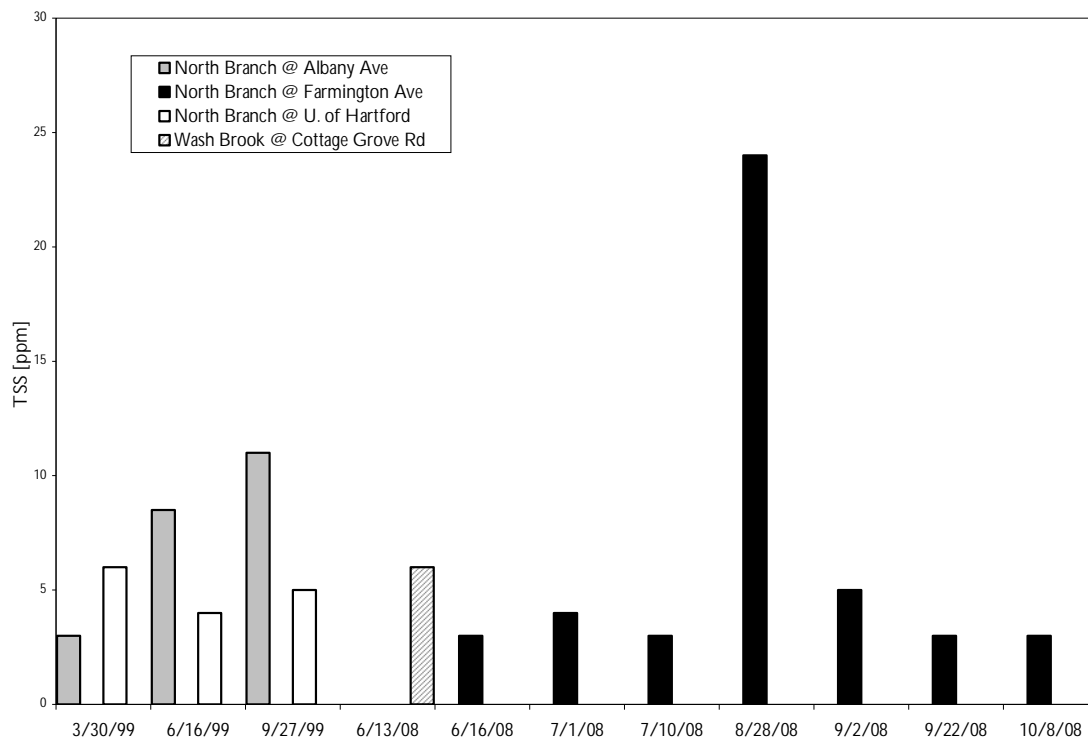
Figure 6-4. Total Suspended Solids (TSS) – North Branch Park River Watershed

There are no numerical state or federal water quality criteria for TSS. The Connecticut Water Quality Standards require that suspended and settleable solids not be present in concentrations or combinations that would impair designated uses, alter the composition of the water body substrate, or impact aquatic organisms.

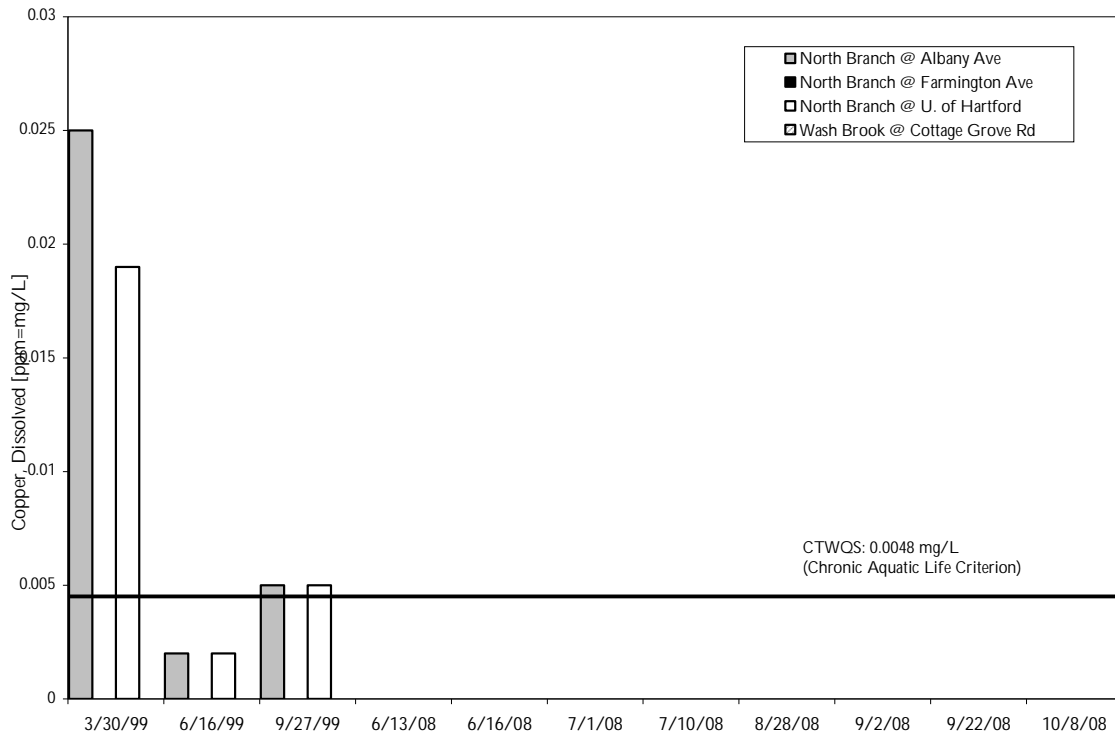
Figure 6-5. Dissolved Copper – North Branch Park River Watershed

Dissolved copper was measured at two locations within the watershed on three occasions in 1999, and has not been sampled since. Both locations, at Albany Avenue and the University of Hartford, were found to have levels above the Connecticut Water Quality Standards freshwater chronic aquatic life limit of 4.8 micrograms per liter (*Figures 6-5*) during two of the three monitoring events. Biological integrity can be impaired when the ambient concentration of dissolved copper exceeds this value on more than 50 percent of days in any year (Connecticut Water Quality Standards, 2002). These elevated copper levels may result from stormwater runoff and combined sewer overflows.

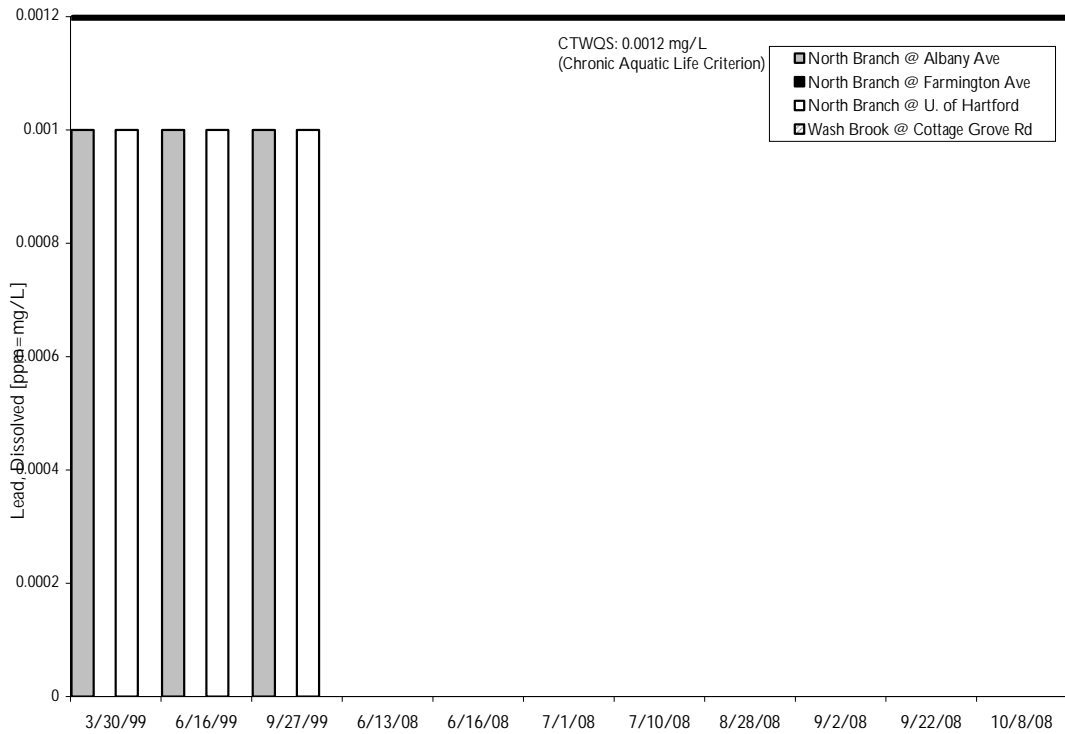
Figure 6-6. Dissolved Lead – North Branch Park River Watershed

Figure 6-6 summarizes dissolved lead concentrations at watershed sampling locations relative to the freshwater chronic aquatic life criterion of 1.2 micrograms per liter. None of the measured dissolved lead concentrations exceeded the criterion. Dissolved zinc concentrations were measured on three dates at two locations (Albany Avenue and University of Hartford) in 1999 (Figure 6-7). Of the six samples, two (one at each location) exceeded the freshwater chronic aquatic life criterion of 6.5 micrograms per liter.

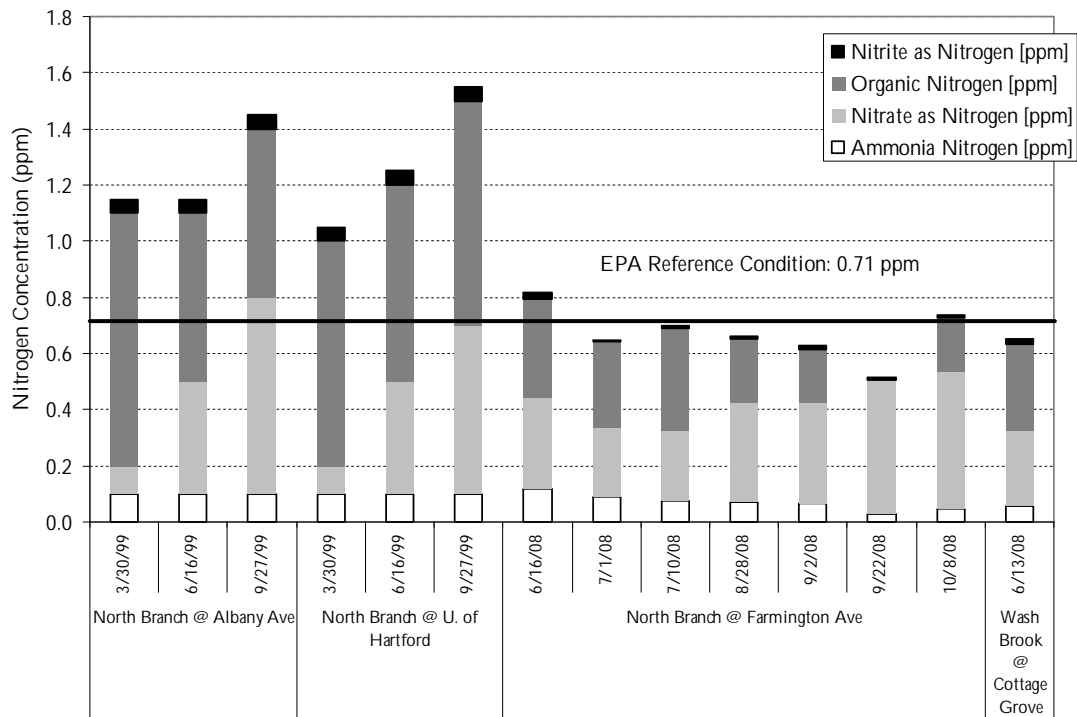
Figure 6-8. Total Nitrogen – North Branch Park River Watershed

Note: Organic nitrogen data were unavailable for 9/22/08 at the Farmington Avenue sampling site.

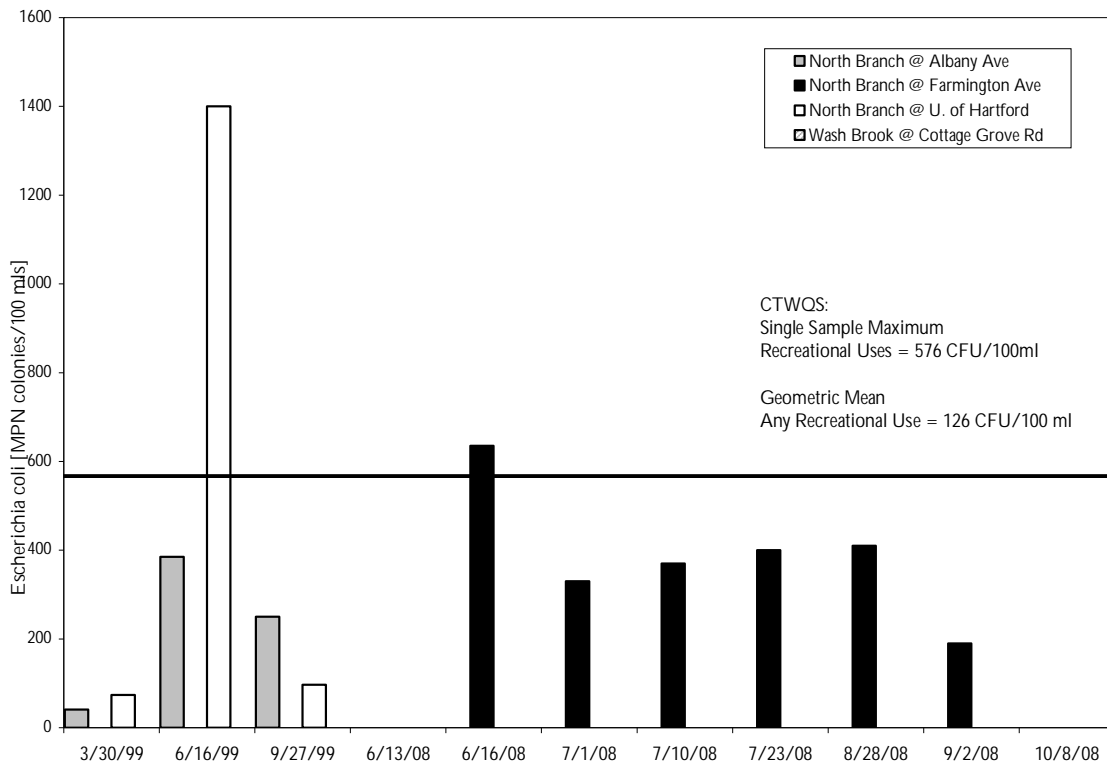
Figure 6-10. *Escherichia coli* – North Branch Park River Watershed

Determining the potential sources of indicator bacteria is difficult, especially since precipitation conditions prior to and during the sampling events are not known. Elevated bacteria levels during wet weather suggest stormwater runoff and other non-point sources (sewer overflows, pet waste, waterfowl, septic systems, etc.) as likely contributors of pathogens in the North Branch Park River and its tributaries. Alternately, elevated dry weather concentrations may be related to illicit discharges, septic system failures, or natural sources of bacteria such as waterfowl or wildlife. Samples collected at the Farmington Avenue (6/16/08) and University of Hartford (6/16/99) monitoring locations exceeded the single sample water quality standard of 576 CFU/100 ml.

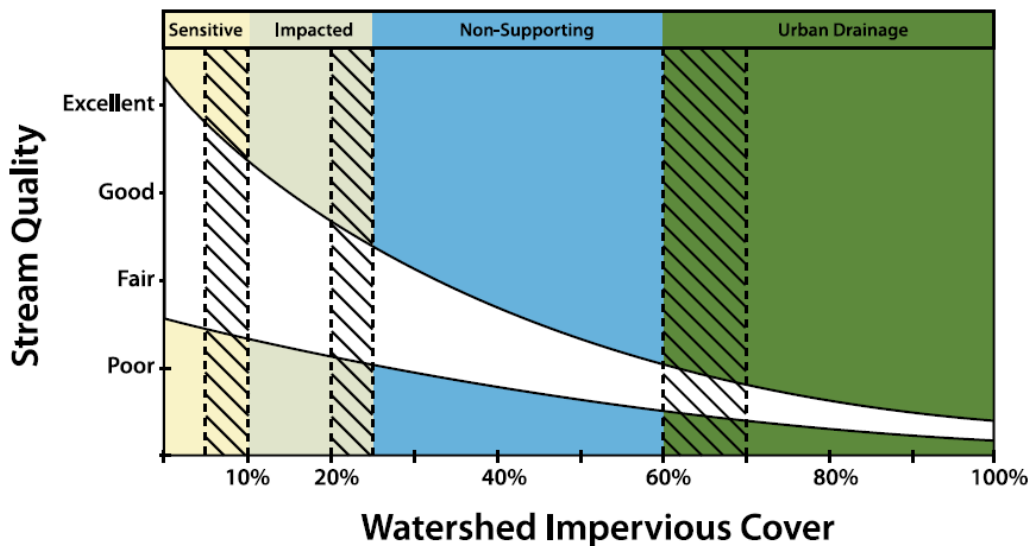
Figure 7-4. Conceptual Model Illustrating Relationship Between Watershed Impervious Cover and Stream Quality

Figure 7-4 also demonstrates the wide variability in stream response found in less-urban watersheds at lower levels of impervious cover (generally less than 10 percent). Stream quality at lower range of impervious cover is generally influenced more by other watershed metrics, such as forest cover, road density, extent of riparian vegetative cover, and cropping practices. Less variability exists in the stream quality at higher levels of impervious cover because most streams in highly impervious, urban watersheds exhibit fair or poor stream health conditions, regardless of other conditions (CWP, 2008).

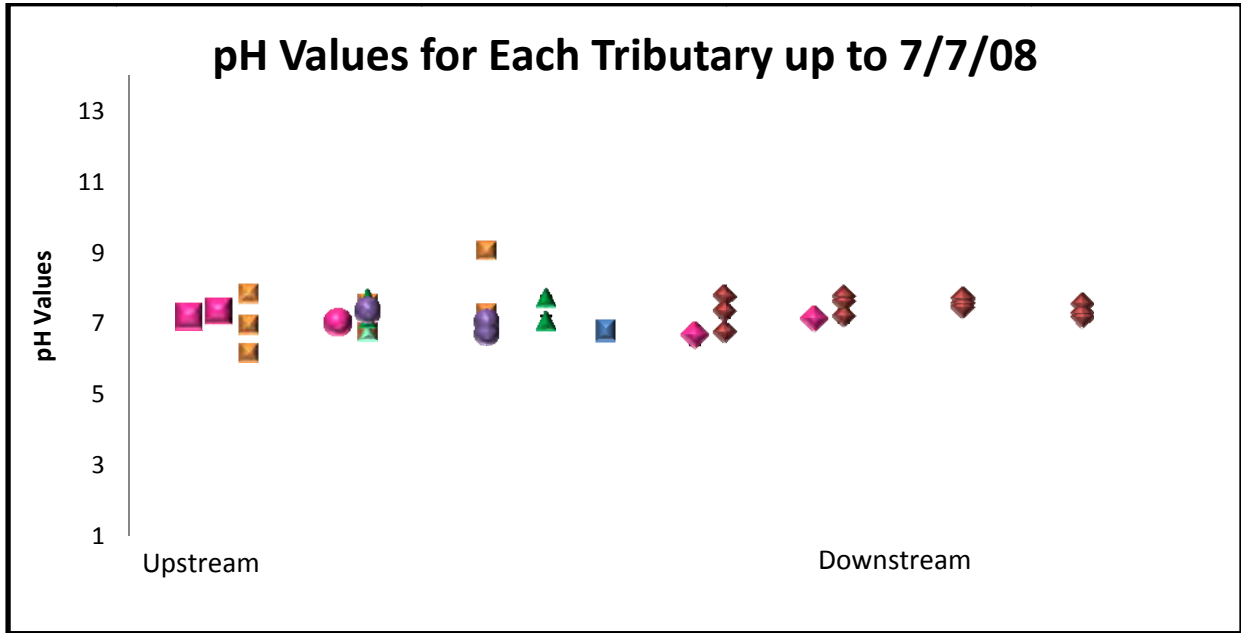
Graph 1: This graph shows the pH values by tributary.

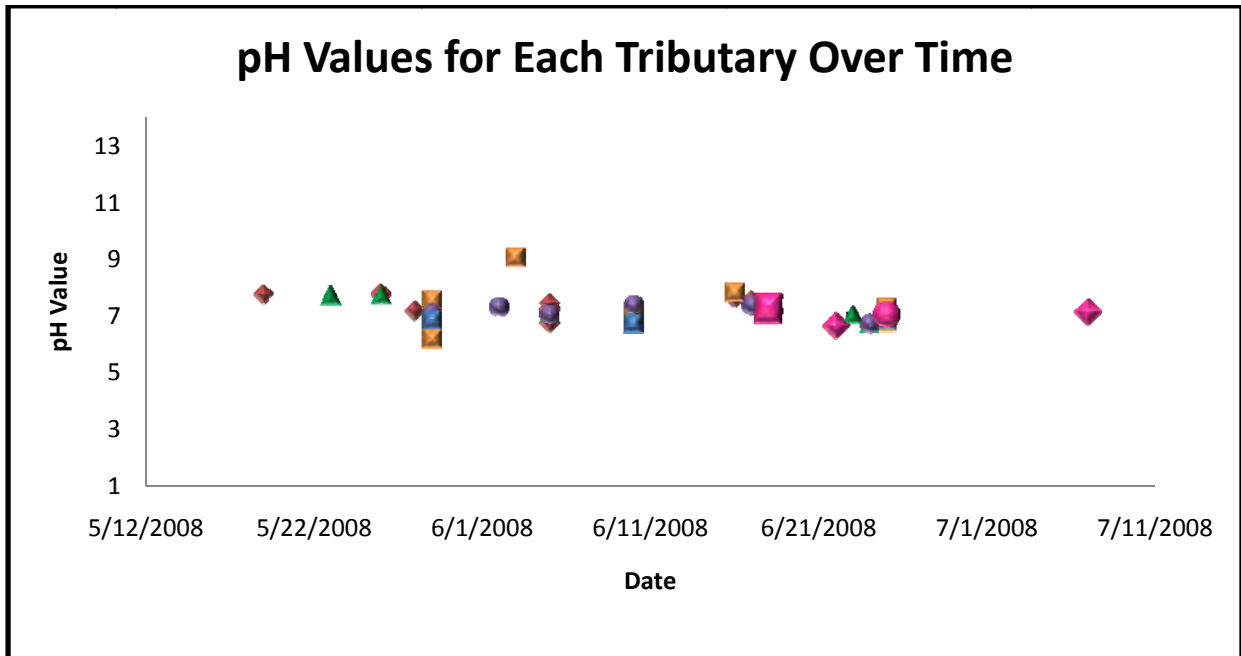
Graph 2: This graph shows the pH values over time for each site.

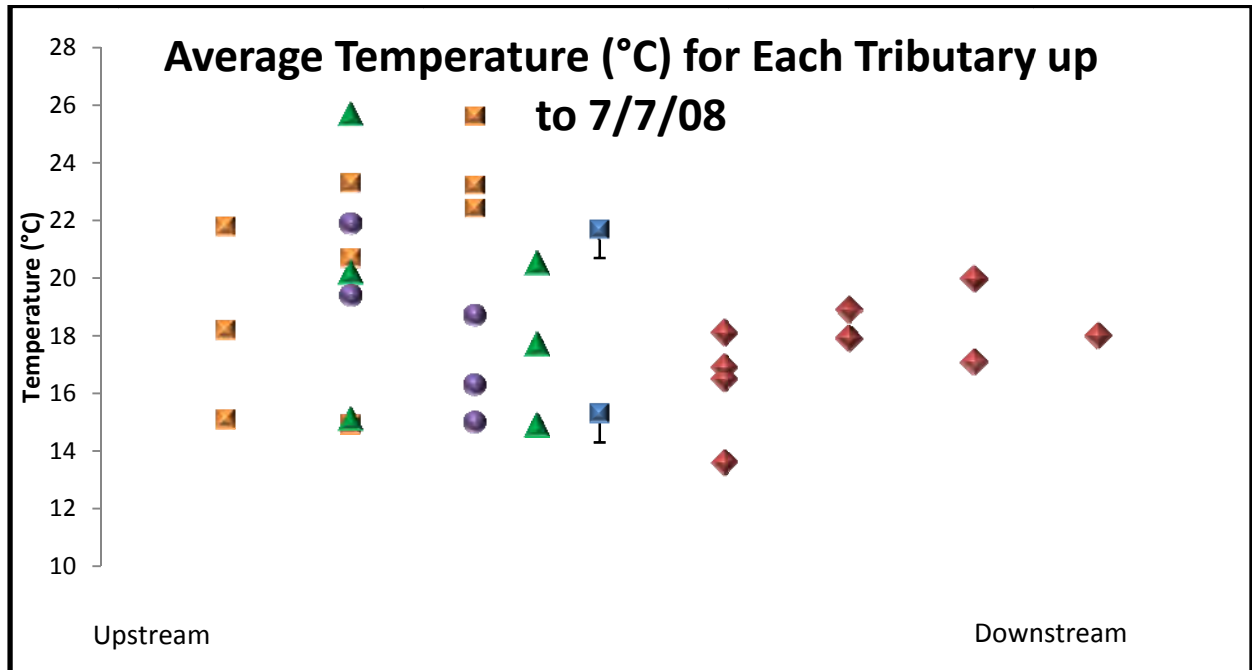
Graph 3: This graph shows the temperature in °C for each tributary.

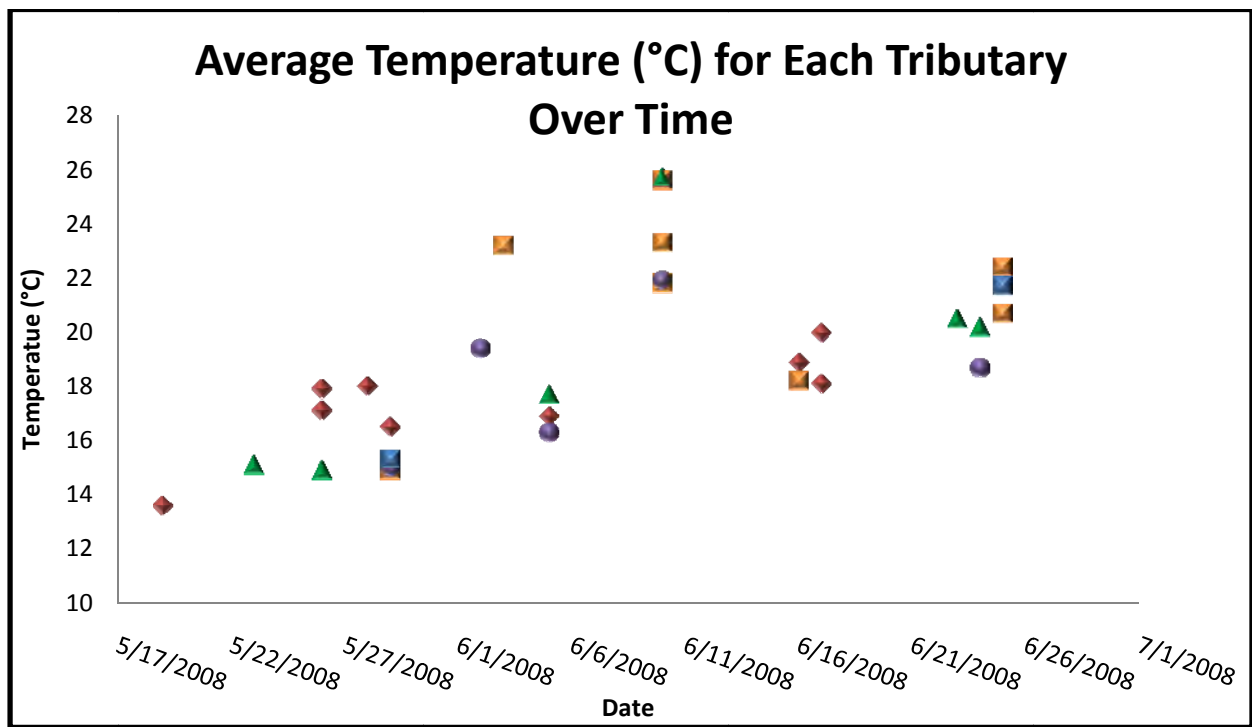
Graph 4: This graph shows the temperature in °C of each tributary over time.

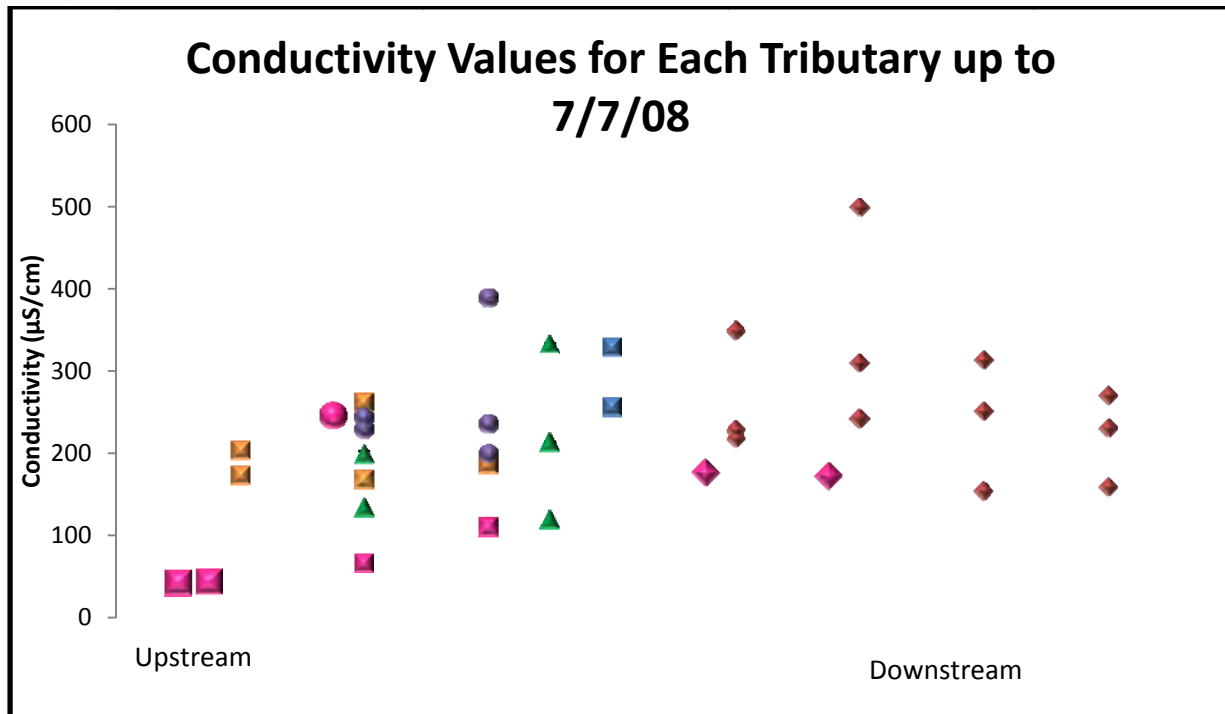
Graph 9: This graph shows the conductivity values in $\mu\text{S}/\text{cm}$ for each tributary.

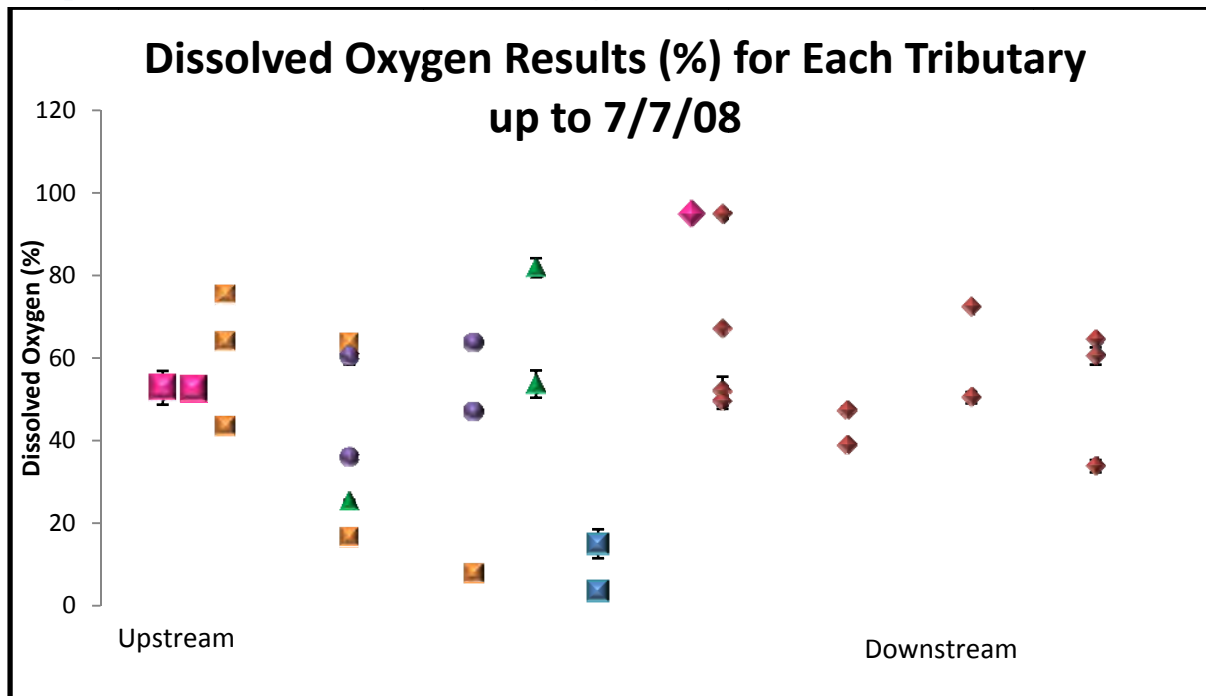
Graph 13: This graph shows dissolved oxygen readings in % air saturation for each tributary.

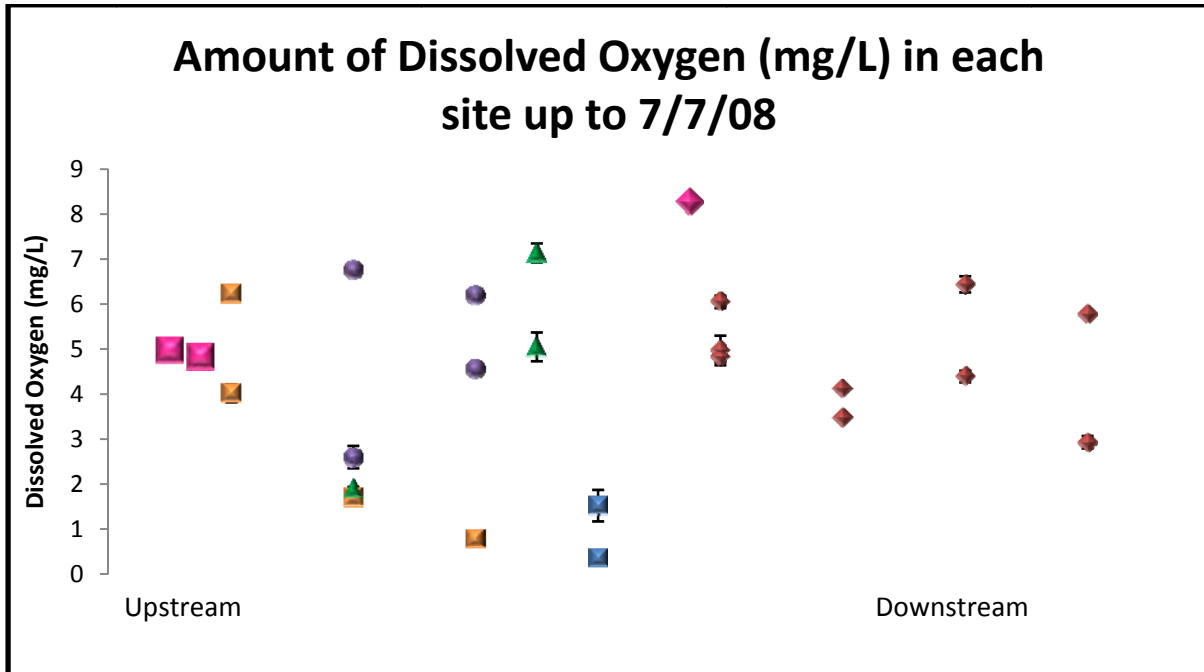
Graph 15: This graph shows the amount of dissolved oxygen in mg/L for each tributary.

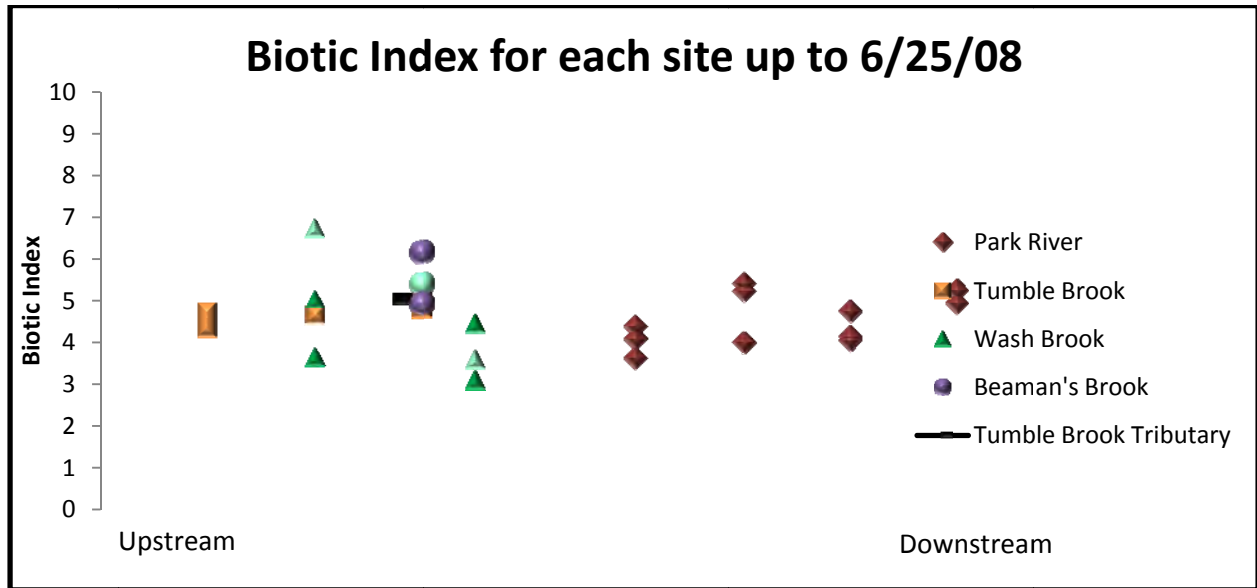
Figure 1. The biotic indices of each sample taken from all sites along the Park River and each Tributary by position.

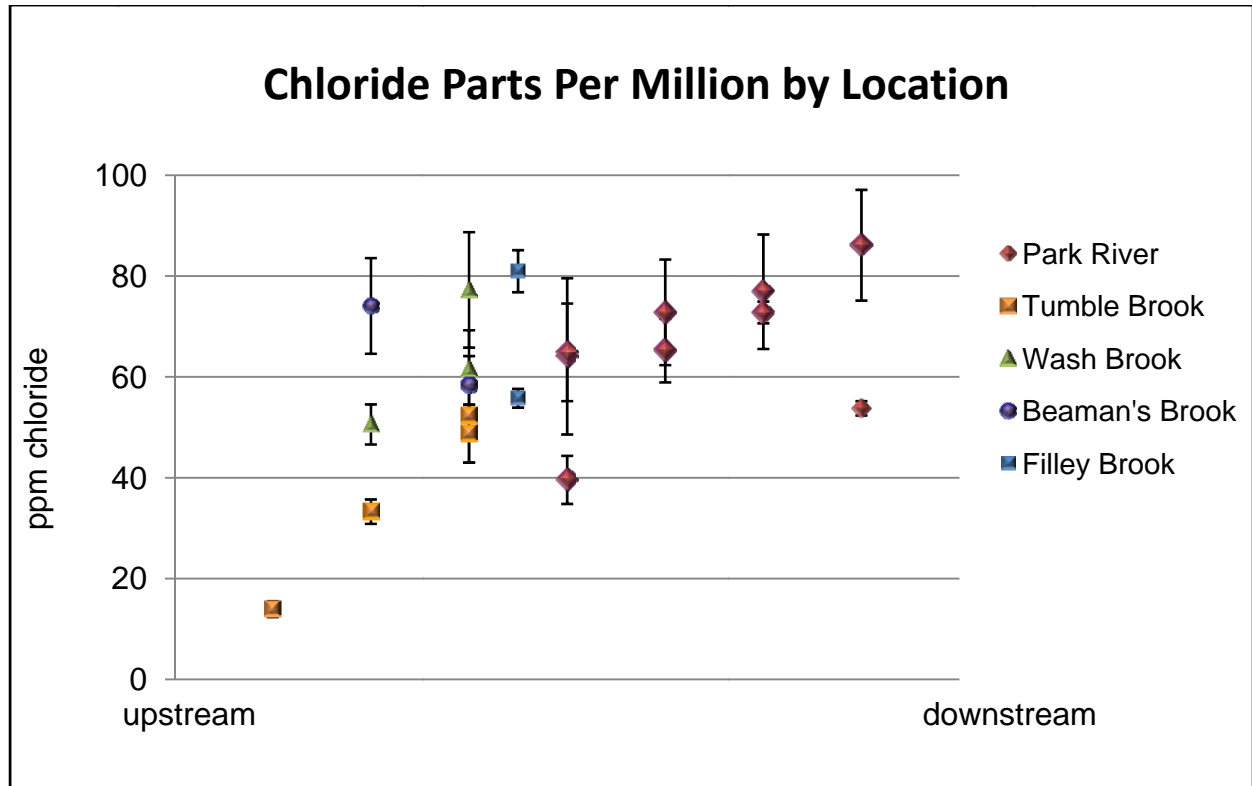
Graph 1:

Graph 1 shows the chloride anion concentration in parts per million organized by position in the watershed. There is generally a steady upward trend in chloride anion concentration across the watershed. However, not all tributaries show this trend. There is no trend evident in Filley Brook since there are so few data points. Beaman's Brook anion concentration decreases, however, there are only two data points, both with large margins of error. The Tumble Brook tributary shows an upward trend, as does Wash Brook and the Park River, not including the one obvious outlier for the Park River. There are three data points, one for Beaman's Brook, Wash Brook, and Filley Brook, that have higher anion concentrations than would be expected so far upstream in the watershed.

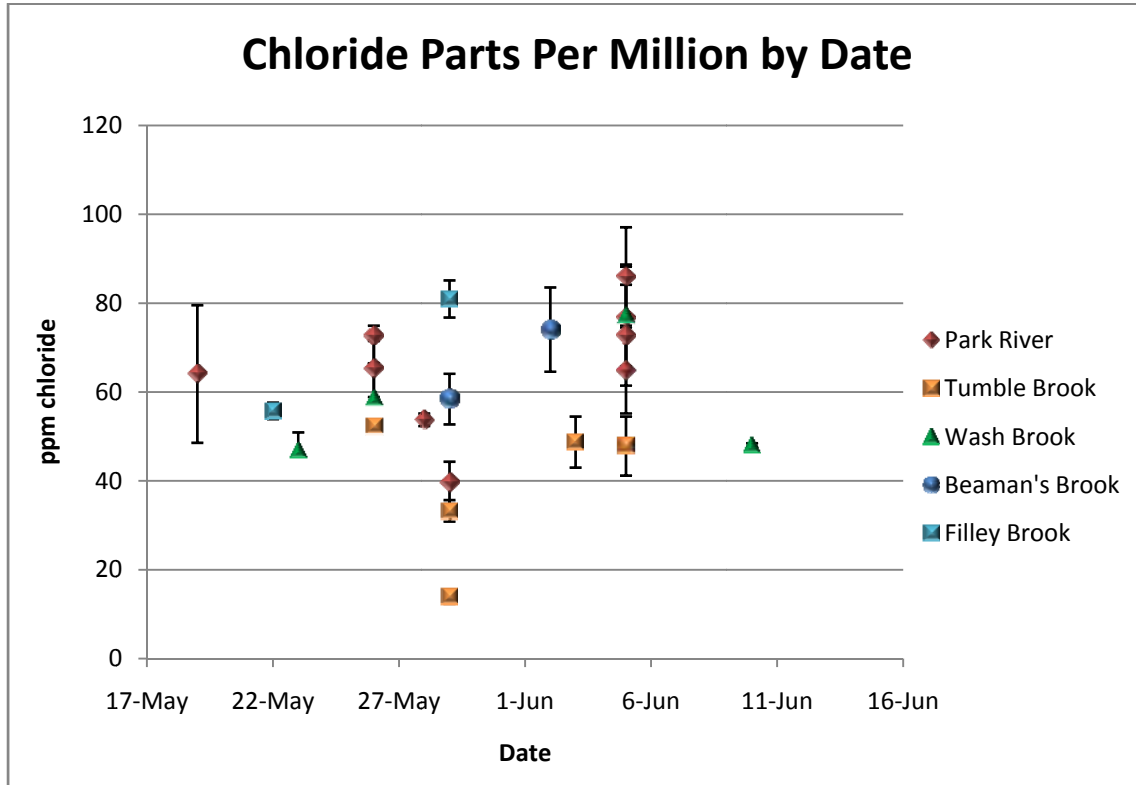
Graph 2:

Graph 2 shows the chloride anion concentration in parts per million organized by date collected. There is not a trend in chloride anion concentration across time.

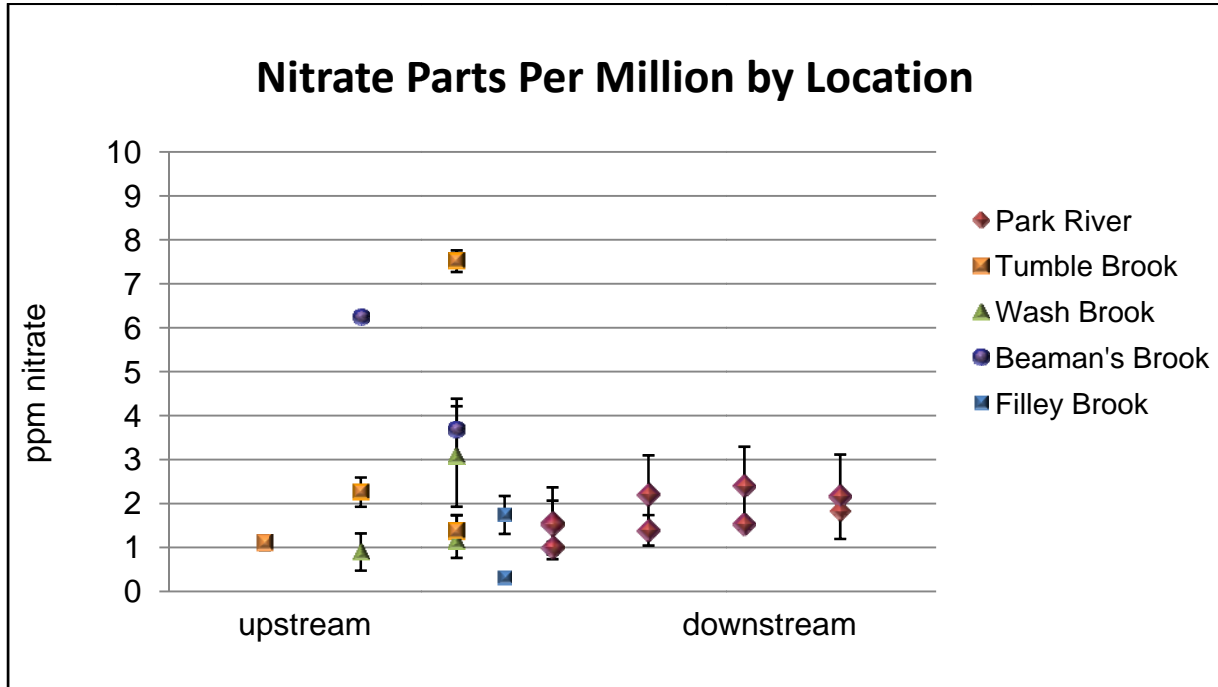
Graph 3:

Graph 3 shows the nitrate anion concentration in parts per million organized by position in the watershed. There may be a slight upward trend in nitrate anion concentration across the watershed, visible in the Park River, but not in any of the tributaries. There is a spike of nitrate anions on two different dates at Tumble Brook and Beaman's Brook. The spike in nitrates at Tumble Brook could be due to runoff from fertilizers from the golf course that is located directly upstream from our testing site. The spike at the Beaman's Brook site could be due to a current construction project occurring there.

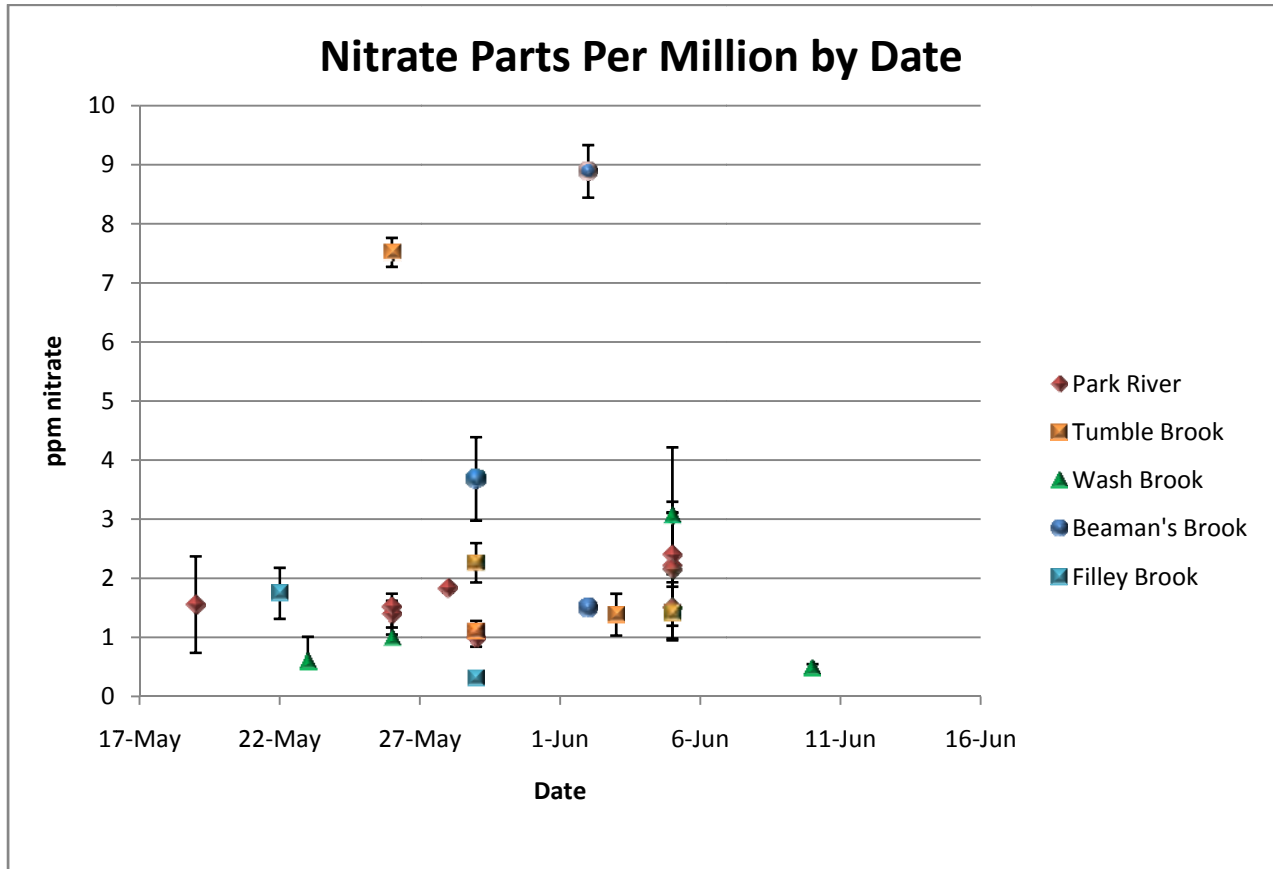
Graph 4:

Graph 4 shows the nitrate anion concentration in parts per million organized by date collected. There is not an obvious trend in nitrate anion concentration across time. There is the same spike of nitrate anions in Tumble Brook and Beaman's Brook as seen in graph 3.

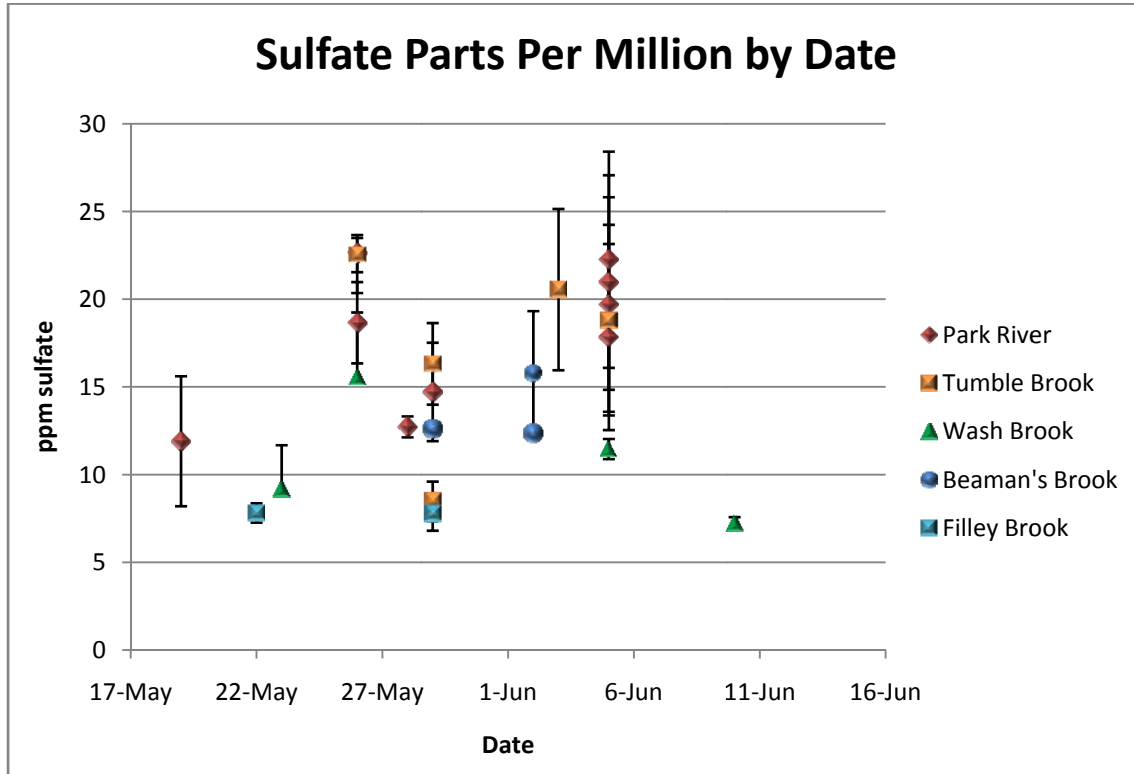
Graph 6:

Graph 6 shows the sulfate anion concentration in parts per million organized by date collected. There is not an obvious trend in sulfate anion concentration across time.

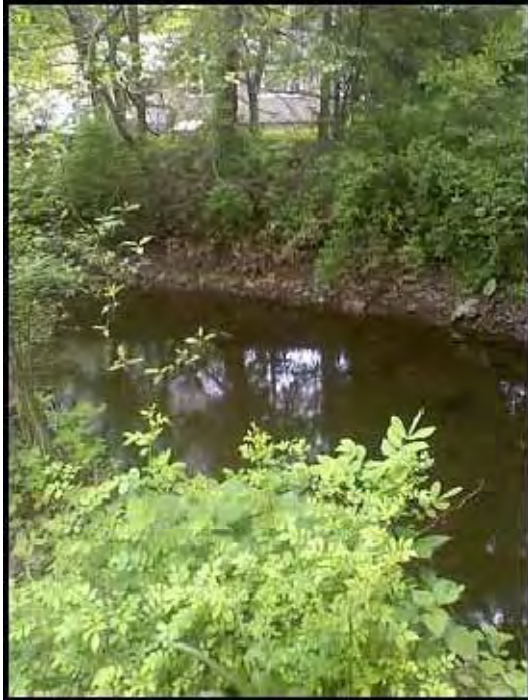
Site 5.5 (Middle Tumble Brook) – MTB 5.5

This portion of the river runs through a residential area. The water is about 1 meter deep. The water is still and the bottom is muddy. There is little vegetation on the banks. There is a bridge, which supports Still Road, crossing over the river. Still Road intersects the Brook a half mile west of the intersection of Still Road and Route 173.

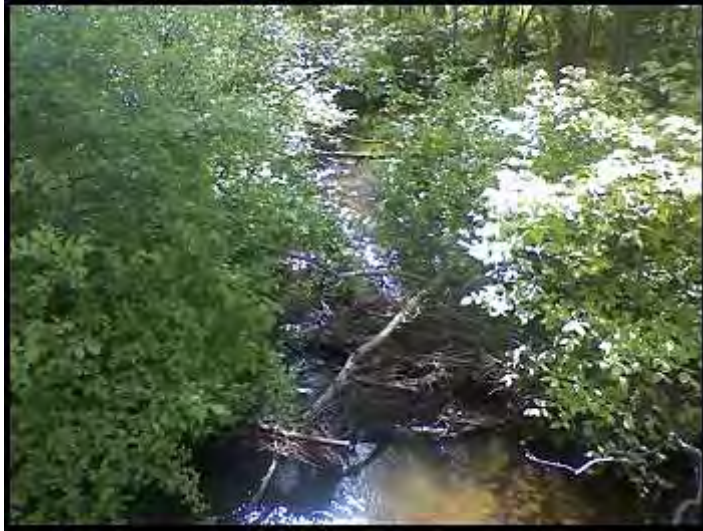
Site 7 (Top Wash Brook) – TWB 7

The site is located on Route 189, $\frac{3}{4}$ of a mile North of where Terry Plains Road intersects Route 189. There is a small beaver dam downstream from the bridge/road. There are several outflow pipes draining into the river. The depth of the water varies; it is deeper under the bridge, and gets shallower downstream, near the beaver dam. It is mostly muddy bottom with a few small rocky parts (around 4 feet long). There are slow-flowing riffle zones directly after the beaver dams. There is rip rap surrounding the abutment of the bridge

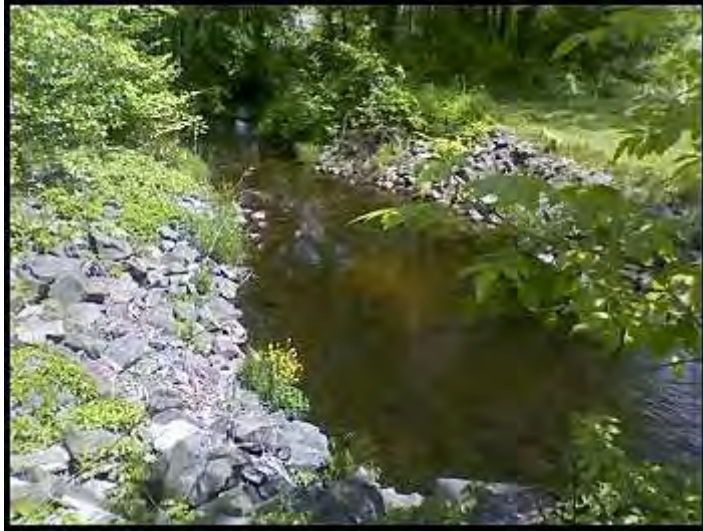
Site 6 (End Tumble Brook) – ETB 6

A bridge crosses the river upstream from our sampling location. There are tall grasses surrounding the right bank (looking downstream) and a forested area on the left. There is a tree whose branches shade the river over the riffle zone. There are small-medium rocks covering the bottom. The sampling site is accessible from Medinah Drive .1 mile east of Maple Avenue.

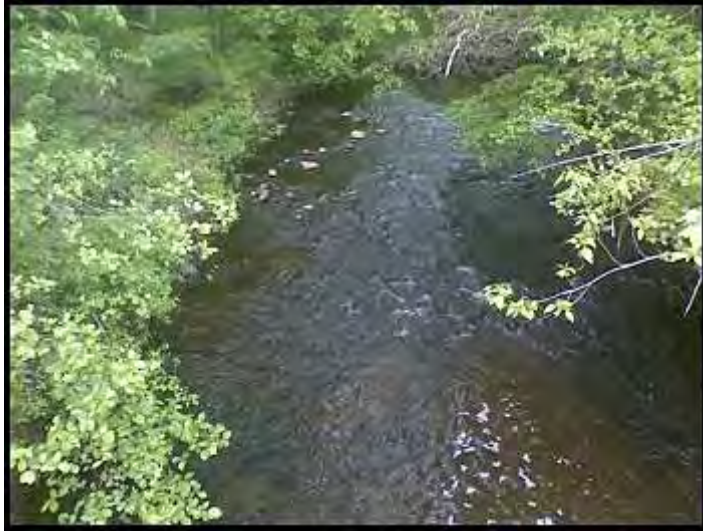
Site 8 (End Wash Brook) – EWB 8

Site 8 is located at the intersection of Route 218 and Bloomfield Avenue. A bridge crosses downstream of our sampling site. The section under the bridge is channelized. The river is much shallower in the channelized section under the bridge, about a foot and a half deep. On the other side of the bridge, the water is calm, and still shallow. The section of the river used for sampling is downstream of the bridge, and is a fast-flowing riffle zone. The bottom is very rocky, containing rocks of various sizes. Trees, shrubs, and grass are present on both banks.
