Baseline Watershed Assessment North Branch Park River Watershed

Connecticut Department of
Environmental Protection

July 2010

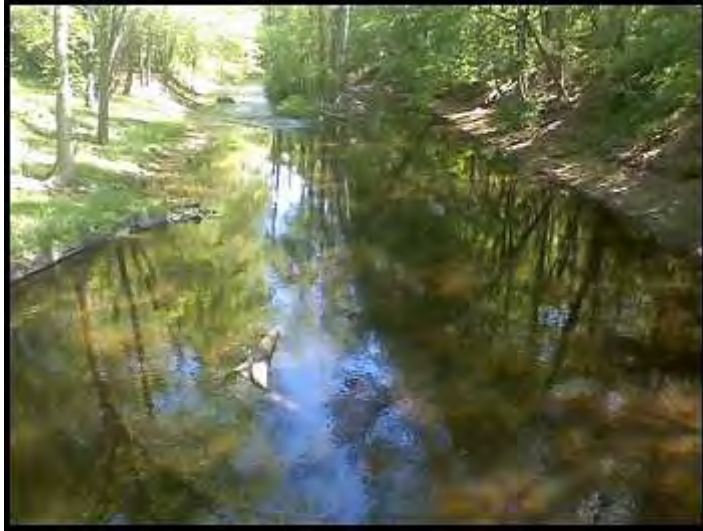
Site 1 (Top North Branch Park River) – TNBPR 1

Site 1 is located just downstream of where Portage Road crosses over the river, approximately .1 miles east of where Portage Road intersects Bloomfield Avenue. This section of the river runs through a residential area with houses on both banks. It has a rocky bottom that includes a mixture of rock sizes.

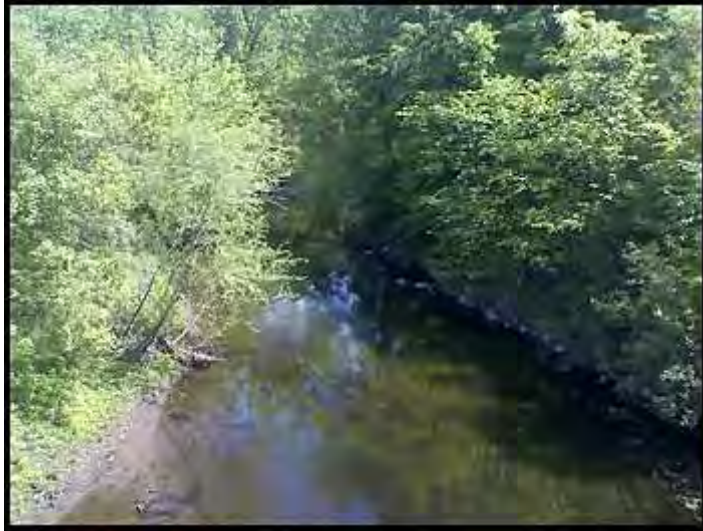
Site 3 (Mid 3 North Branch Park River) – MRBPR 3

Site 3 is located just downstream from the intersection of Albany Ave and Scarborough Street. The river is deep even on the bank and only gets slightly deeper in the middle. The river reaches a depth of approximately 1 meter in the middle. The riffle zone is downstream from blocks of concrete that create a miniature waterfall. There is a fast current around the riffle zone.

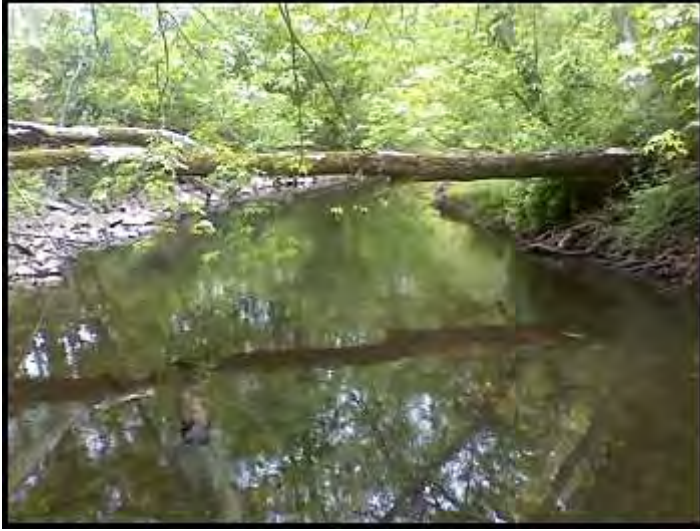
Site 4 (End North Branch Park River) – ENBPR 4

Site 4 is accessible from the back of the Medical Arts Building parking lot off of Woodland Street, .1 mile North of Farmington Avenue. The river is separated from the parking lot of the medical arts building by a brief wooded area. The water is about $\frac{3}{4}$ of a meter deep and there is a slight current. The bottom of the river is mostly sandy with a few scattered rocks.
