Connecticut Work Zone Reviews

Annual Report

2017

State of Connecticut
Department of Transportation
Office of Construction

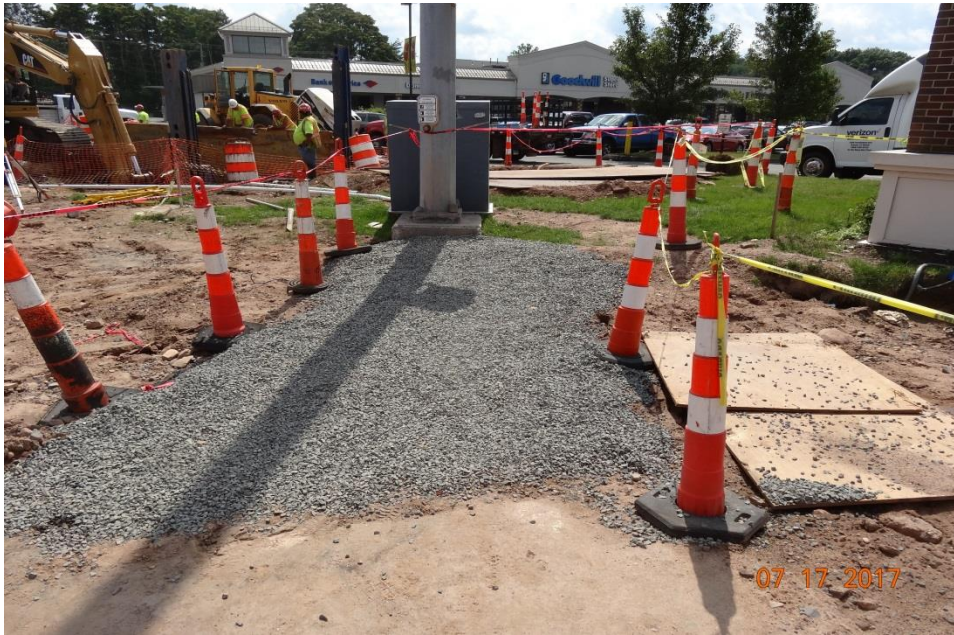
Photo 10: This temporary ramp to the push button located on the span pole was well formed, but it was done with loose ½ inch stone. A wheelchair would have trouble traversing through the loose stone. A more dense graded material that compacts to form a tight surface should be used.

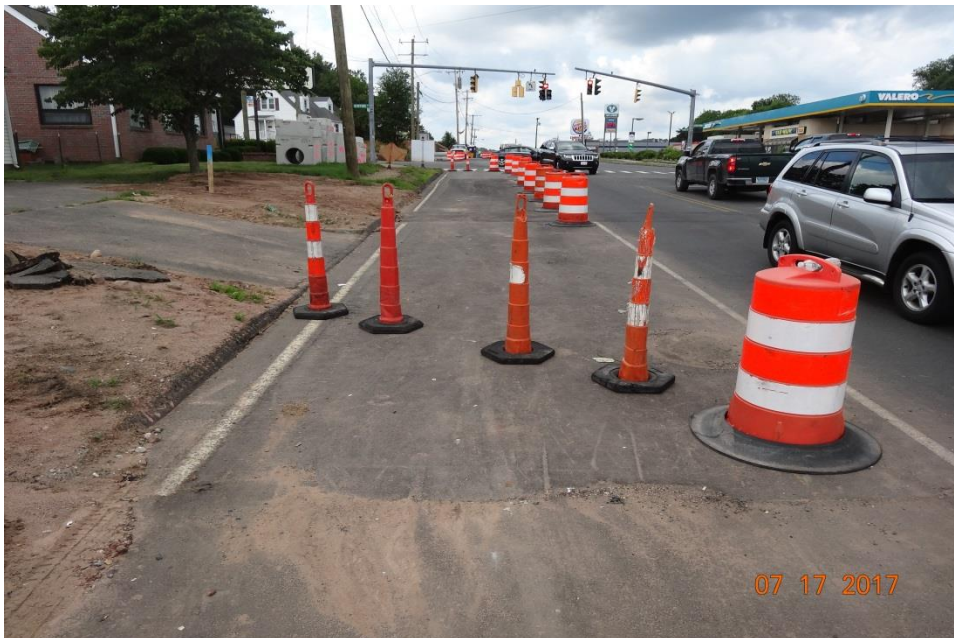
Photo 16: Cones that do not meet the reflectivity requirements need to be removed from the project and replaced with cones in good condition.

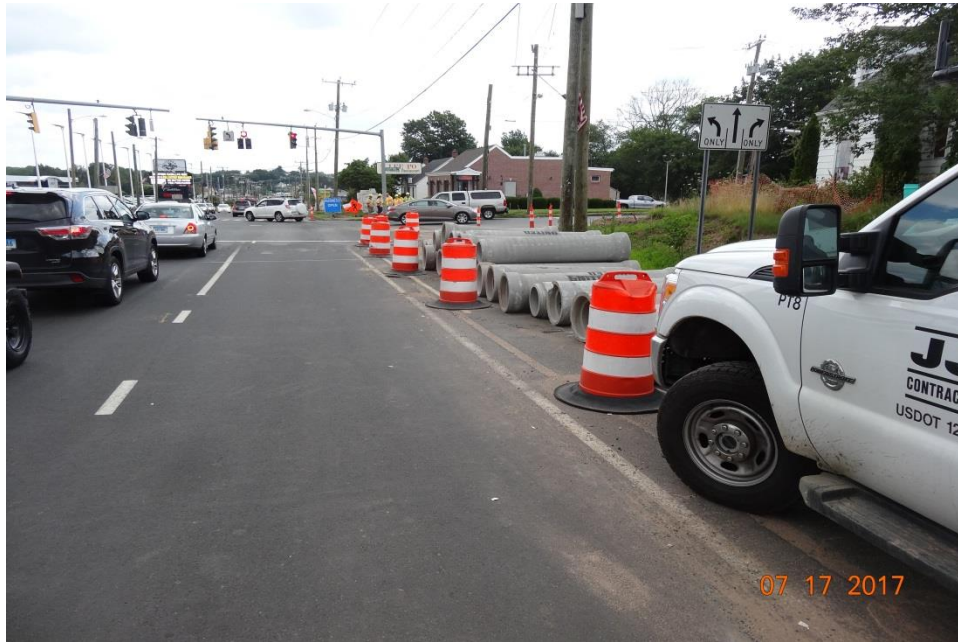
Photo 17: Like Photo 15, this concrete pipe was stored right along the edge of the travelway.

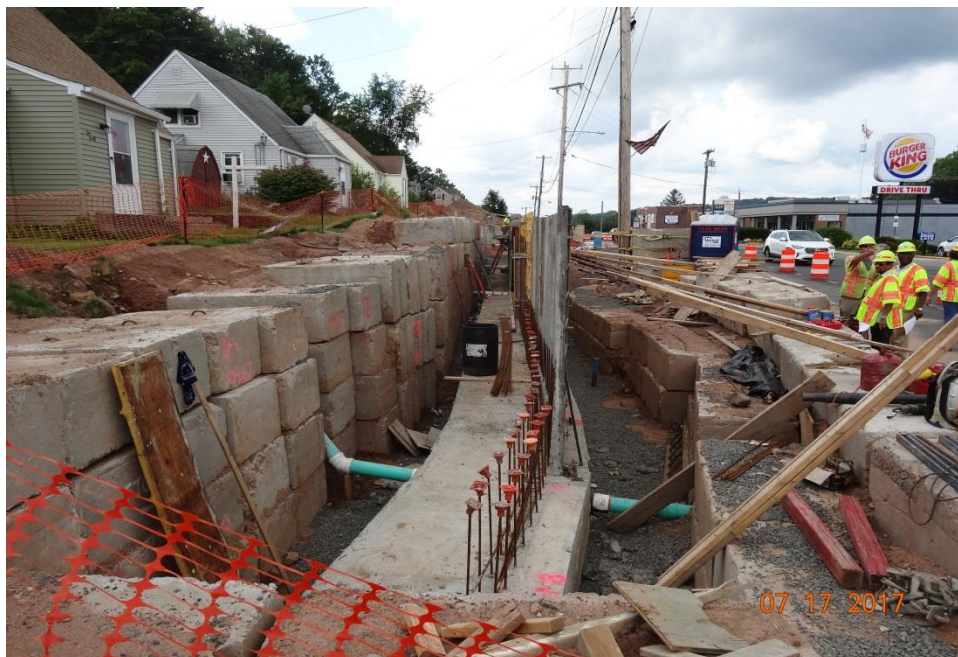
Photo 18: Here the Contractor has installed construction fencing around the back and sides of the excavated area to prevent anybody from walking into this potential hazard.

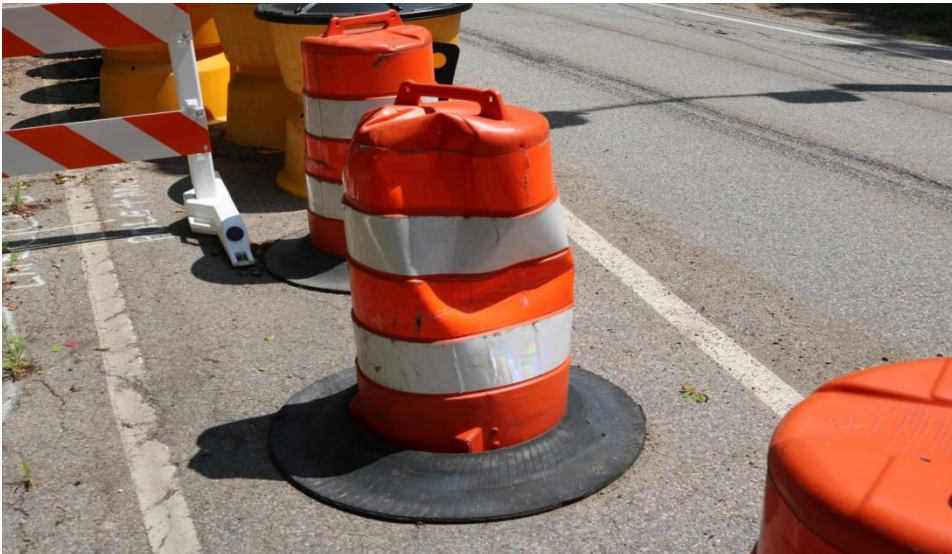
Photo 5: Any damage that may affect a traffic control device's ability to reflect light should be repaired or replaced.

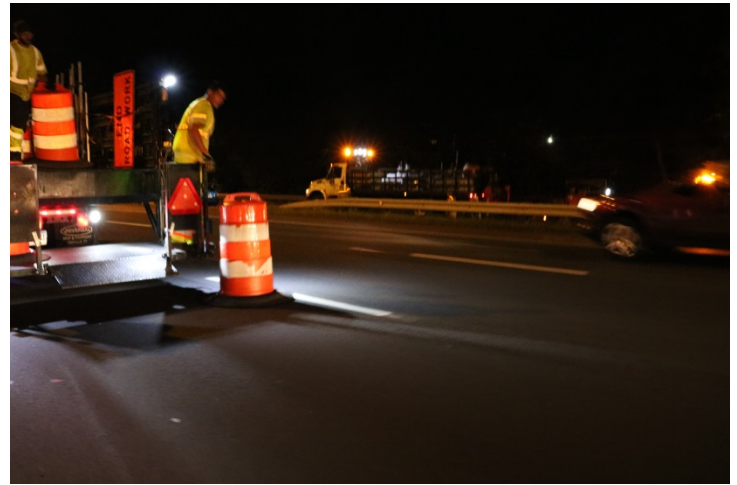
I-95 NB: This traffic drum is missing reflective tape and is marginally acceptable.

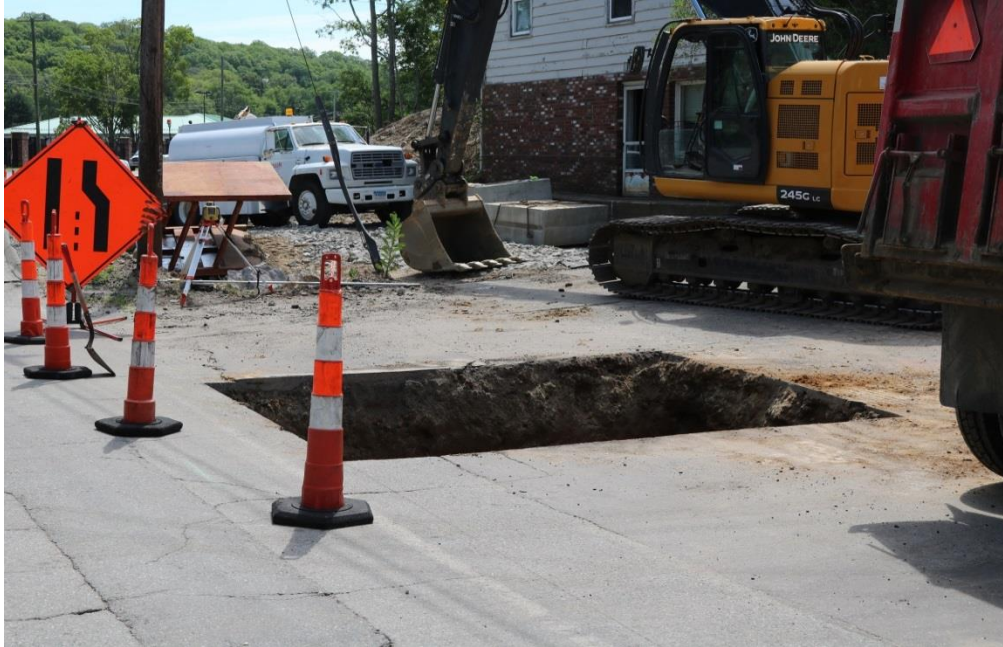
Photo 9: Here, the Contractor had just completed excavation of a small pit, 10'x12'x6'deep. The protection around the pit is inadequate. Pedestrians or anyone walking through this area are susceptible to falling in. Better protection is needed to fully block off this pit to anyone passing through this area.

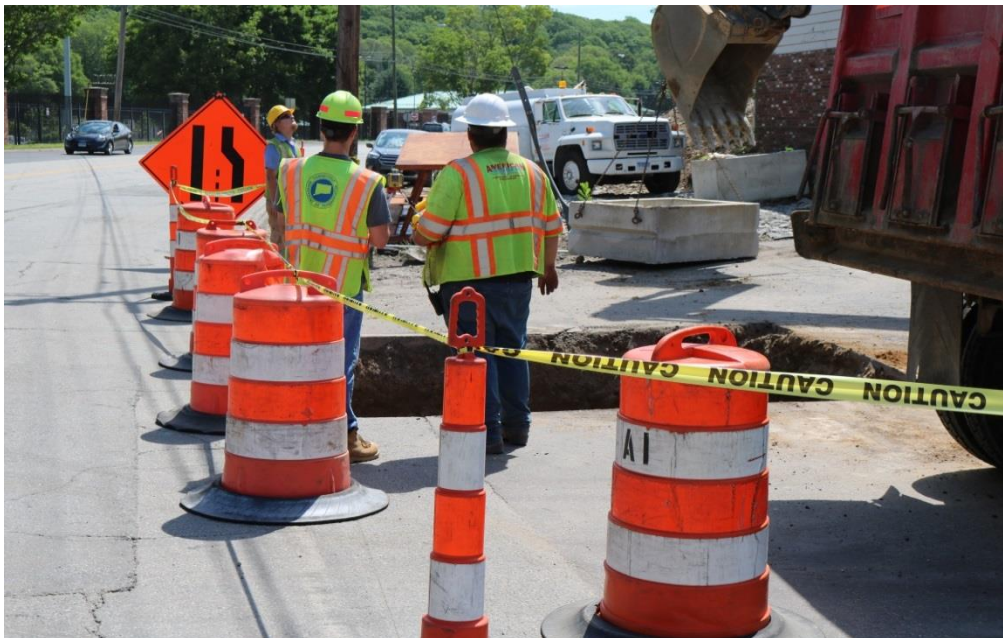
Photo 10: Here is the same area after the Contractor made some adjustments. The area is now well delineated and prevents a potential clear pass-through by pedestrians or others passing along the edge of the roadway.

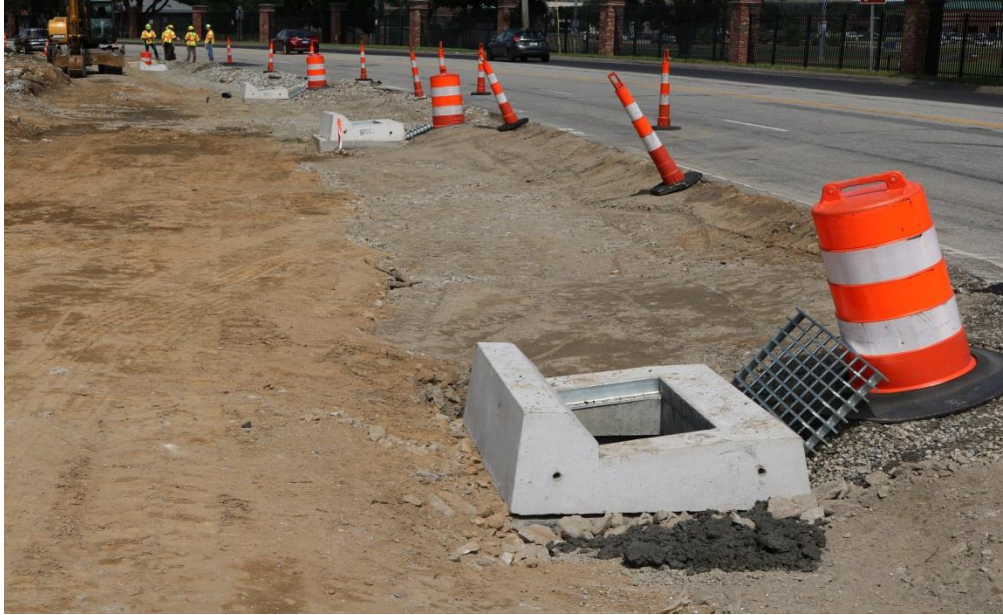
Photo 11: These new basins being set are within the 16 foot clear zone and are protruding high enough above the surrounding ground to create a potential hazard to motorists if left like this overnight. The drop-off is rather abrupt and too close to the travel way once the pattern is taken down. And although these basins had been worked on earlier, the grates were left off of several of them while they were not being worked on. If the basin is left unattended the grates or some other protection should be placed over the opening.

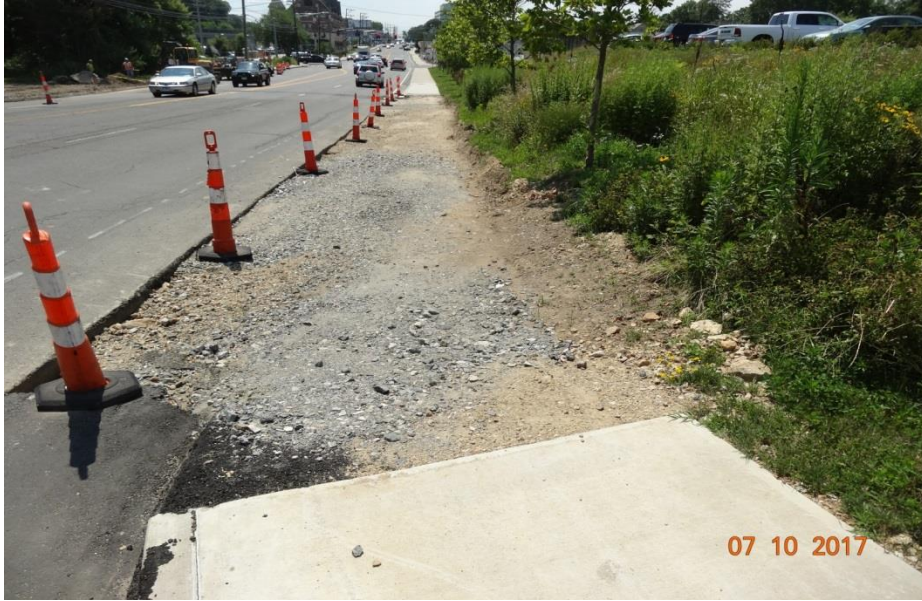
Photo 7: Looking south on Route 1. This sidewalk section is being reconstructed. When reconstructing existing sidewalk areas, the existing condition and functionality must be maintained or improved while the new sidewalk is being built unless a pedestrian detour is provided. The temporary condition of this sidewalk may not be adequate for some pedestrian groups.

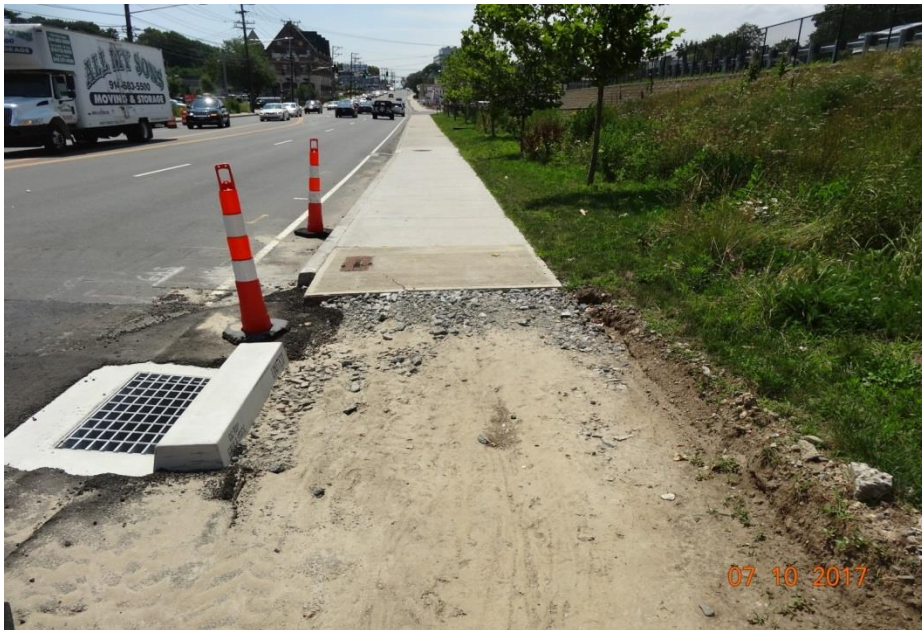
Photo 8: Showing the southern end of the same sidewalk as in Photo 7. The crushed gravel ramp formed at the transition is approximately 6 inches high by 12 inches long. The existing sidewalk condition has not been matched or made better at this location.

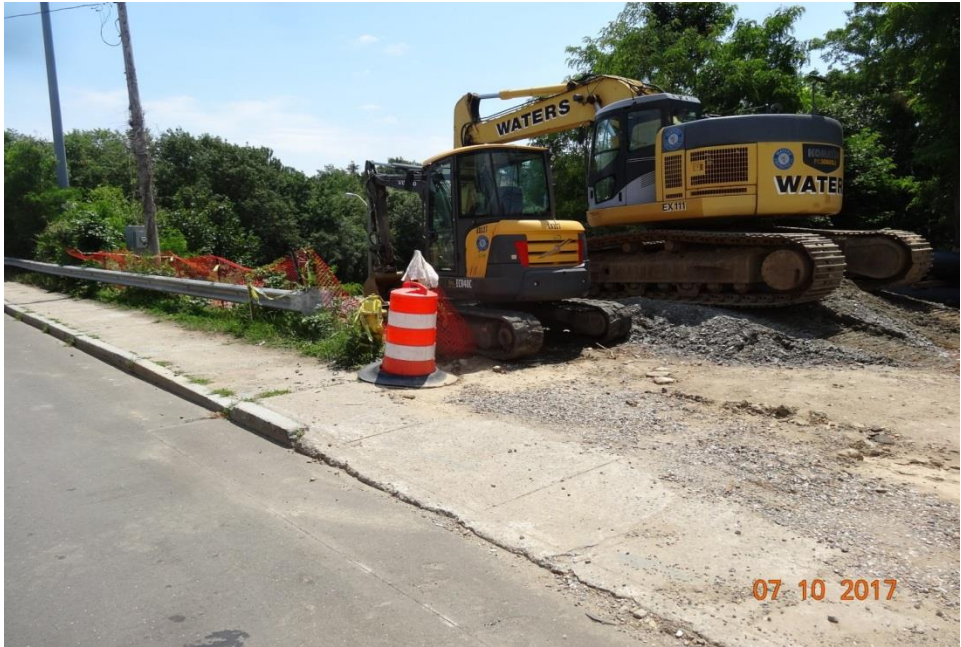
Photo 13: This is the same area as photos 11 and 12. An attempt to use equipment to block off the slope to I-95 has resulted in a potential clear zone hazard. All equipment and materials are to be stored a minimum of 16 feet off of the roadway.

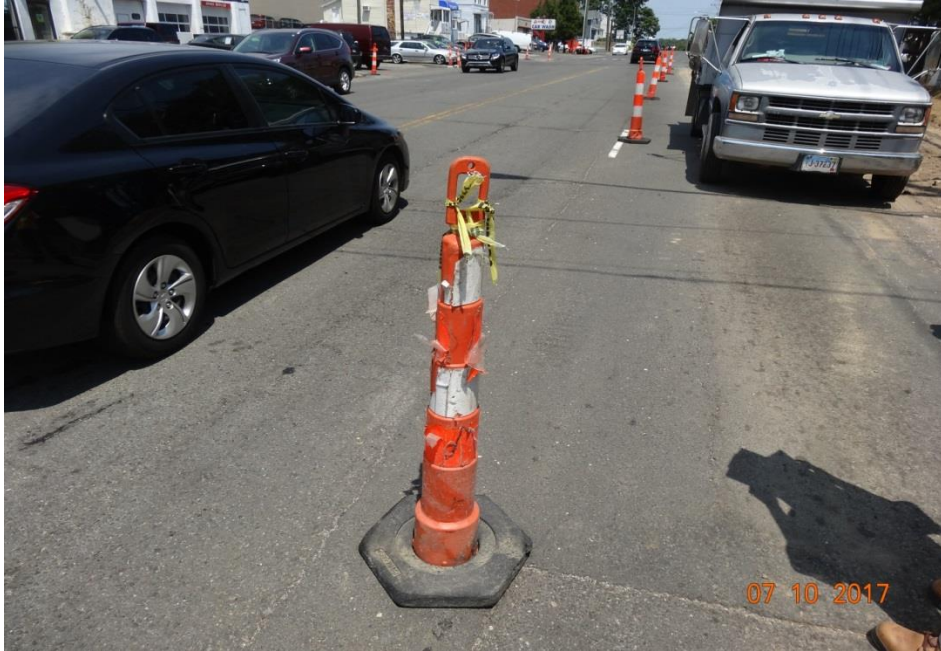
Photo 15: This cone has lost a significant amount of reflective material. Cones in poor condition should be replaced.

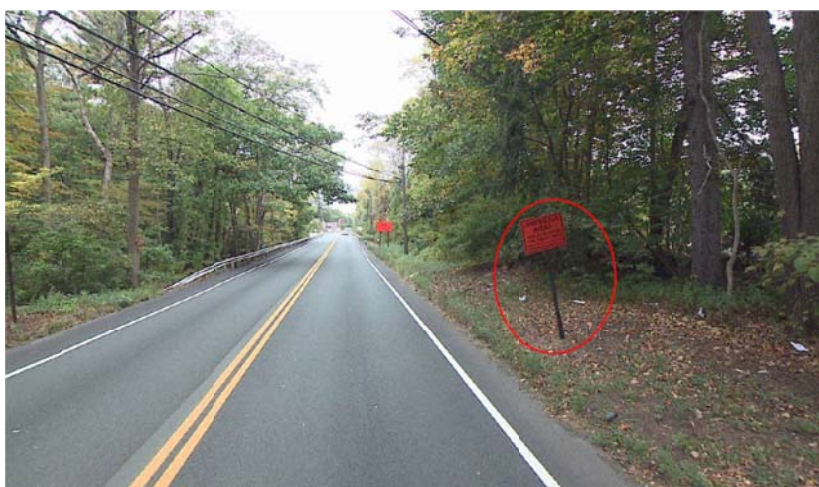
Signs left from a previous project that should be removed. See Finding #5.

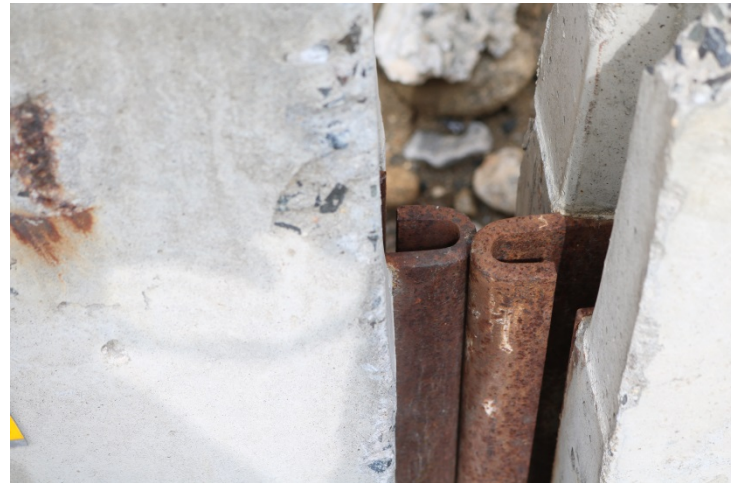
The sections of the TPCBC aren't connected at their joints. If impacted, a vehicle could displace a section and hit the blunt side of another.

0135-0326	Leading end on TPCBC along Wall No. 103 needs protection. Also, sections of the TPCBC were left not connected at the loops.	TPCBC leading end should be protected or angled away from the roadway. Also, if TPCBC sections are missing the connection pins, the ends will become snap points or dislodge upon vehicular impacts.

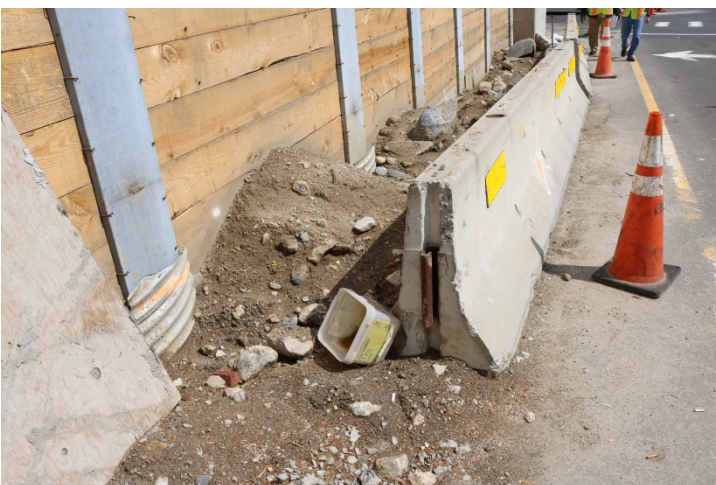
I-95 Exit 8 Off Ramp: The TPCBC is missing a section causing the exposed end to be a blunt end.

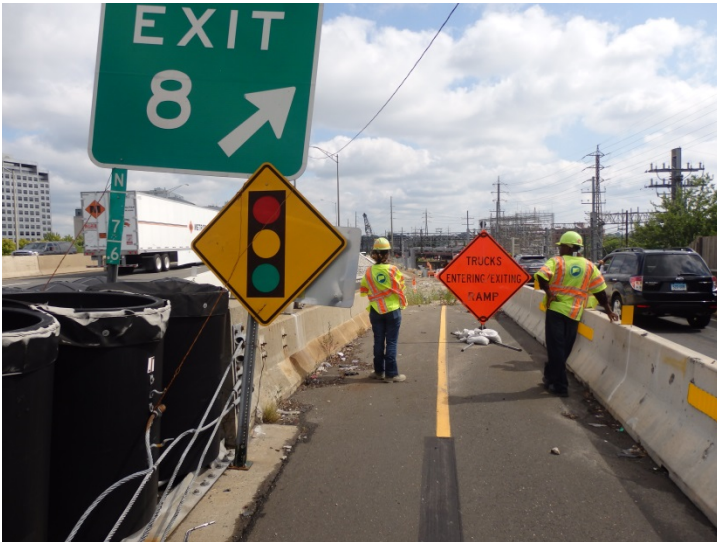
I-95 Exit 8 Off Ramp: There is a temporary signal sign right when a vehicle exits the highway. The impact attenuation system is in disrepair and needs to be attended to.

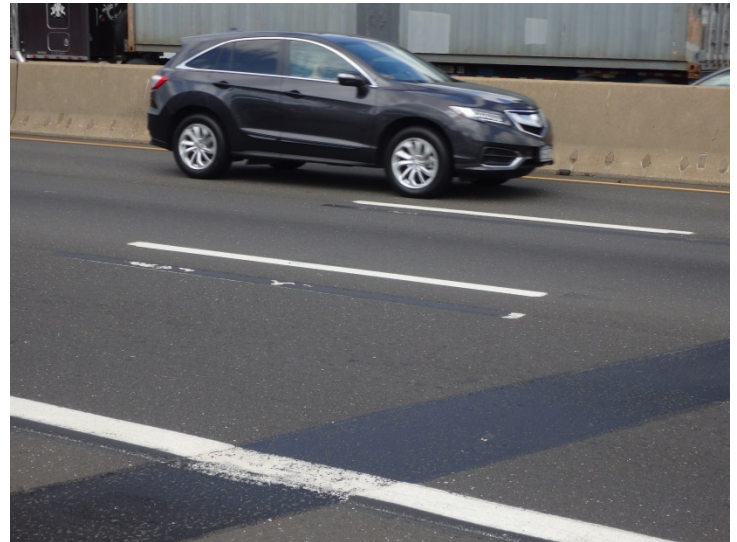
On I-95 pavement markings covered with black aggregate cover-up resin pavement markings are starting to wear and should be refreshed.

Pavement Markings		
0135-0326	The black aggregate cover-up markings on I-95 are beginning to wear and should be refreshed prior to winter.	Pavement markings should be regularly maintained to indicate to motorists where the lanes are.
0162-0145	Pavement markings for pedestrian detour pathway are faded.	Pavement markings should be clearly defined and should not conflict with other markings. If the markings are worn, they should be refreshed.

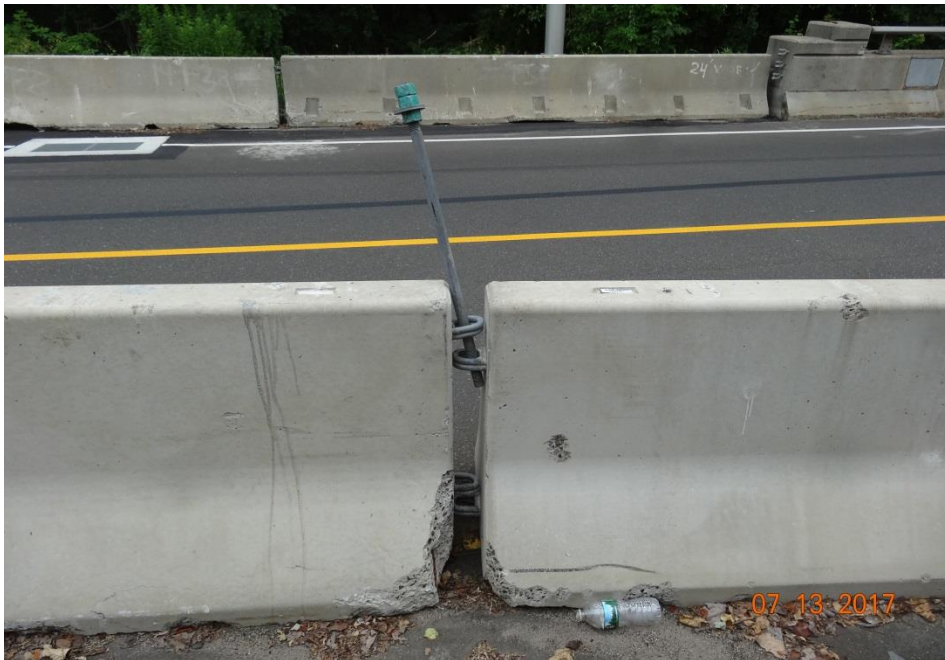
Photo 12: The connection rods for the temporary concrete barrier were not locked down with a threaded nut on the bottom of the rod.

<u>Project No.</u>	<u>Finding</u>	<u>Recommendation</u>
0100-0178	Some of the Temporary Precast Concrete Barrier Curb sections had pins that were not fastened at the bottom.	The TPCBC needs to be installed according to the plan including fastening the pins at both ends.
0100-0178	The liability sign for the project is posted after the start of the pattern not before the advance warning signs closer to the project limits.	Liability and Fines Doubled signs should be at the beginning of the advance warning signs so motorists are aware of their responsibility when entering the work zone.
0160-0139	The only sign in advance of the project on Phelps Way was the legal sign. There were no "signal ahead" sign or "road work ahead" sign until right before the temporary bridge.	More advance warning should be on Phelps Way and not just before the project site to allow motorists ample time for notice of what's to come.

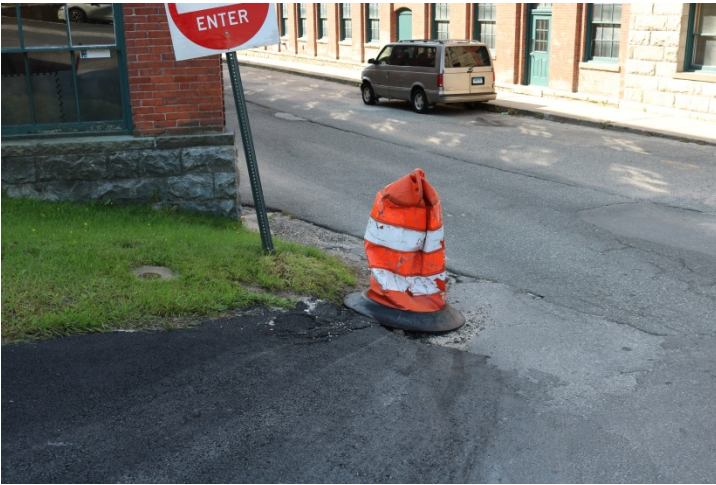
This traffic drum is badly misshaped and needs to be replaced.

0162-0145	Some traffic drums are badly misshaped.	Traffic control devices that are misshaped, scuffed, or missing reflectivity are in unacceptable condition and should be replaced.
0170-3435 C & C1	The construction signs were mounted on waffle board.	Construction signs should not be mounted on waffle board types of plastic substrate, foam core, and composite sign substrates. These materials decrease the reflectivity of the signs.
0170-3435 C & C1	Most cones used for the traffic pattern on the southbound side were in marginal or unacceptable condition.	Traffic devices and signs should be cleaned if dirty or replaced if misshapen, worn, or missing reflective tape.
0170-3435 D	The signs are mounted on waffle board.	Waffle board is an unacceptable material to use for construction signs since the reflectivity of the signs is poor.
0170-3435 D	Some of the traffic cones used were worn, bent out of shape, or missing reflective tape. There was also a sign mounted too low and one had paint on its face..	Traffic devices in marginal or unacceptable condition should be replaced and signs should be mounted with an adequate height to increase visibility to the motorists.

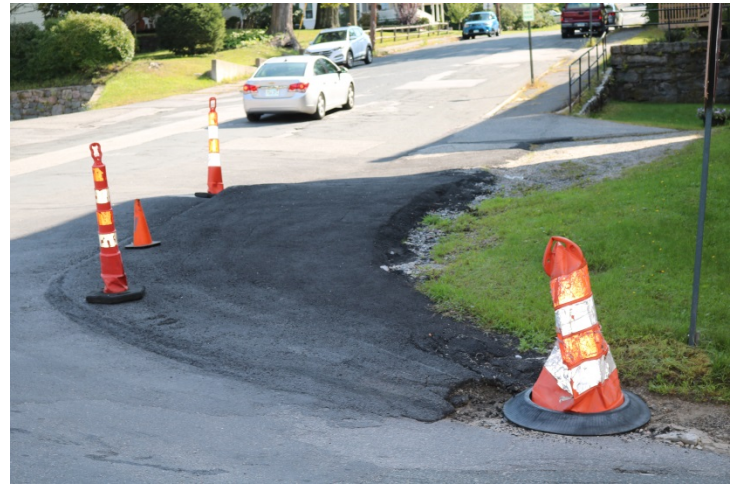
Motorists have worn down the corner of this sidewalk by driving over it. The project has paved a new corner and ramp so pedestrians can access it, however, it is deteriorating due to motorists still driving over it.

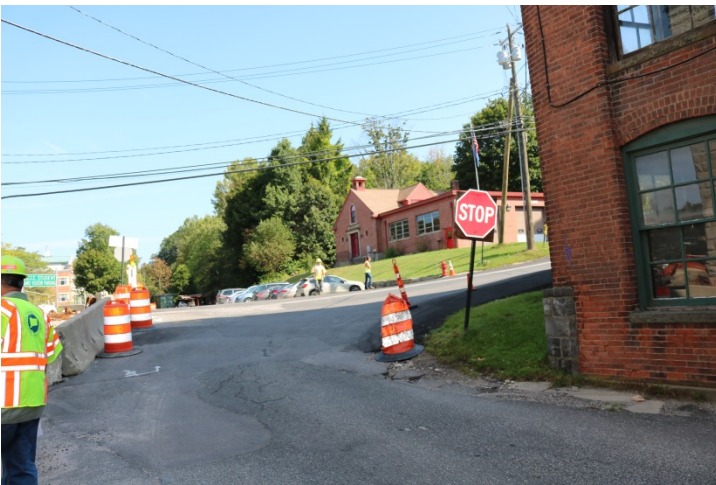
A utility project on Whiting Street has posted a STOP AHEAD sign since there is poor sightline for the Stop sign at the end of the street. However, when the utility project finishes the sign will be removed. The Town should consider permanently mounting a Stop Ahead sign.

Project No.	Finding	Recommendation
0162-0145	There is poor sightline for the Stop sign at the end of Whiting Street.	The project can add a "Stop Ahead" construction sign on Whiting Street to inform motorists of the Stop sign they cannot see from the road.
0162-0145	Northwest Connecticut Community College parking lot sign is within the TPCBC.	If existing signs are obstructed from view by construction devices or activities, they should be relocated to a more visible location.
0170-3435 C & C1	The pattern on the Northbound side didn't include an END ROAD WORK sign at the end.	Signs noted on the plans within the Work Zone Safety Guidelines for Maintenance Operations need to be installed correctly and completely.
Specification Enforcement		
0050-0219	"Road Work Ends" signs were only installed on one side of the road (the closure side) instead of both sides of the road, as shown in the special provision for Item No. 0971001A: Maintenance and Protection of Traffic.	Compliance with the traffic plans should be enforced and have signs installed on both sides of the roadway as required in the contract.

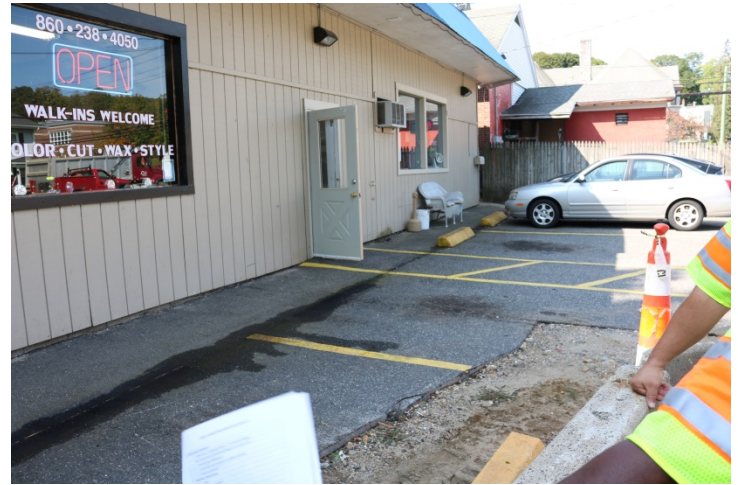
This is the business parking lot the project is impeding upon. Half the lot has been taken for construction. The project had to leave enough space for trucks to access the back of the building but the roof overhang wasn't taken into consideration and prohibits access.

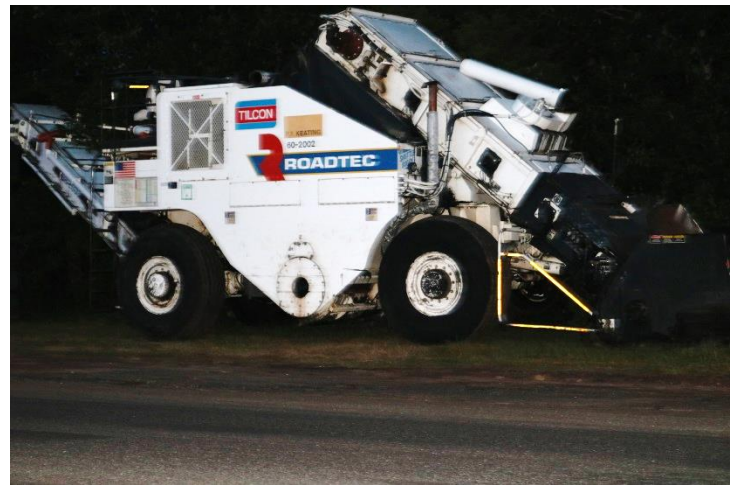
I-91 NB: Equipment is parked off the side of road when not in use, however it looks to be within the clear zone.
