DANBURY BRANCH IMPROVEMENT PROGRAM TASK 7

EXISTING CONDITIONS-RAIL INFRASTRUCTURE DRAFT FINAL REPORT

STATE PROJECT 302-008

APRIL 2009

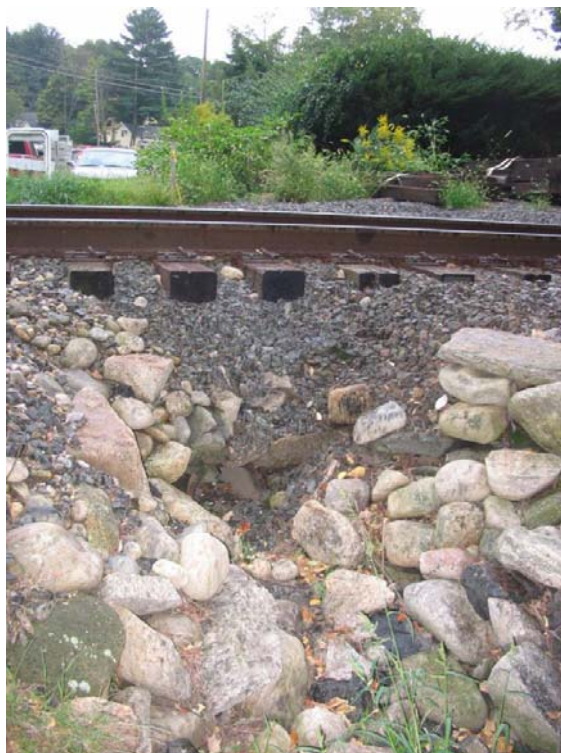
Typical Culvert Crossing (MNR MP 6.8)

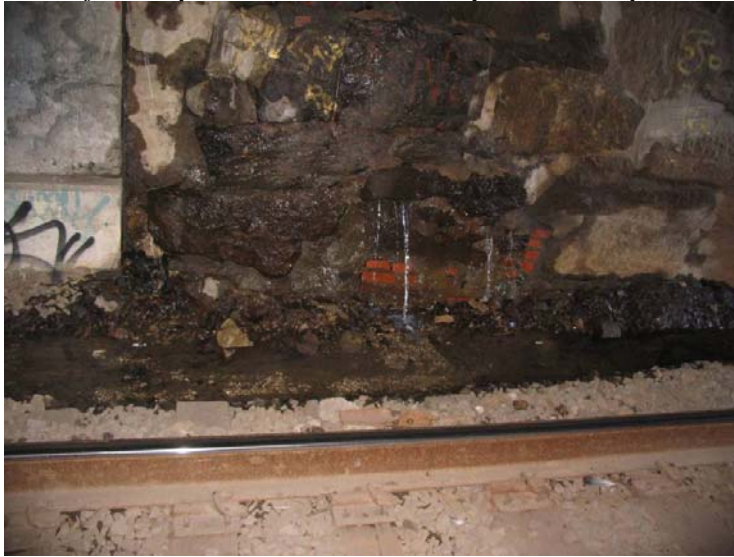
There were several drainage issues noted between the South Norwalk Station and the old New Milford Station. One of the most notable drainage problems noted was at the Wall Street Tunnel (MP 1.5) pictured below. Water is leaking from the east abutment wall resulting in standing water all along the east side of the tracks for the majority of the length of the tunnel.

Water Leakage at East Abutment at Wall Street Tunnel (MNR MP 1.50)

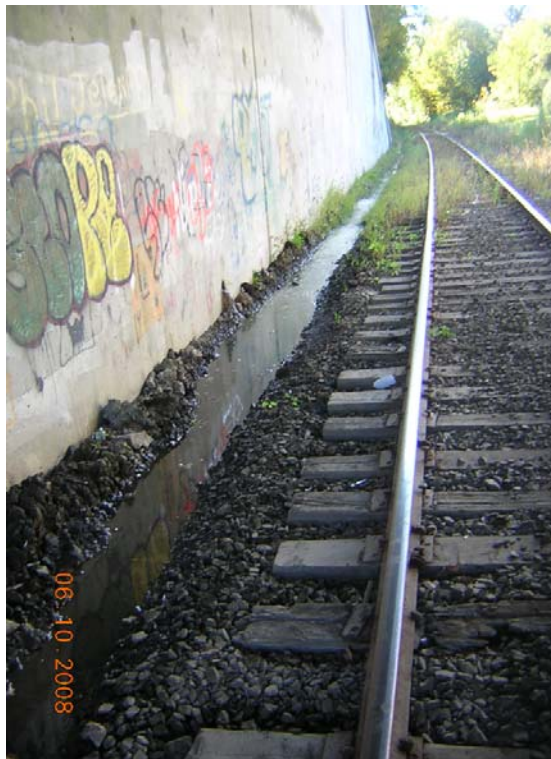
Photographed below is the drainage issue underneath the Whisconier Road Bridge along the HRR – Berkshire Line segment of the railroad line. Runoff from the bridge overpass drains into this area. Standing water is present along the tracks for the length of the bridge and beyond.

Standing water by tracks under Whisconier Road Bridge (HRR – Berkshire Line)

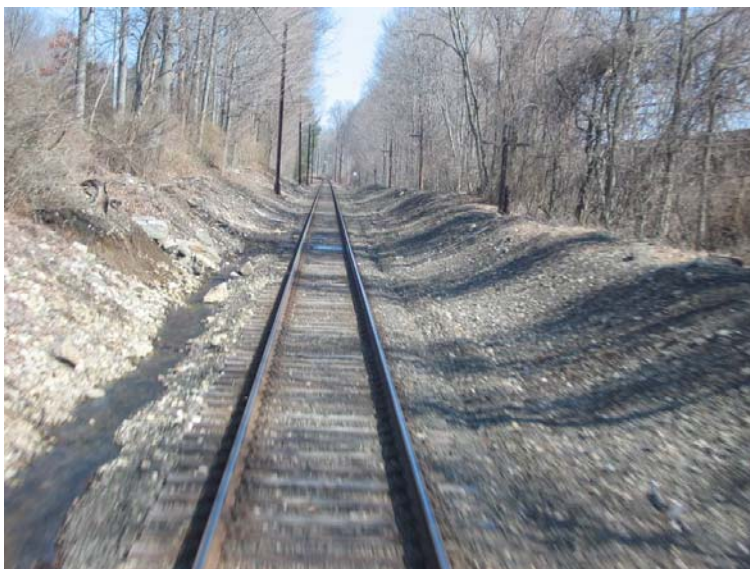
Standing water adjacent to the tracks is a common drainage issue along the tracks. Pictured below is standing water along the west side that meanders across the tracks. A similar drainage

Standing Water along West Side of Tracks (MNR MP 4.70)

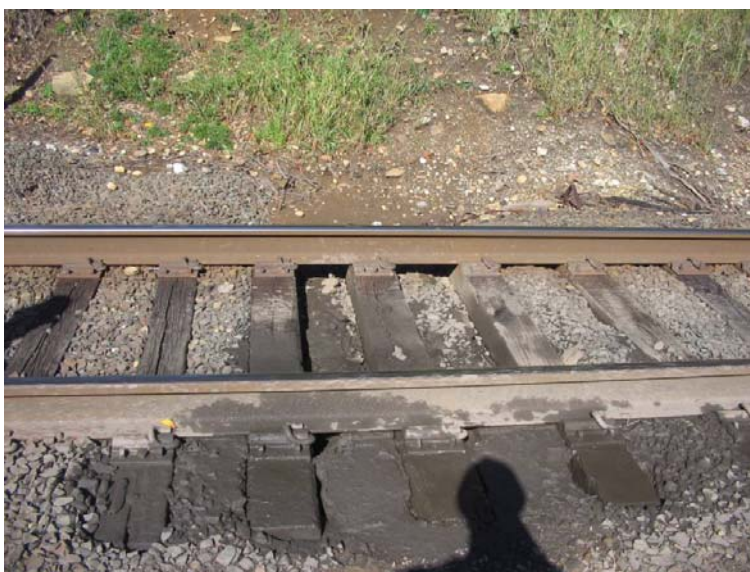
In some locations, poor drainage has caused ballast washout within the tracks and erosion at the base of the cross ties. Photographed below is a washout observed at MP 9.4 along the MNR segment of the rail line.

Poor Drainage (MNR MP 9.40)

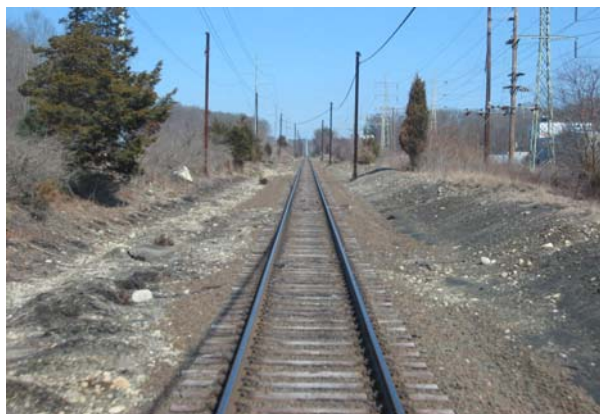
Utility lines in proximity of tracks (MP 5.30)

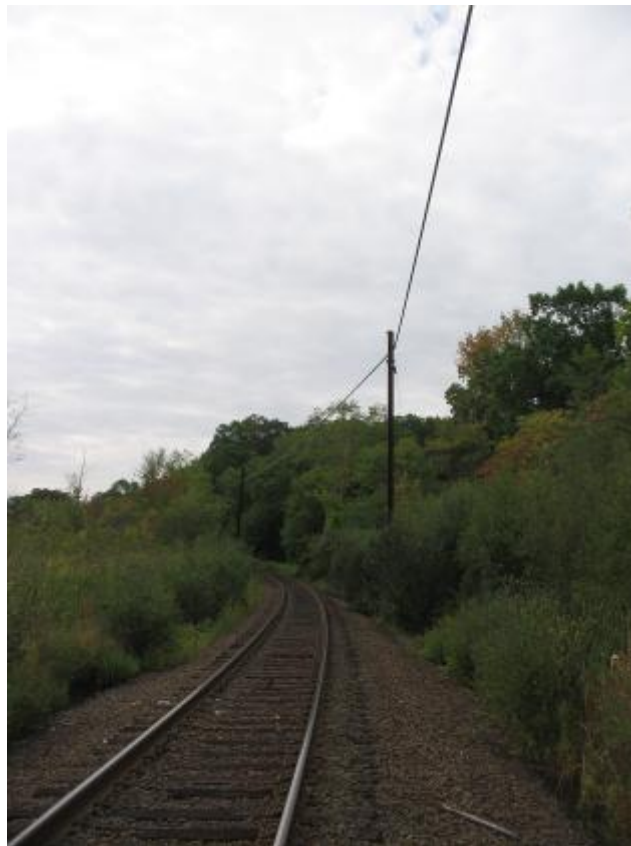
Figure 1 - Typical existing cat. poles supporting fiber optic cable (MNR MP 15.7)

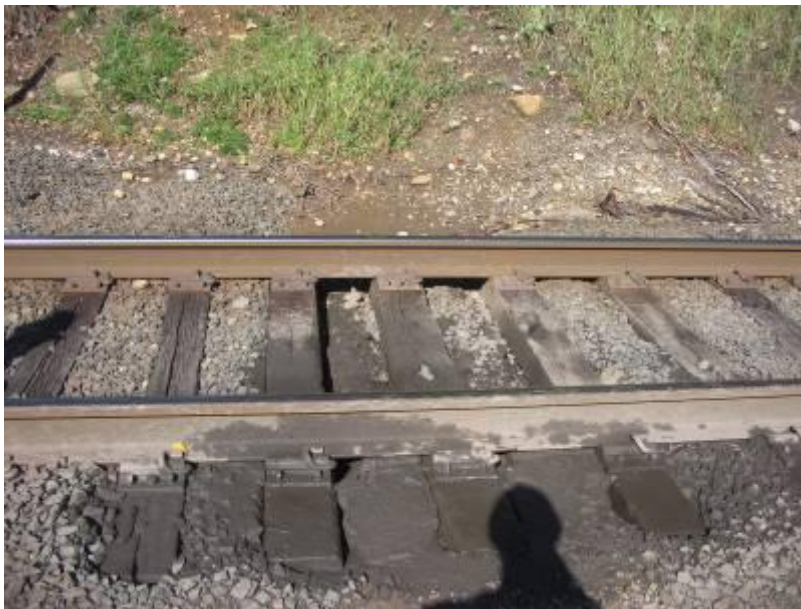
Figure 7 - Poor maintenance of grade and ballast (MNR MP 9.40)

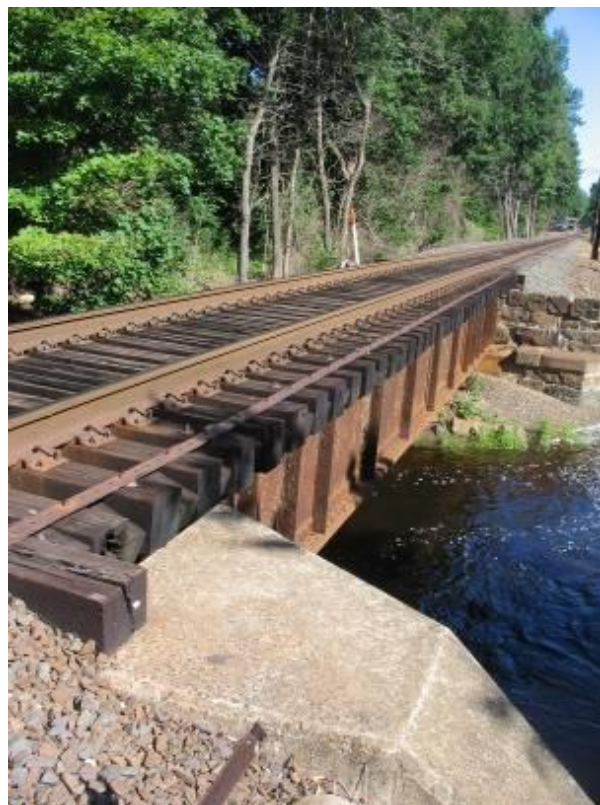
Figure 9 - Norwalk River (MNR MP 8.7)
Bridge is in poor condition according to bridge inspection reports. Observed deficiencies include rust on steel beam supports.

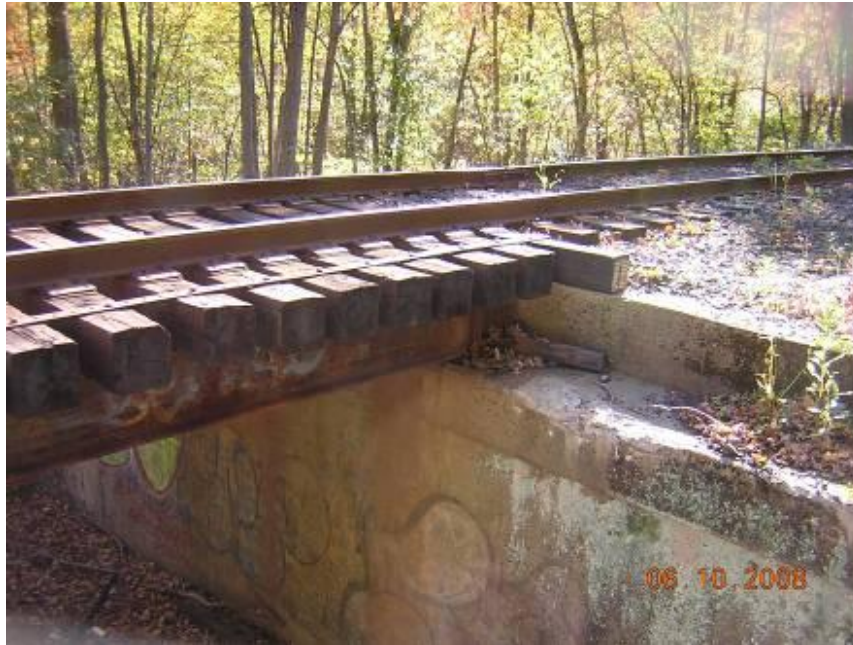
Figure 10 - Cattle Pass (HRR – Berkshire Line MP 2.96)
Concrete spalling observed on abutment wall.

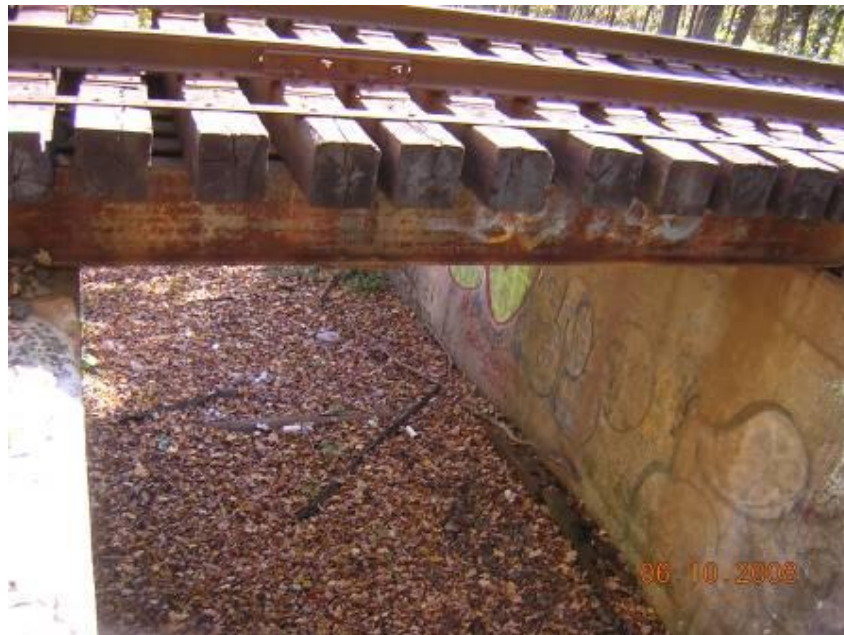
Figure 11 - Cattle Pass (HRR – Berkshire Line MP 2.96)
Steel support beam rusted and in need of painting.

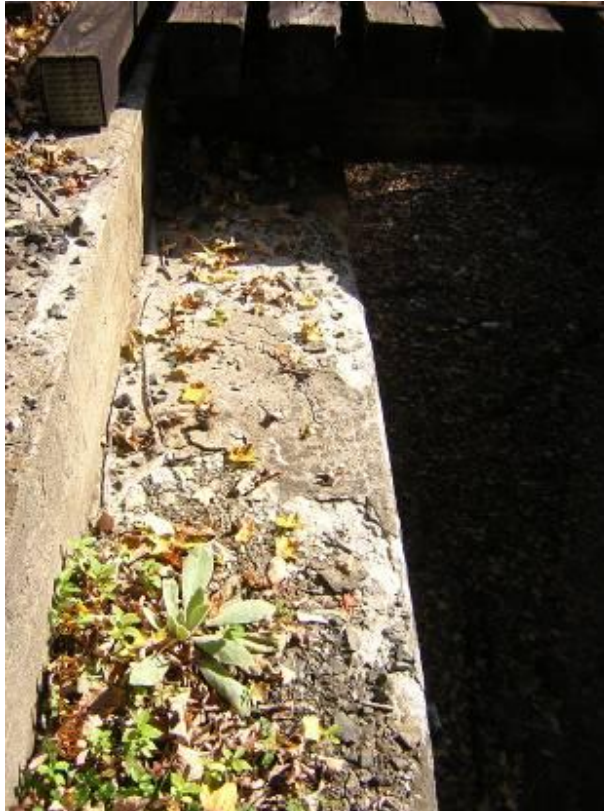
Figure 12 - Cattle Pass (HRR – Berkshire Line MP 2.96)

Observations include concrete spalling on abutment wall and vegetation growth.

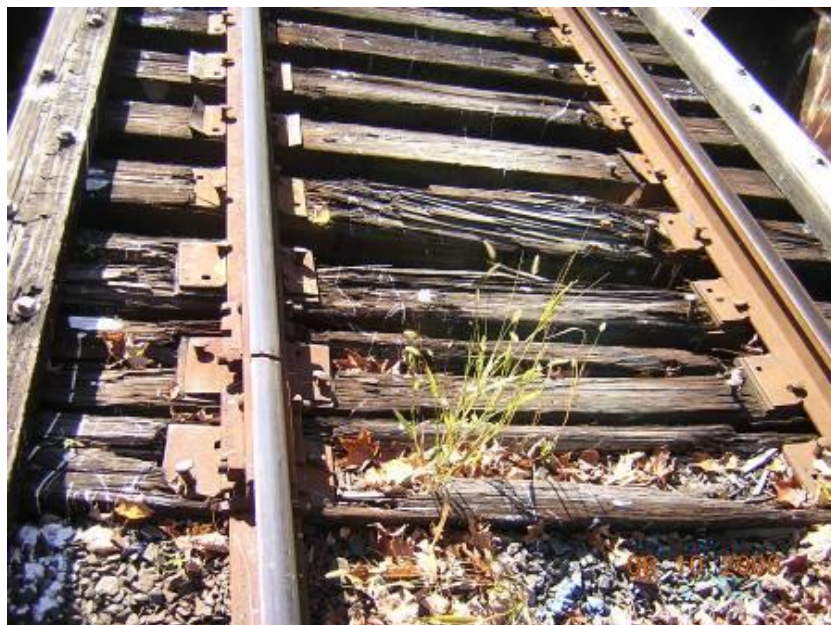
Figure 13 - Junction Rd (HRR – Berkshire Line MP 2.51)

Deteriorating timber cross ties were observed on bridge.

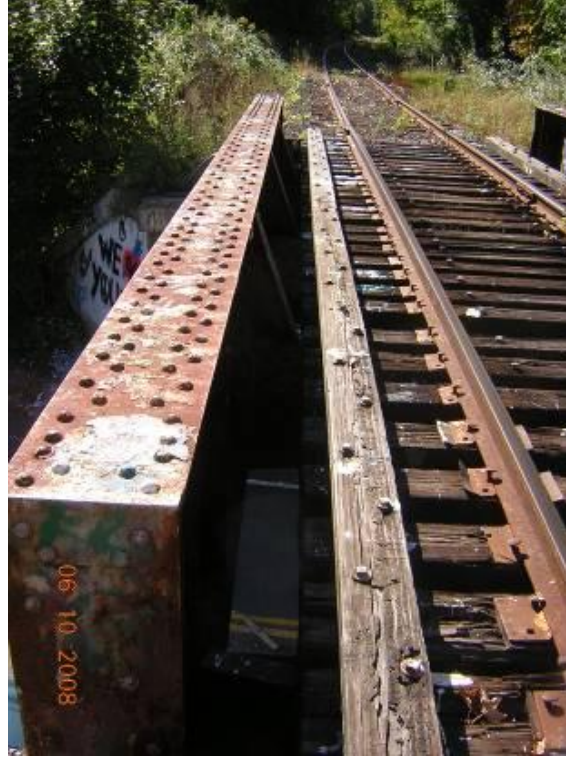
Figure 14 - Junction Rd (HRR – Berkshire Line MP 2.51)
Deteriorating timber and rusting at truss were observed.

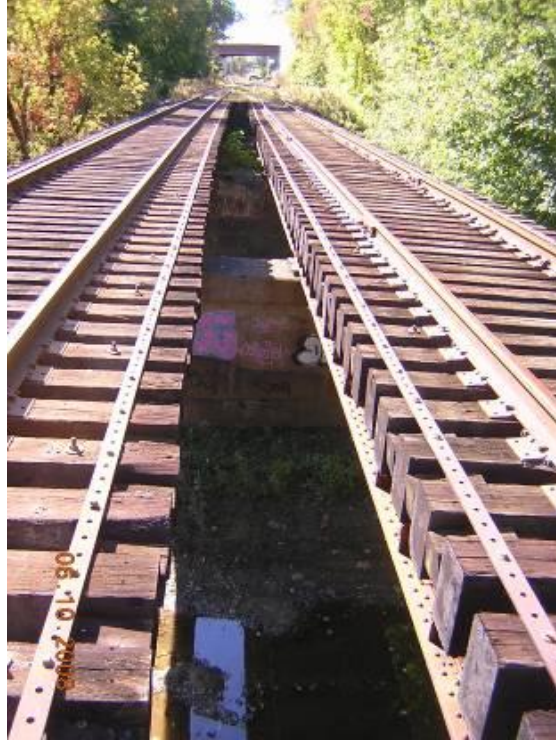
Figure 16 Still River (HRR - TILCON/Maybrook Line MP 79.65)

Moderate corrosion on girders. Bearing shim at north side, span #2 at pier is fully out of position. Severe corrosion on top lateral bracings at various locations. Anchor bolts in need of repair.

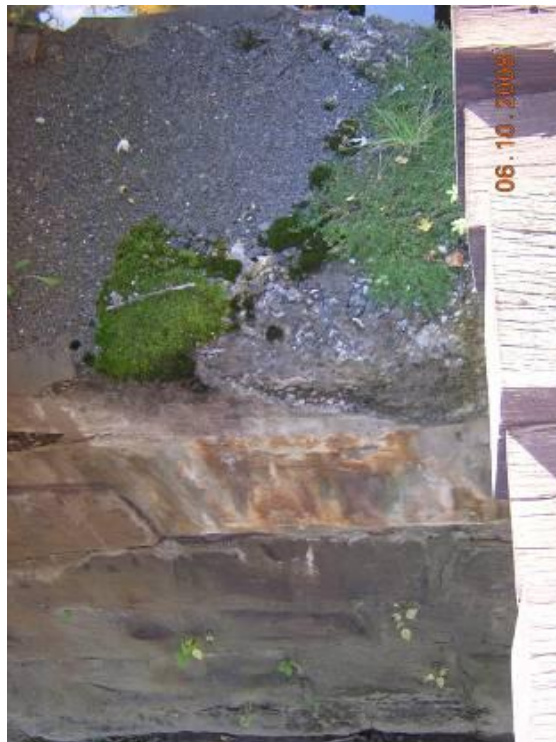
Figure 17 - Still River (HRR - TILCON/Maybrook Line MP 79.65)

Stone abutment wall in poor condition.

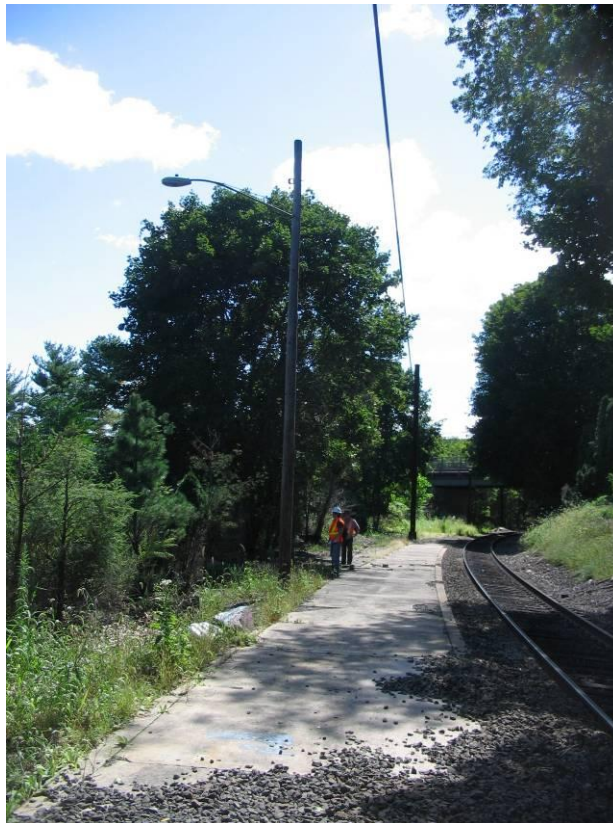
Other Noteworthy Observations: Existing platform located on the east side of the tracks was found at MP 11.90. This is the proposed location for the new Georgetown Station.

Figure 20 - Existing platform. Proposed location for Georgetown Station. (MNR MP 11.9)
