Field Evaluation of an Experimental  
Bituminous Pavement Utilizing an  
Ice-Retardant Additive - Verglimit

FINAL REPORT

Report No. 1085-F-92-4  
Research Project HPR-1085

Dr. Charles E. Dougan, Ph.D., P.E.  
Director of Research & Materials  
Bureau of Engineering and Highway Operations  
280 West Street  
Rocky Hill, CT 06067

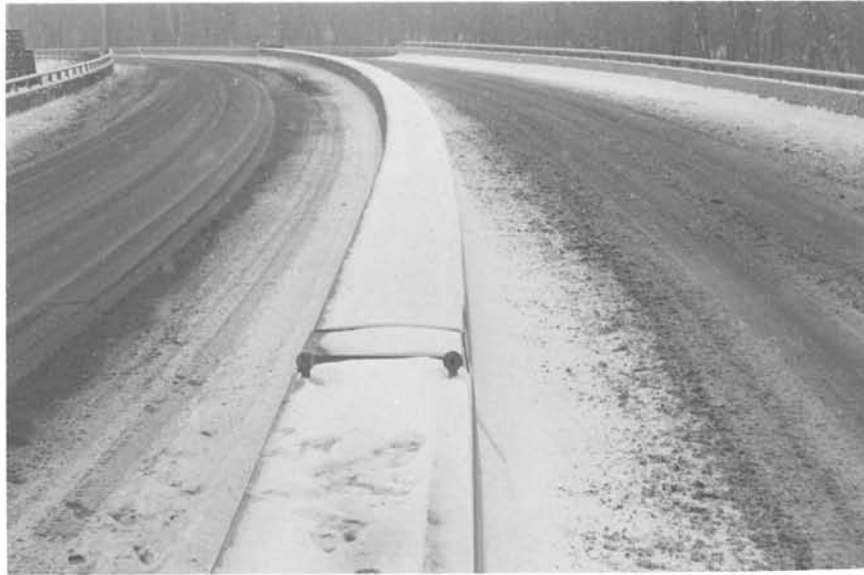
Figure 4. Section Comparison at Temperature Near Freezing

Verglimit Section

Control Section

The first winter after placement (1987-88), the Verglimit pavement seemed slightly more resistant to skidding and adhesion of snow pack than the control. The differences between the sections were very subtle, and could have been due to other circumstances, in addition to the presence of Verglimit. Figure 4 shows the Verglimit section to be slightly clearer during a moderate snow storm in the first winter. When the Verglimit seemed to be somewhat effective, the ambient temperature was at or near 32°F. At temperatures below 25°F, the Verglimit's influence on surface condition was not apparent (See Figure 5). This is consistent with the product literature and reports from other Verglimit users.

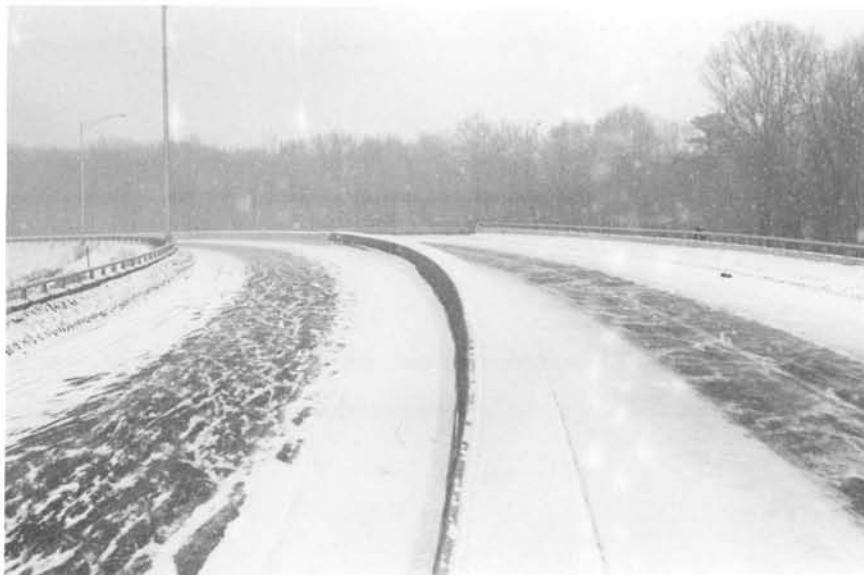
Figure 5. Section Comparison at Temperature Well Below Freezing

Verglimit Section

Control Section
