Title: EXPERIMENTAL EVALUATION OF A PORTABLE ENERGY-ABSORBING SYSTEM FOR HIGHWAY SERVICE VEHICLES. ABRIDGMENT

Experimental Evaluation of a Portable Energy-Absorbing System for Highway Service Vehicles

John F. Carney III, University of Connecticut, Storrs

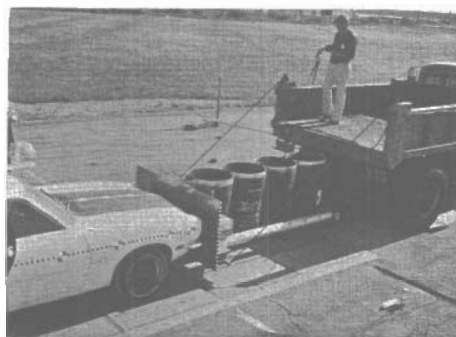
Figure 1. Two views of the portable energy-absorbing system.

The energy-absorbing system involves three components: (a) the service vehicle guidance frame, (b) the energy-absorbing pipes, and (c) the impacting plate assembly. The unit, as mounted on the service vehicle, is shown in Figure 1 (top). The impacting plate assembly shown in Figure 1 (bottom) is constructed of 6061-T6 aluminum. The remaining components of the energy-absorbing system are made of steel. It is interesting to note that the round aluminum tubing in the impacting plate assembly slides inside the structural tubing on collapse of the system.

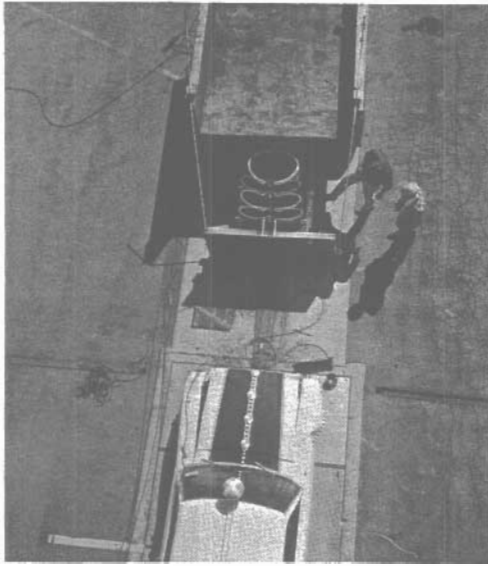
Figure 2. Crash test 1.

The results of test 1 are presented in Figure 2, which shows the energy-absorbing system and the 1971 Ford Maverick after the collision. In this test, the average deceleration of the automobile was 9.8 *g*.

The deceleration levels in the three "heavy" automobile crash tests were well within the guidelines set forth in Bronstad and Michie (2). In the 10.05-kN (2260-lb) automobile crash test, although the average deceleration was less than the limiting value of 12 *g* (2), there was an initial 80-*g* acceleration "spike" of approximately 10 ms duration after which the decelerations dropped to and remained at acceptable levels. This light-weight vehicle "spike" is caused by a 1.913-kN (430-lb) aluminum impacting plate assembly and can be reduced by decreasing the weight of this component, which must be moved to permit the collapse of the energy-absorbing system. Work in this area is continuing at the University of Connecticut.
