# Connecticut Work Zone Reviews

## Annual Report

# 2015

State of Connecticut  
Department of Transportation  
Office of Construction

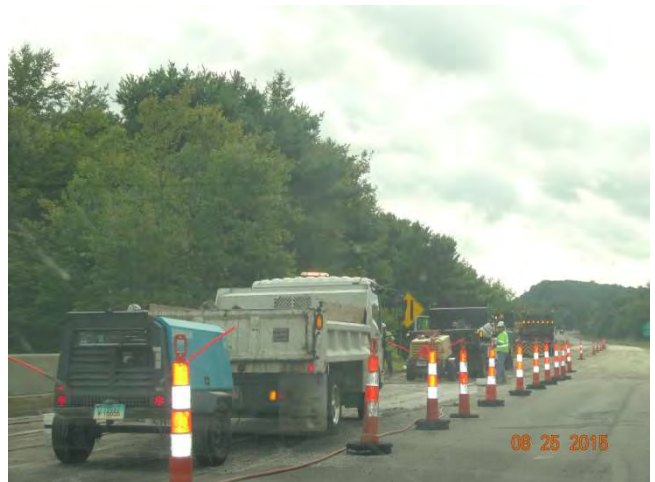
**Route 11 SB: Approaching the third work zone in the left lane. The taper is comprised of traffic drums and there is a flashing arrow within. The flashing arrow is on but the lights are very dim due to the angle the board is tilted.**

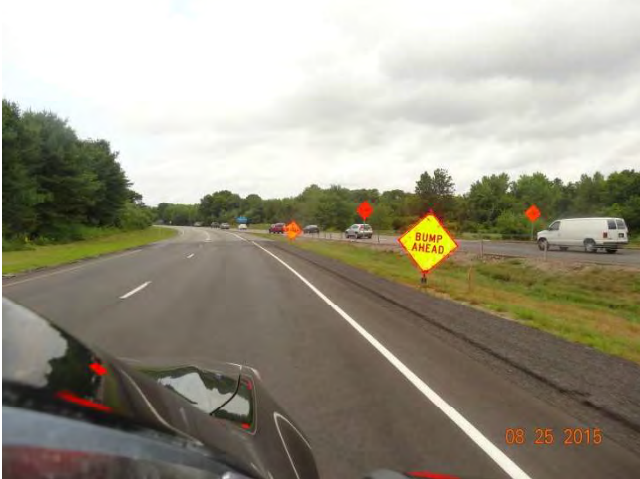
**Route 11 NB: Route 11 merging with Route 2. Temporary signs warning motorists of BUMP AHEAD and BUMP, respectively. The reflectivity of the BUMP AHEAD sign is visibly displayed.**

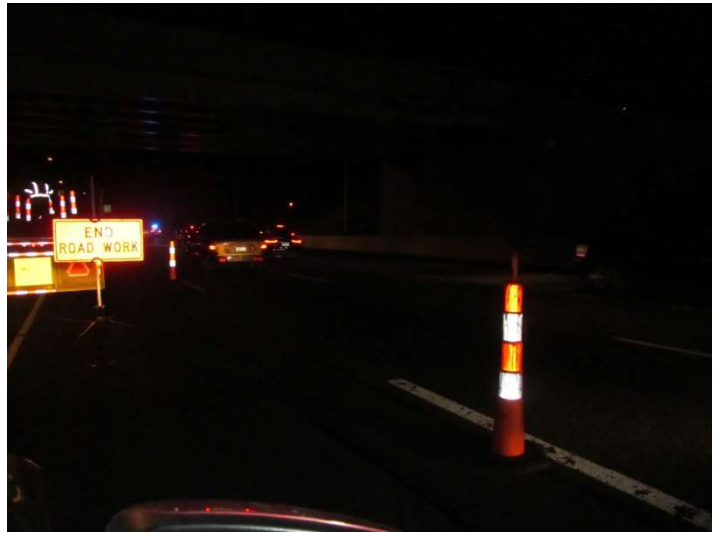
I-95 NB: The END ROAD WORK AREA sign directly after the lane closure with traffic starting to bypass the work zone. This sign was not visible to motorists and was not installed on both sides of the road.

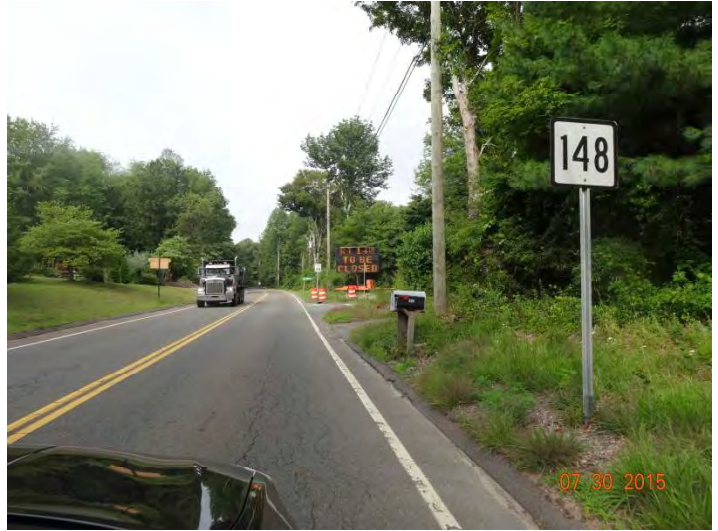
**Route 148 WB: A Changeable Message Sign with the first frame saying RT 148 TO BE CLOSED. The CMS is not 30 feet off the travel way and is behind traffic drums which aren't adequate protection.**

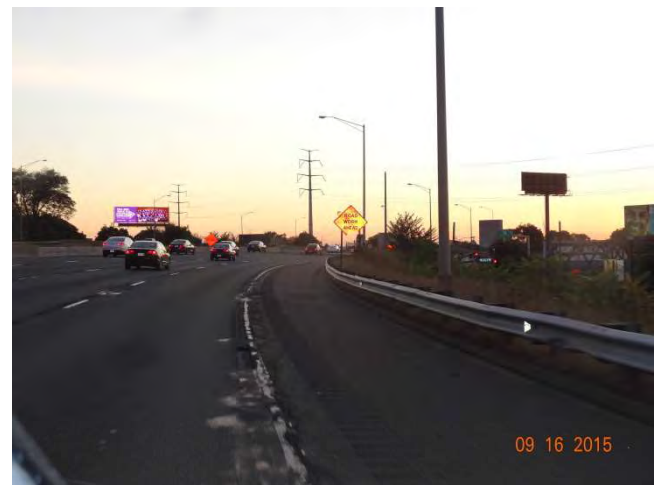
**I-91 SB: A post-mounted ROAD WORK AHEAD sign with a barricade warning light attached. The bottom point of the sign has been broken off; the condition of the sign is poor and should be replaced.**

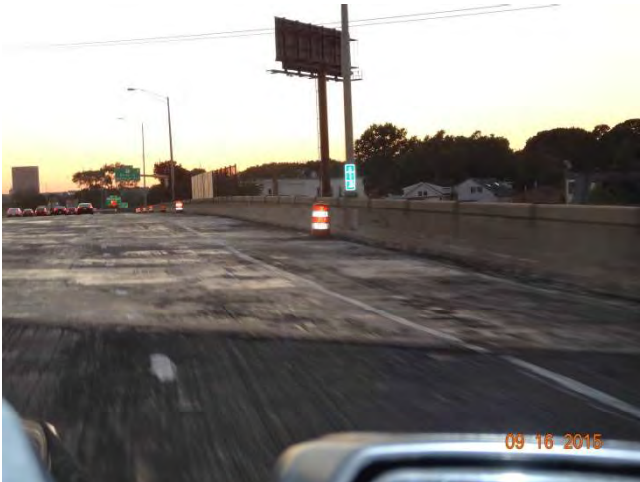
**I-95 SB: This section of the road is the work site being repaired. The surface has been milled and temporary pavement markings placed but are faded. Traffic drums are lined up on the bridge parapet where work is being done.**

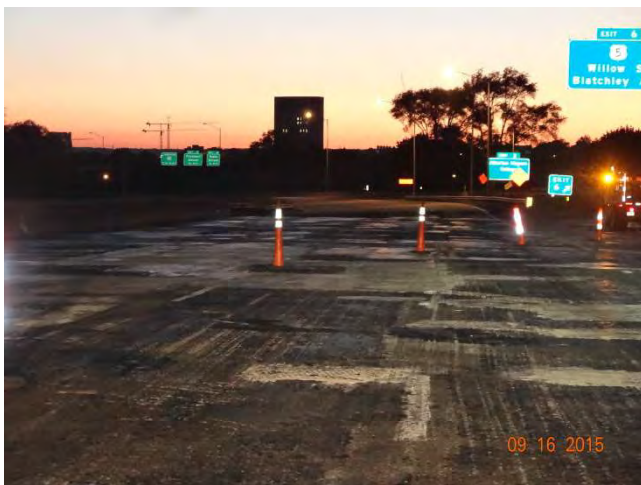
**I-91 SB: These are a couple of traffic cones that were in poor condition. The reflective collars were missing, they weren't clean, and some were bent out of shape.**

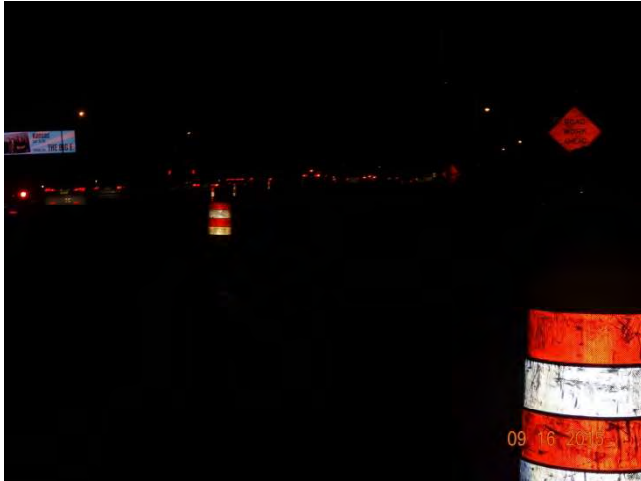
**I-91 SB: The condition of the traffic drums shows that they either need to be cleaned or if scuffed, replaced.**

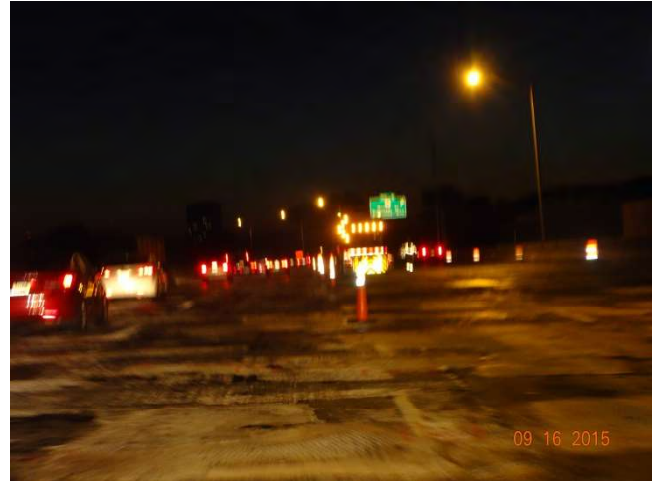
**I-91 SB: The other flashing arrow is mounted on a Truck-Mounted Attenuator in the closed lane. It is signaling for motorists to merge left but since it is in the closed lane it should signal lane closed using a straight bar.**

0092-0612	Incorrect Flashing Arrow	The advance flashing arrow in the closed lane was not in the correct mode and the Changeable Message Sign had a message too long to read while driving.	Proper use of the advance warning devices will notify motorists of the road conditions ahead. Messages should be in accordance with the contract plans.
0094-0255	Training Need	The project staff was unaware of the Transportation Management Plan (TMP) for the project.	Better communication between Engineering and Construction to bring awareness of the TMP requirements.
0151-0273	Incorrect CMS Height	The height of the Changeable Message Sign on I-84 Eastbound was placed too low, especially with a guiderail immediately in front of it.	CMS should be installed at the proper height for visibility.
0153-0118	ADA Requirements	Some of the detectable tactile warning did not extend to the full width of the curb.	According to ADA requirements, the detectable tactile warning needs to extend a minimum of two feet in the direction of travel and the full width of the curb ramp.

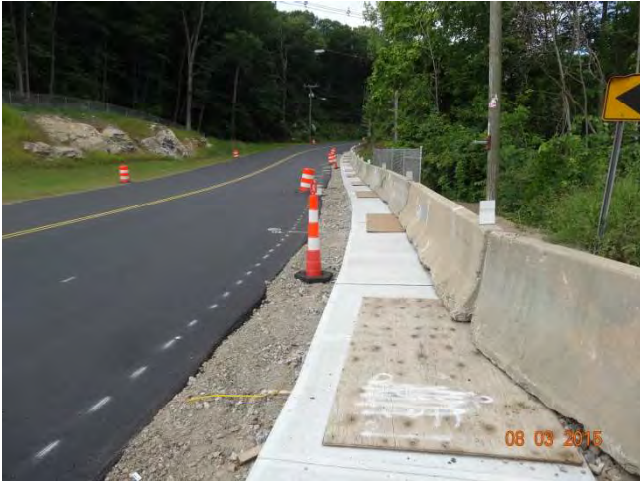
**Route 73 NB: Concrete barrier that was previously separating the road from the pedestrian walkway. The Contractor put the barrier on the plywood to protect the new sidewalk but refused to cut it because they were good pieces. The large pieces of plywood were trip hazards to pedestrians using the sidewalk.**

0153-0118	Pedestrian Hazard	The plywood protecting the sidewalk from the concrete barrier projected into the walkway of the new sidewalk and posed a trip hazard to pedestrians.	The plywood should be cut down to flush with the edge of the barrier or smaller pieces be used to rest the barrier on.
0153-0118	Incorrect Delineators	The delineators on the concrete barrier were in poor condition, were not facing in the correct direction, or were missing the appropriate color on one side.	The delineators should be replaced if in poor condition or incorrect application. Delineators with the appropriate colors of white (used on the right side of oncoming traffic) and yellow (used on the left side of oncoming traffic) should be applied.
0160-0145	Public Outreach	The Project Engineer was unaware that informing nearby hospitals was a necessary part of the public outreach for the project.	Project staff should contact all the stakeholders of the project and inform them of the work being done and how it could affect them. Stakeholders include police (either State or municipal), fire departments, hospitals or medical facilities, etc.

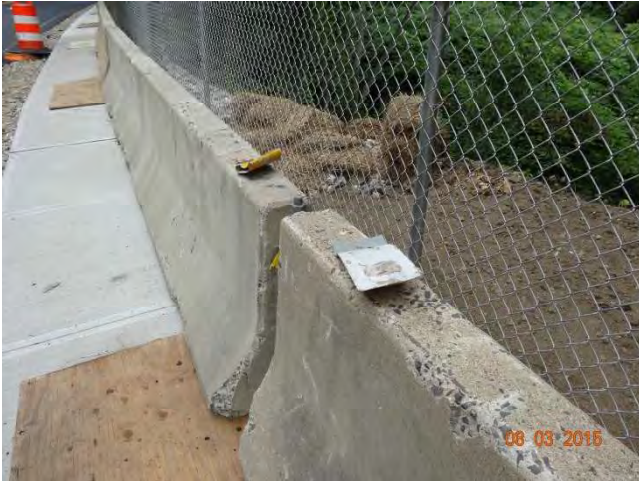
**Route 73 NB: The delineators on the concrete barrier were in poor condition. They were bent over and misshapened. Some were facing the wrong direction or didn't have the second color on the opposite side.**

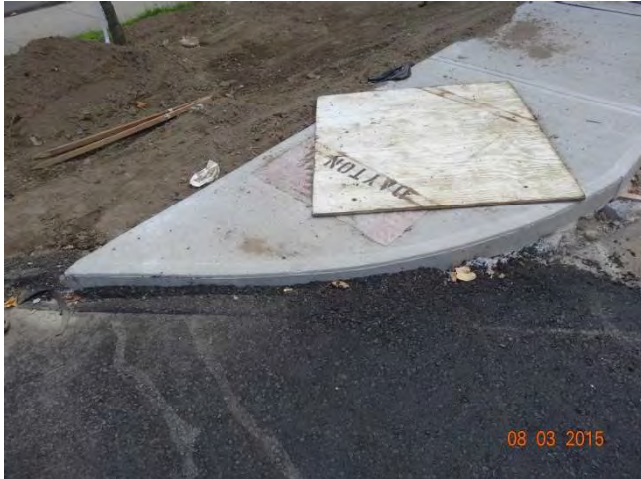
**Route 73 NB: Plywood covering a detectable warning pad. This poses as another unnecessary trip hazard.**

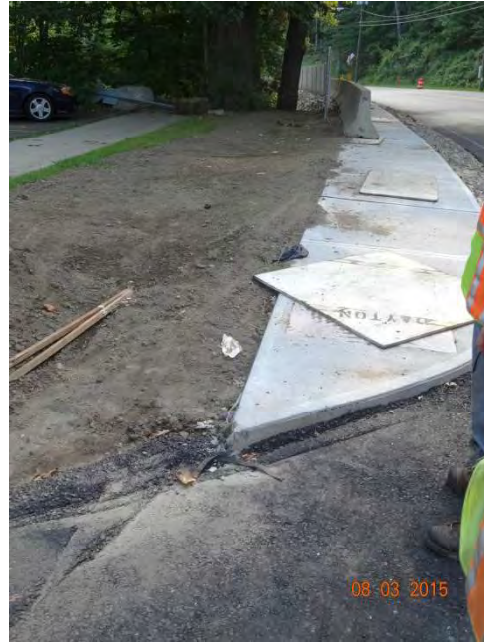
**Route 73 SB: The sidewalk curb lip is higher than the half inch requirement from the roadway. Although this is a new sidewalk on the route, it still needs to meet ADA requirements during construction not just at the finished state.**

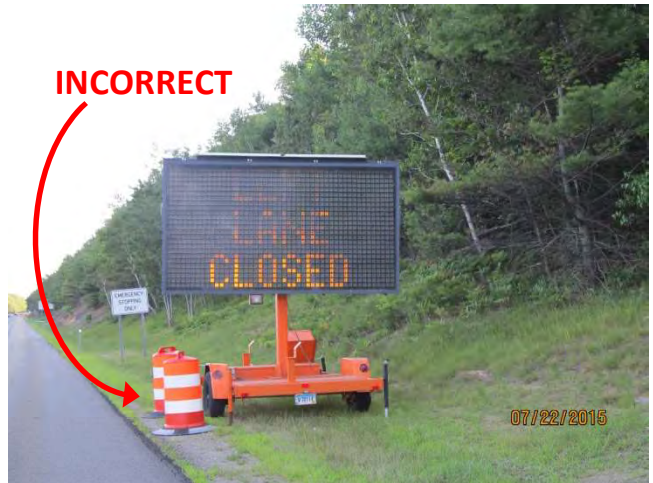
**I-84 WB: The first frame for the Changeable Message Sign. The CMS is within 30 feet of the edge of the roadway and is improperly protected by two traffic drums. It should have positive protection around it if it is placed this close to road.**
