# NRD Project Final Grant Report

**Reporting Organization:** Housatonic Valley Association (HVA)  
**Project Name:** Furnace Brook Fish Ladder Restoration  
**Project Location:** Cornwall Bridge, Connecticut  
**Cooperative Agreement #:** F12AC00302  
**Period of Agreement:** March 2012 – December 2017  
**Dates covered by this Report:** Project start – March 31, 2018

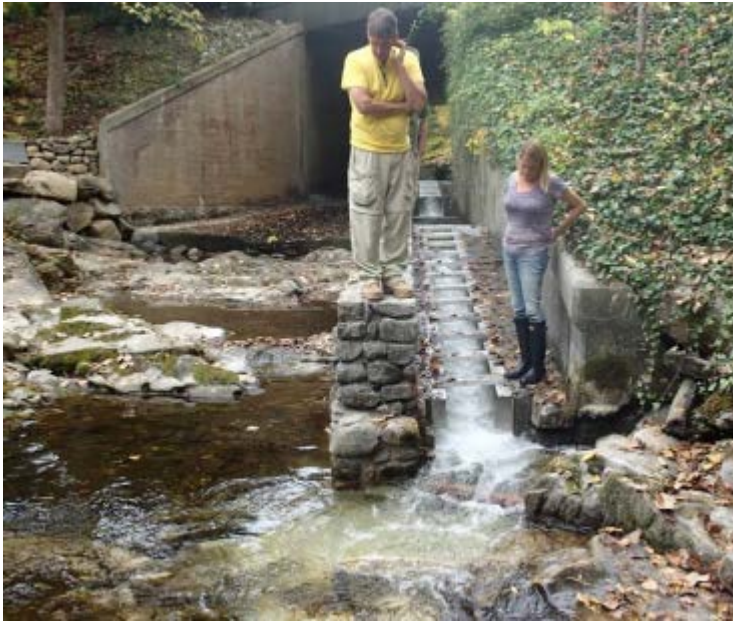
Figure 12. Tim Wildman (IFD) and Laura Wildman (design engineer with Princeton Hydro) observe the lower portion of the refurbished fishway.

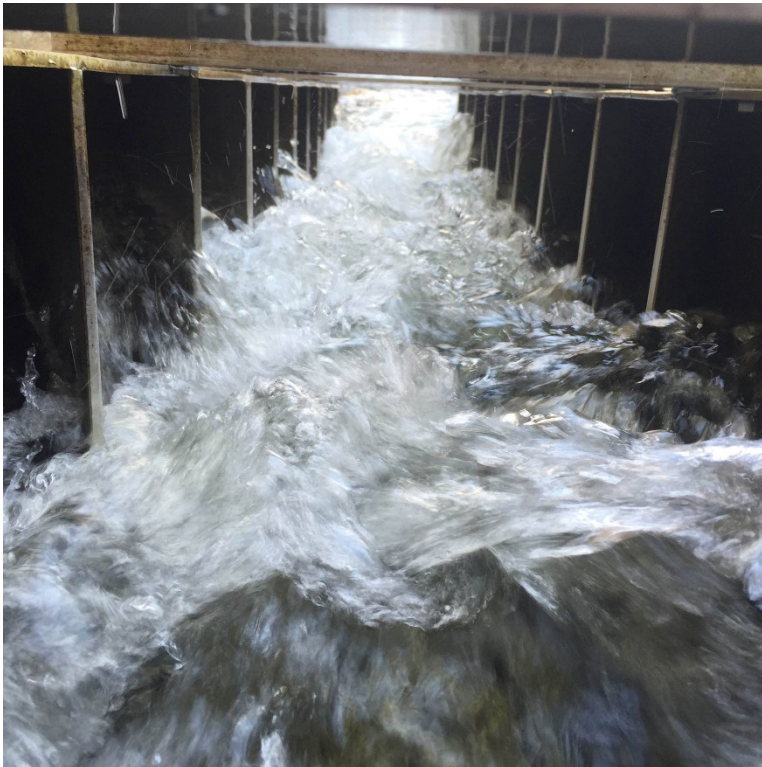
Figure 13. The baffles of the fish ladder allow native brook trout to more easily pass through the culvert and return to primordial spawning grounds.
