CONNECTICUT
DEPARTMENT
OF
TRANSPORTATION

CONDITION INSPECTION
FOR THE
DANBURY STATION

CONN. DEPT OF TRANSPORTATION
STATION INSPECTION REPORT
SHEET 3 OF 42

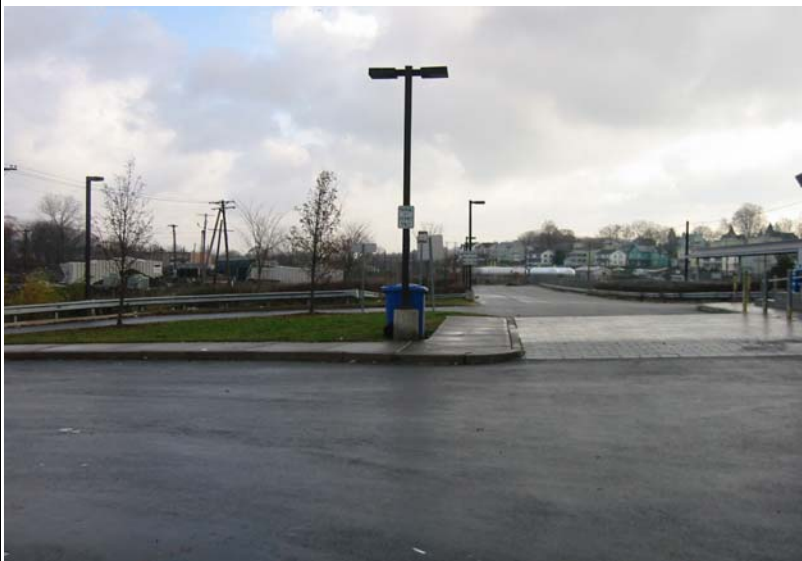
Description: _____
General view of Quad I

Reference: _____
Looking South

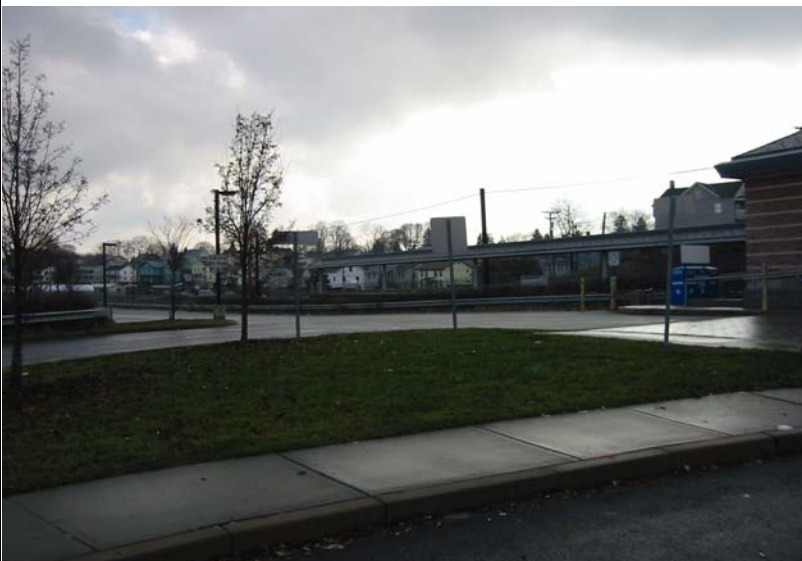
PHOTO NO. 2

Location: _____
Southeast corner of
Quad II

Description: _____
General view of Quad I

Reference: _____
Looking Southwest

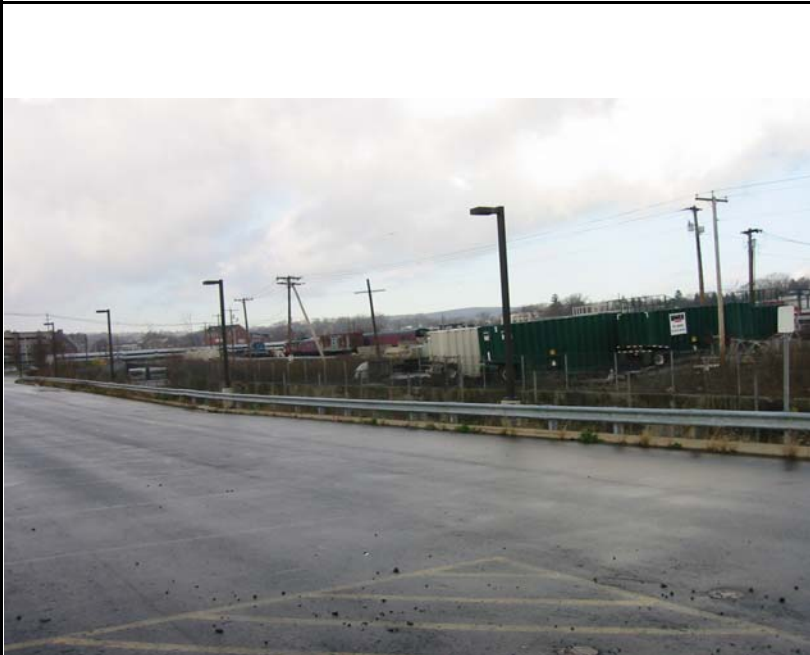
PHOTO NO. 4

Location: _____
Southwest corner of
Quad I

Description: _____
General view of Quad I

Reference: _____
Looking Northeast

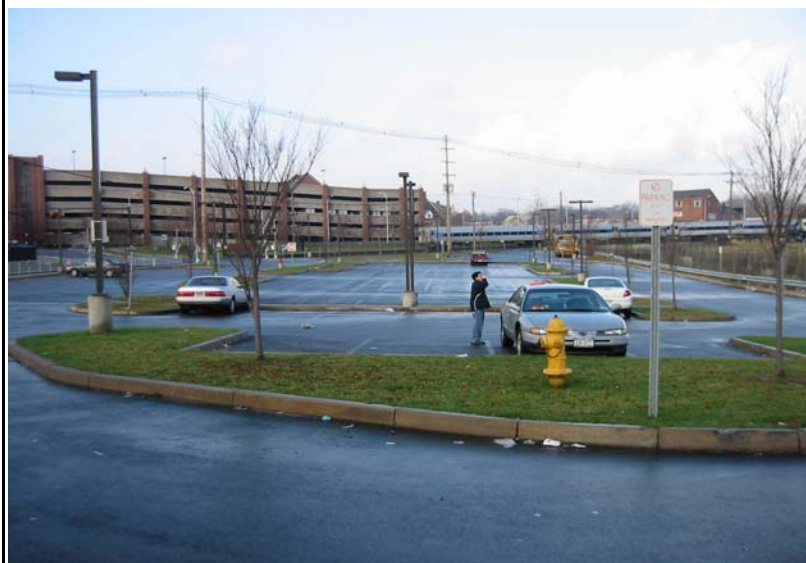
PHOTO NO. 6

Location: _____
South end of Quad II

Description: _____
General view of Quad II

Reference: _____
Looking North

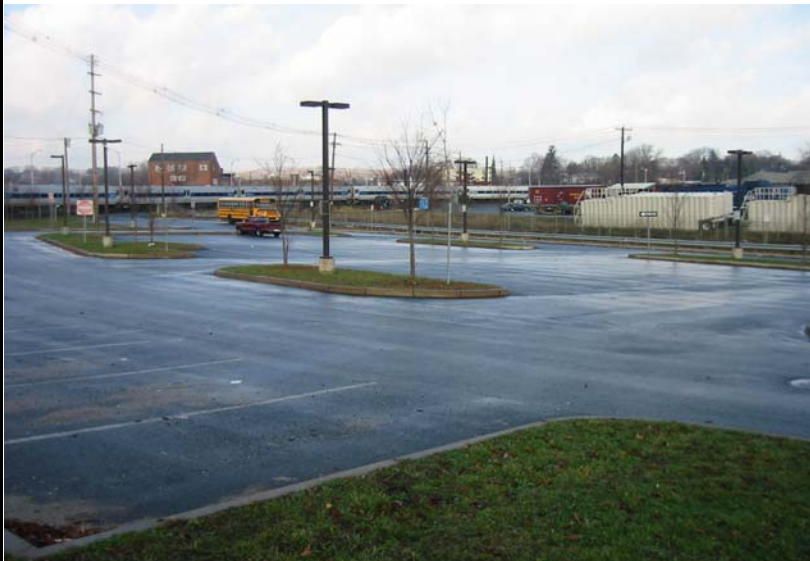
PHOTO NO. 8

Location: _____
Westside of Quad II

Description: _____
General view of Quad II

Reference: _____
Looking Northeast

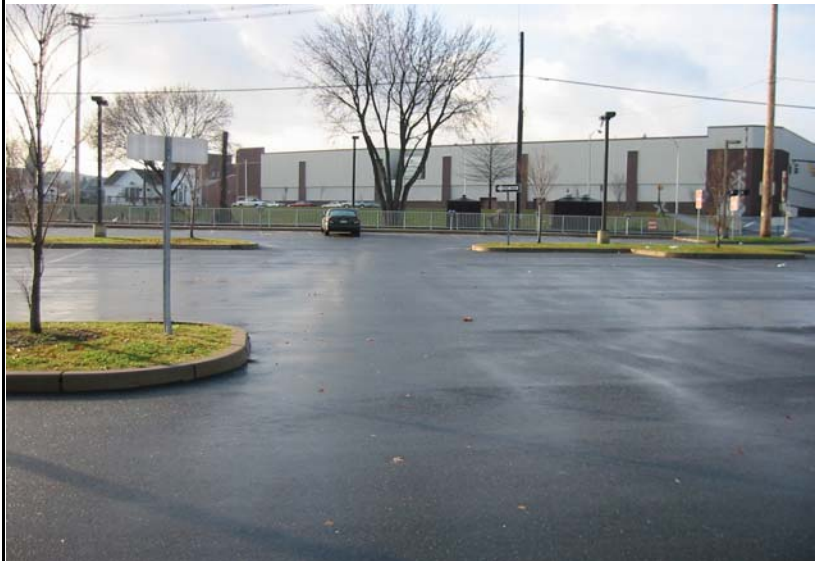
PHOTO NO. 10

Location: _____
Eastside of Quad II

Description: _____
General view of Quad II

Reference: _____
Looking West

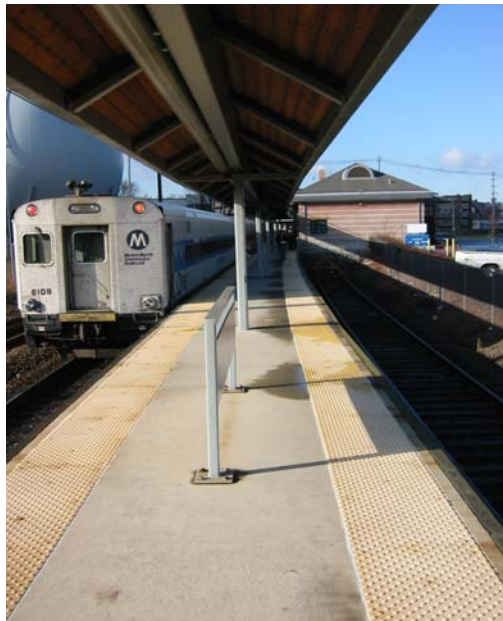
PHOTO NO. 12

Location: _____
South end of the platform

Description: _____
General view of the platform

Reference: _____
Looking North

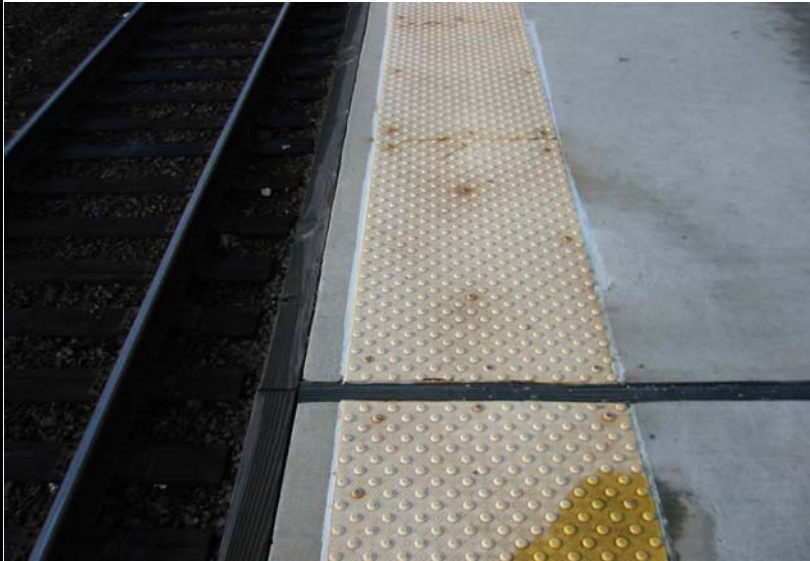
PHOTO NO. 16

Location: _____
Span I of the platform

Description: _____
Typical view of the
rubbing board, warning
strip, and an expansion
joint

Reference: _____
Looking North

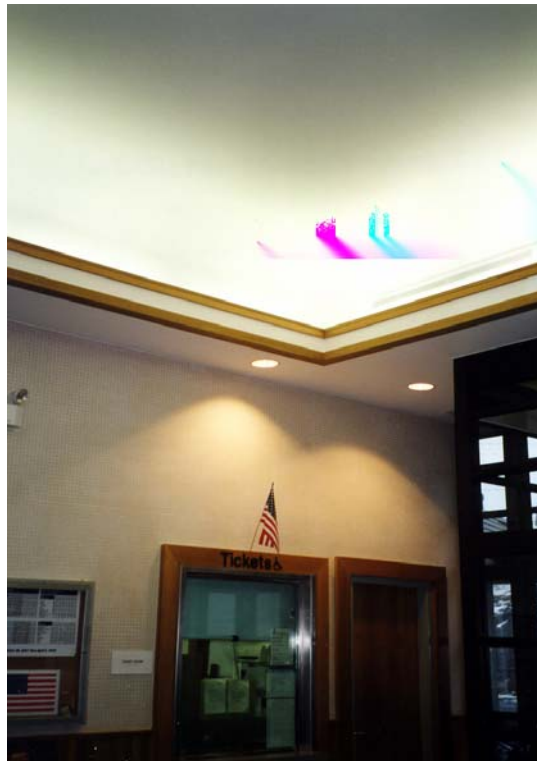
PHOTO NO. 30

Remarks: A typical section of the waiting room was measured and found to average 8.18 fc.

The waiting room maintains an average of 8.18 foot-candles, which exceeds the minimum light levels as recommended by the IESNA. Exit and emergency lighting are operational and meet the requirements of NFPA 101.

Location:
building waiting
room

Description:
waiting room
lighting

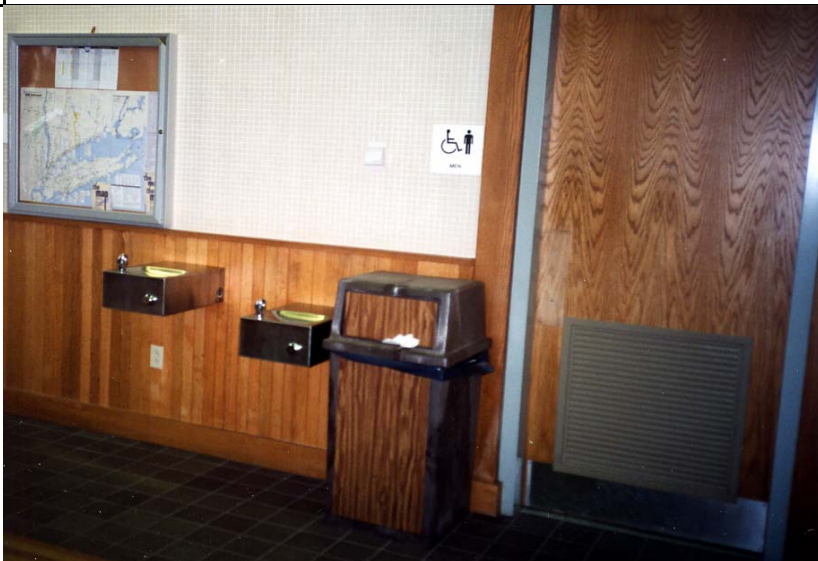
In the waiting area there are two drinking fountains that are stainless steel, one regular, one handicapped, both in Good Repair

Description:
Drinking water
fountains,
one handicapped
accessible

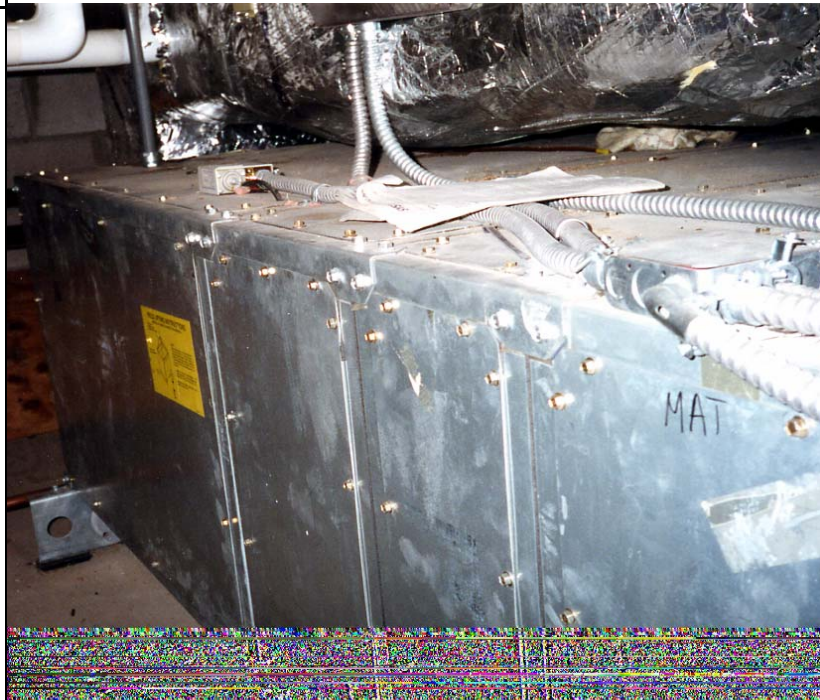
PHOTO NO. 36

Units (2) in the attic, one unit for waiting area
and restrooms. The other unit is for the cafeteria and ticket office.
Each unit has a hot water heating coil and a cooling
coil. Good Repair
HEATING UNIT / FURNACE: coil. Good Repair

Location:
ATTIC

Description:
Heating and
airconditioning
fabricated unit

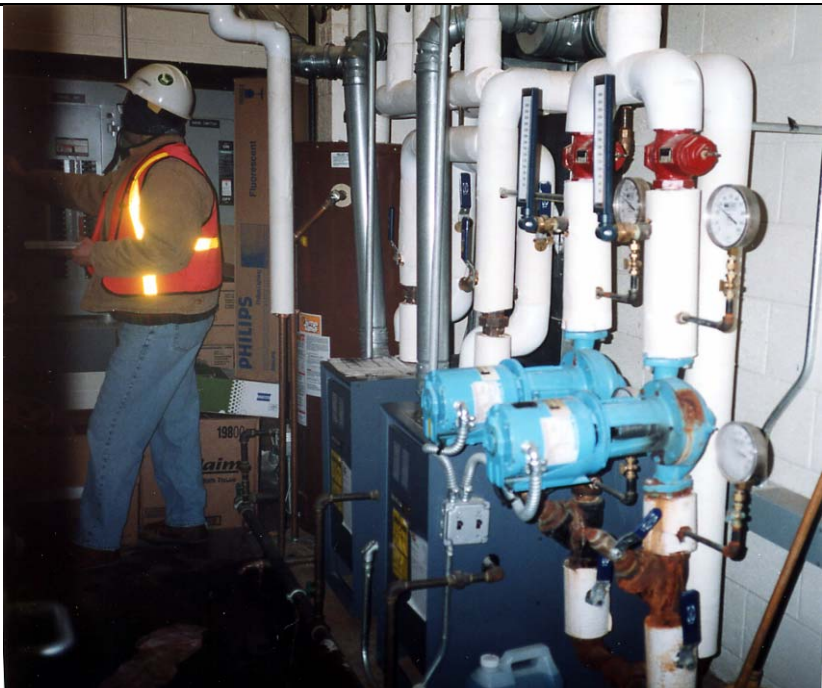
Two small Weil McLain hot water boilers
Model HE II-5 Serial 1
BOILER: Natural Gas input 133,000 Btu/hr, Good Repair

PUMPS: Two hot water circulating pumps Model 1 GTS, Good Repair

Description:
Two Weil McLain
gas boilers and
two hot water
circulating pumps
