Individual Station Report

Redding

Station Condition Inspection

CONDITION INSPECTION WEST REDDING STATION

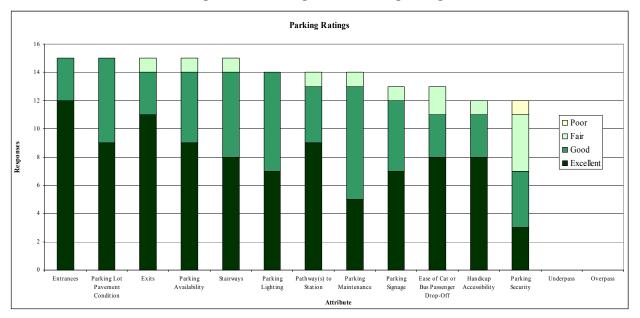
Figure 210: Redding Station Parking Ratings

Figure 210 shows the parking ratings for the Redding Station. As mentioned, the Redding parking ratings were the highest on the Danbury Line. Furthermore, Redding had the highest rated parking of all the stations in the survey. Due to the small survey size, several elements

received 100% positive ratings. The lowest rated element was parking security with 58% approval. All of the other parking elements had positive ratings of 85% or higher. Redding does not have an overpass or an underpass.

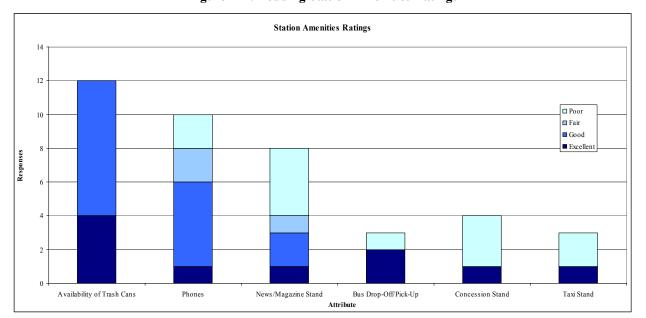
Figure 211: Redding Station Amenities Ratings

Amenities ratings in Redding were more positive than negative. Figure 211 shows the amenities ratings. Three elements were rated negatively by a majority of respondents. The concession stand was rated the worst with 75% negative ratings. As was the case at most stations, the availability of trash cans was the highest rated element. At Redding 100% of respondents were satisfied with the trash container availability. Two-thirds of respondents were also pleased with the bus drop-off/pick-up situation.

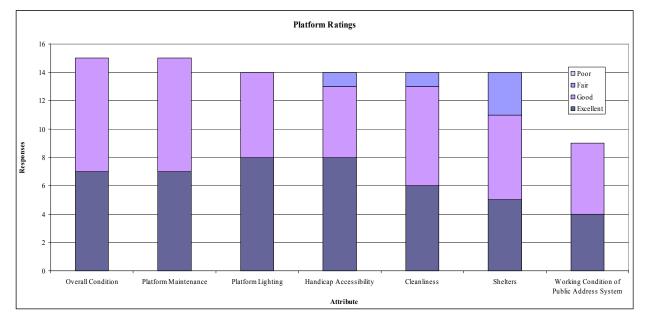
Figure 212: Redding Station Platform Ratings

The Redding station does not have a station building; it consists only of a platform. Thus, while most customers did provide ratings for the platform elements, these are naturally of greater importance when reviewing the survey results. Unlike many stations, for which the platform shelters were cited as a major concern, Redding's platform rated favorably for all categories, including the shelters. Figure 212 shows how Redding respondents rated the platform elements. Redding's platform ratings were not only the highest on the Danbury Line, but were the highest of all the stations surveyed. Shelters, the lower rated element, still only had 21% negative ratings. Four elements, including the overall platform condition, were rated positively by all respondents.

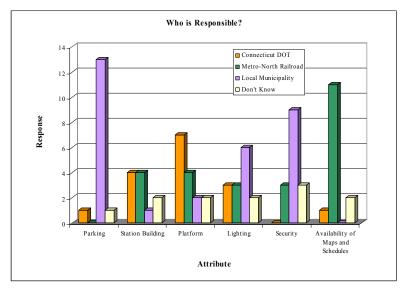
Figure 215: Redding Station – Responsible Agencies

Redding respondents distributed the responsibility for elements much more than respondents at other stations. In general, Redding respondents thought that the local municipality had the most responsibility. Figure 215 shows how Redding respondents viewed the responsibility structure at the station. Redding respondents thought that the flowing elements were responsibility of these agencies:

- The majority (60%) of respondents thought that the local municipality was responsible for security in Redding. Another 20% each did not know who was in charge and thought that Metro-North was responsible for security.

• Respondents either thought that Metro-North was responsible for map and schedule availability (79%) or did not know who was in charge (14%).

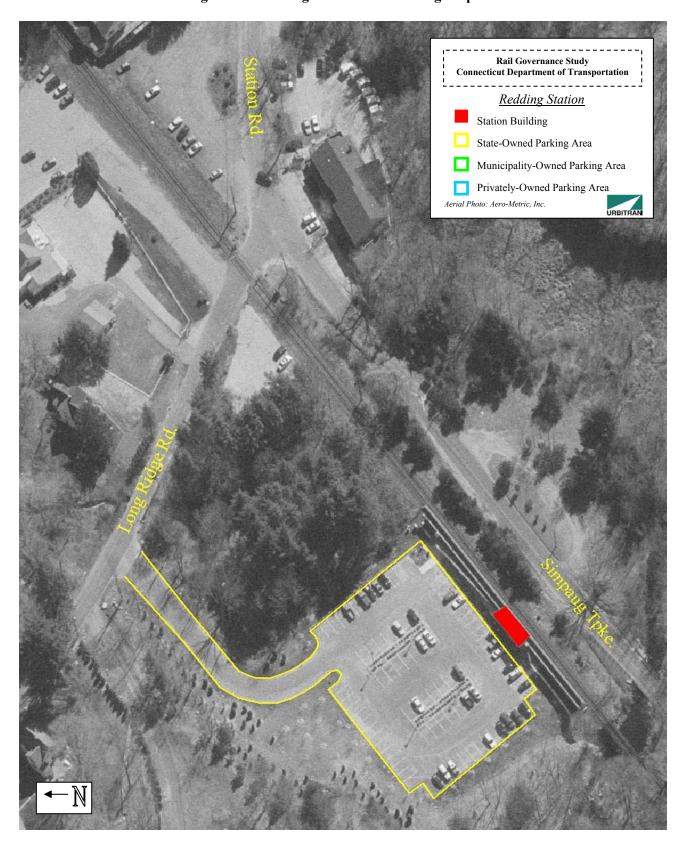
Figure 28: Redding Rail Station Parking Map

All parking at the Redding Rail Station is owned by the State of Connecticut. Figure 28 displays the parking lot location and ownership.

Туре	Capacity	Vehicle Count	Utilization	Ownership
Permit	65	42	64.6%	
Daily	13	10	76.9%	, ,
Handicap	4	0	0.0%	state
TOTAL PARKING	82	52	63.4%
