# STRUCTURE NO. 04601

NORTH BEAR HILL RD  
over  
NATCHAUG RIVER  
CHAPLIN

Indepth Inspection  
on  
7/8/2009

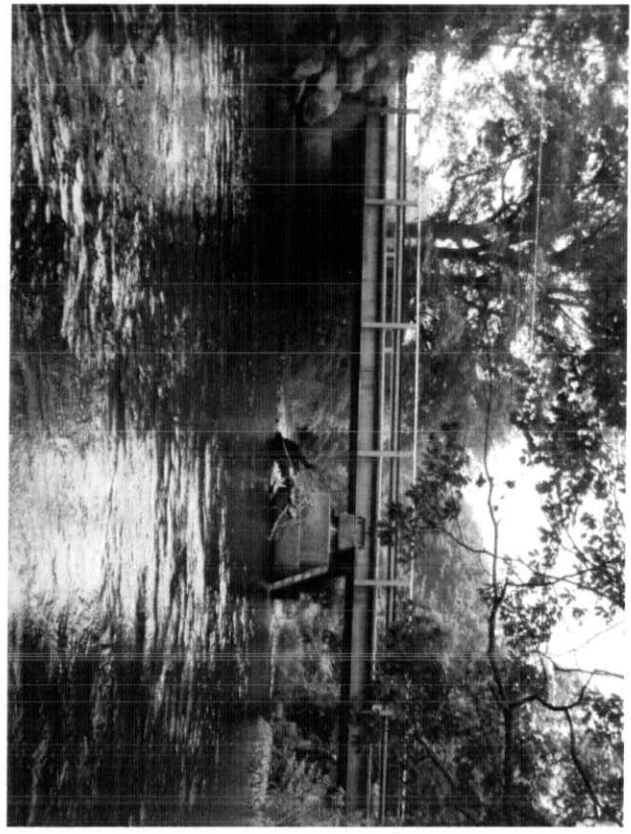
Photo # 3: NORTH ELEVATION.

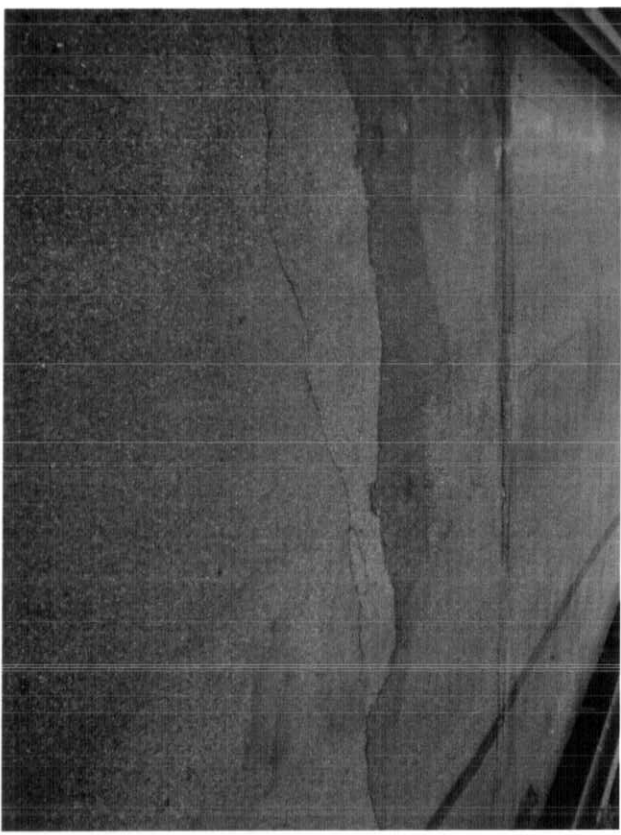
**Photo # 5: WEST APPROACH PAVEMENT.**

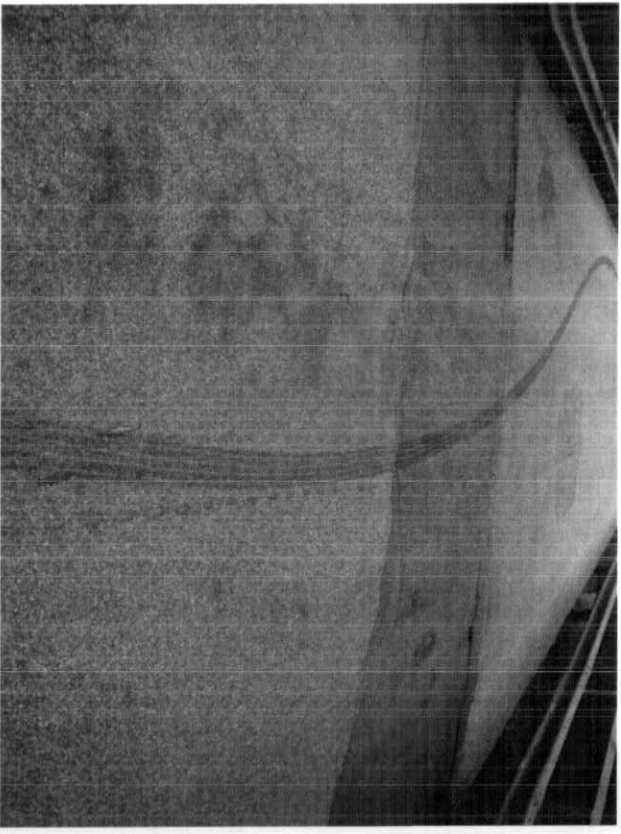
**Photo # 6: EAST APPROACH PAVEMENT.**

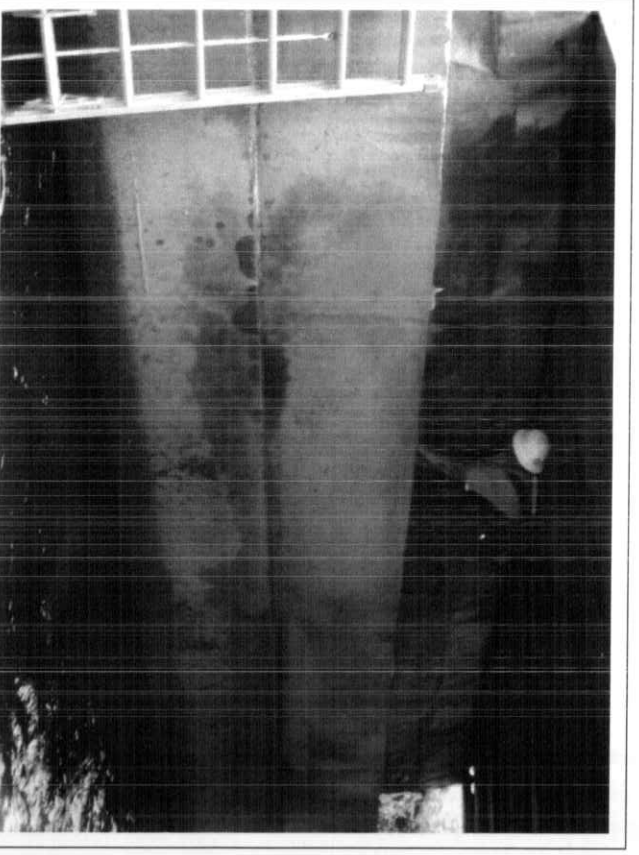
PIERS/BENTS-PILE BENT:	N	-
PIERS/BENTS-COLUMNS:	7	A CAST IN PLACE, SQUARE BLOCK STRUCTURE, HAS BEEN CONSTRUCTED AROUND THE ORIGINAL STEM AREA, IN AN ATTEMPT TO ENCASE THE ORIGINAL STEM AREA. IT SHOWS RANDOM CRACKING, WITH AREAS OF LIGHT HONEYCOMB.
PIERS/BENTS-FOOTING:	6	THE FOOTING IS STILL GENERALLY VISIBLE AROUND THE PERIMETER OF THE PIER. THE NORTHERLY INLET FASCIA OF THE FOOTING, IS STILL EXPOSED UP TO 24 INCHES HIGH. THE FOOTING SHOWS LIGHT TO MODERATE SCALING, WITH TRANSVERSE CRACKING, ALONG THE CAP.
PIERS/BENTS-SETTLMT:	8	THERE ARE NO SIGNS OF SETTLEMENT TO THE PIER.
EROSION-SCOUR:	6	THREE VERTICAL FEET OF SCOUR, HAS PAST OCCURED AT THE NOSE OF THE PIER. THIS TAPERS OFF AS YOU MOVE DOWNSTREAM ALONG THE STEM.
CONCRETE CRACK-SPALL:	4	REFER TO ALL ABOVE DESCRIPTIONS.
STEEL CORROSION:	N	-
PAINT:	N	-
TIMBER DECAY:	N	-
COLLISION DAMAGE:	8	THE SUBSTRUCTURE SHOWS NO COLLISION DAMAGE.
DEBRIS:	7	THERE IS LIGHT SAND DEBRIS ON THE PIER, AND ABUTMENT CAPS.

Photo # 14: WEST FACE OF PIER.

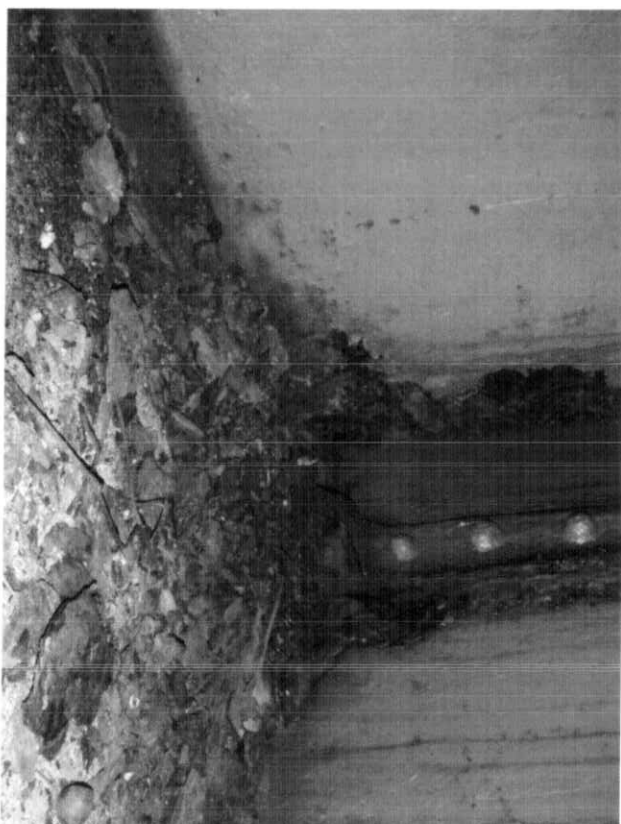
Photo # 27: BEAM END # 7 NORTH FACE AT ABUTMENT # 1
