CONNECTICUT  
DEPARTMENT  
OF  
TRANSPORTATION

CONDITION INSPECTION  
FOR THE  
NAUGATUCK STATION

**CONN. DEPT OF TRANSPORTATION  
STATION INSPECTION**

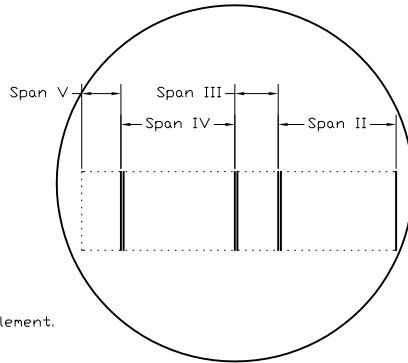
Urbitran Associates, Inc.
Connecticut Dept. of Transportation
Naugatuck Station General Plan
Date: 11-19-01

- NOTES:
1. The asphalt sidewalk contains numerous cracks and uneven settlement.
  2. The asphalt surface in Quad I exhibits numerous cracks and an uneven driving surface.
  3. The asphalt surface in Quad II and III exhibits numerous cracks.
