CONNECTICUT
DEPARTMENT
OF
TRANSPORTATION

CONDITION INSPECTION
FOR THE
RIVERSIDE STATION

**CONN. DEPT OF TRANSPORTATION
STATION INSPECTION**

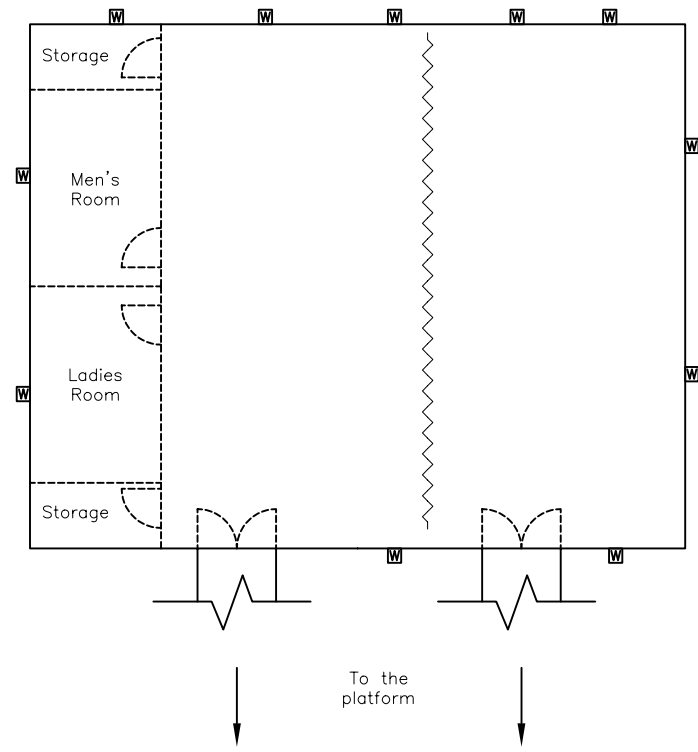
Urbitran Associates, Inc.
Connecticut Dept. of Transportation
Riverside Station Station House Plan
Date: 3/5/02

Legend:
- - - - - Crack
W Window

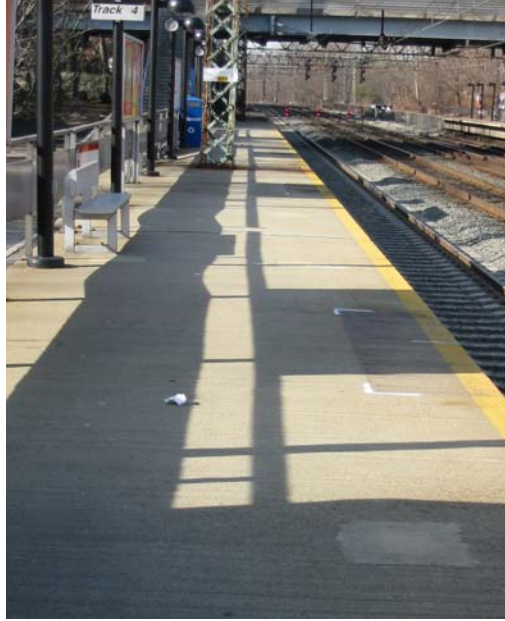
PHOTO NO. 2

Location: _____
Span XI of the
east platform

Description: _____
General view of the east
platform

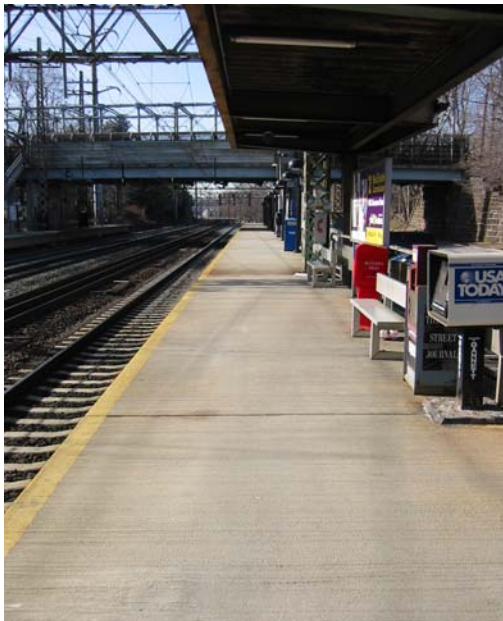
PHOTO NO. 4

Location: _____
Span VIII of the west
platform

Description: _____
General view of the west
platform

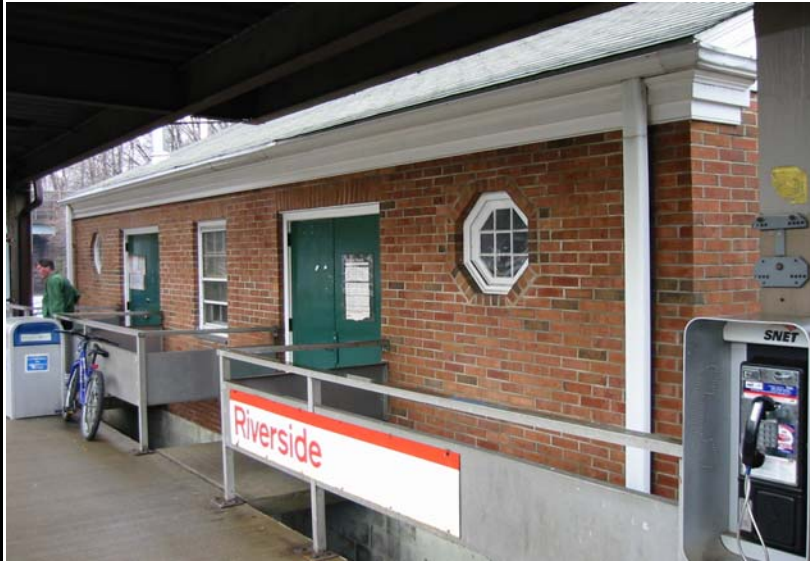
PHOTO NO. 6

Location: _____
Span XII of the west
platform

Description: _____
General view of the
exterior east elevation
of the station house

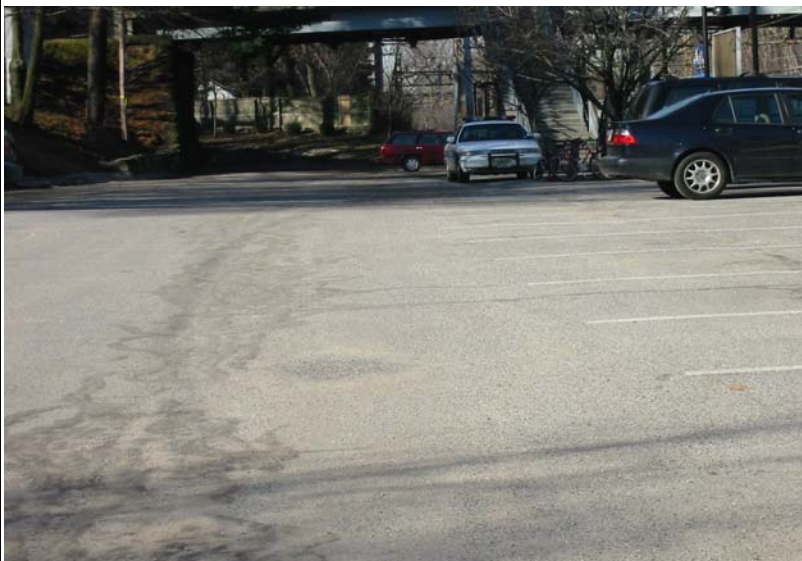
PHOTO NO. 8

Location: North side of Quad I

Description: General view of Quad I

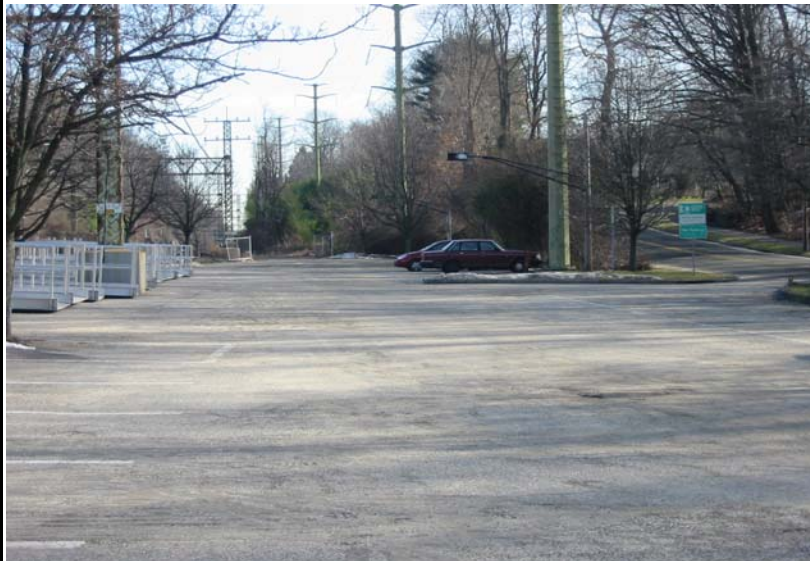
PHOTO NO. 10

Location: South side of Quad II

Description: General view of Quad II

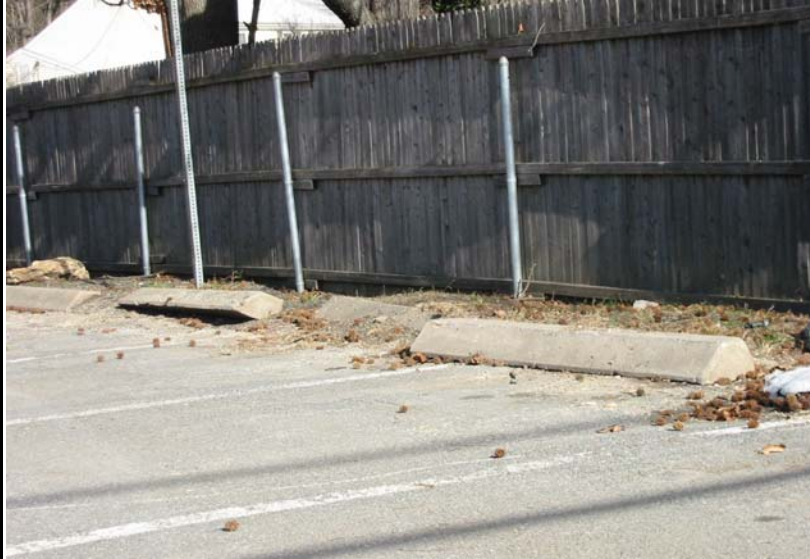
Description: _____
The concrete parking
blocks are displaced

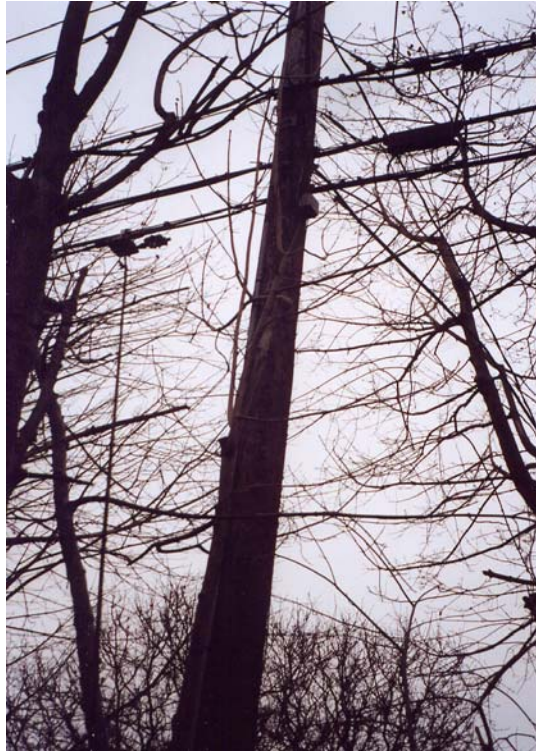
Description:
electrical utility
service pole

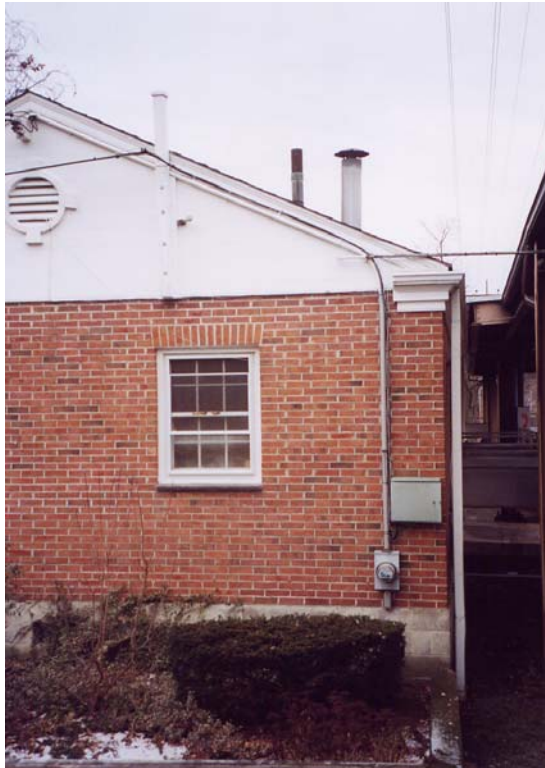
PHOTO NO. 48

The electrical service is routed overhead from a service pole and then terminates at a utility meter mounted on the exterior of the building. The electrical system has minor deterioration, but functions as originally designed.

Location:
adjacent to
the building

Description:
service entrance
and utility meter

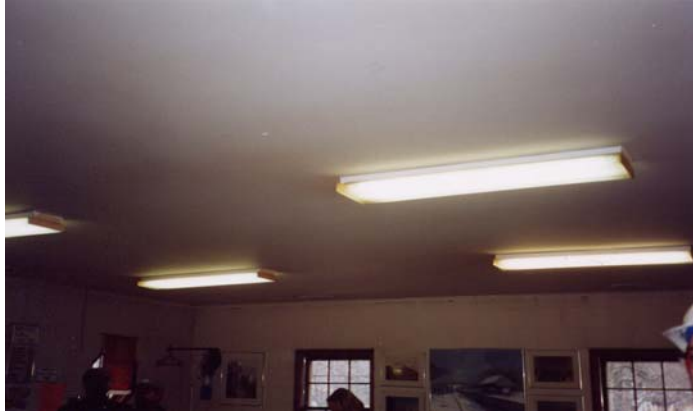
Remarks: A typical section of the waiting room was measured and found to average 6.7 fc.

The station lighting maintains at least an average of 6.7 foot-candles. This value exceeds the minimal value as recommended by the IESNA. Exit and egress lighting is operational and meets the requirements of NFPA 101.

Description:
waiting room
lighting

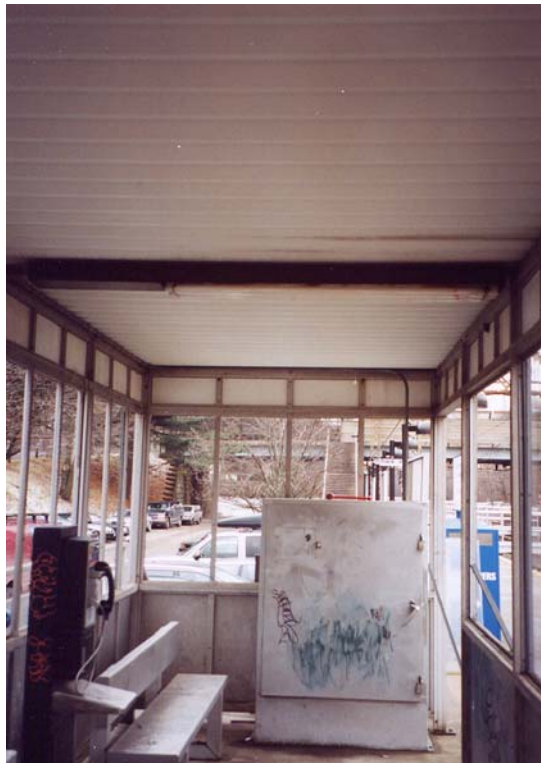
PHOTO NO. 50

Remarks: Electrical service to the southbound platform originates from the station building. The northbound platform has a separate electrical service to an enclosure located on the platform. We were unable to gain access to the electrical enclosure to verify the size and condition of the main circuit breaker in the northbound platform enclosure.

Location:
northbound
platform

Description:
electrical service
enclosure in
shelter

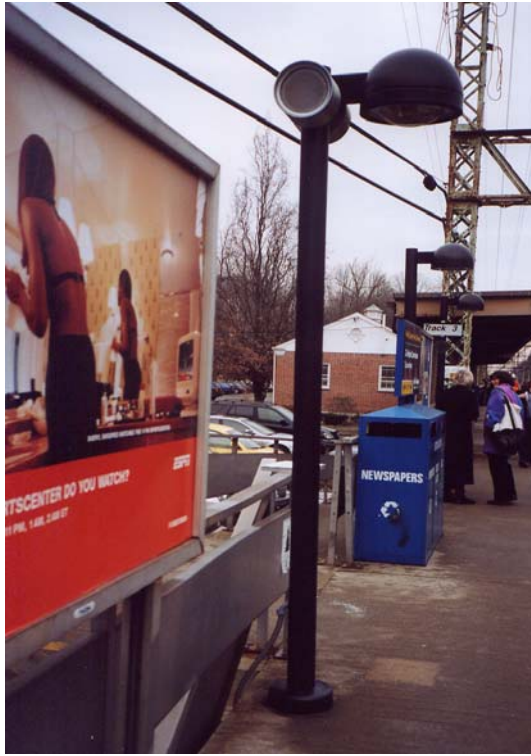
PHOTO NO. 51

Description:
platform lighting
and speakers

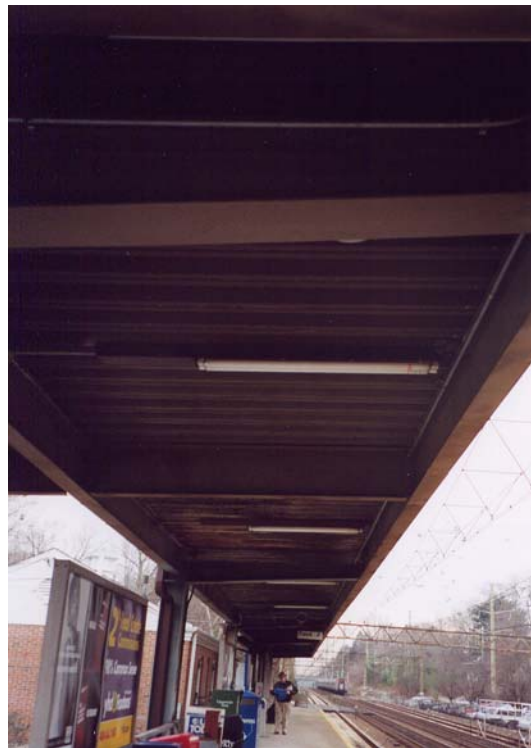
PHOTO NO. 52

Remarks: A typical section of the platform was measured at the location indicated and found to average 11 and 9.2 fc on the southbound and northbound platforms respectively.
Most of the platform canopy luminaires are missing lenses. We found that the pedestrian lighting in the overpass connecting the two platforms was extremely low with levels of 0.2 fc.

The light poles on the platform are relatively new and provide an average of 11 foot-candles on the southbound platform and 9.2 foot-candles on the northbound platform. The luminaires mounted beneath the canopy maintain 12.29 foot-candles but all the fixtures are missing lenses. Without the lenses, the fixture are exposed to harsh environmental conditions and do not perform as designed. We suggest that the under canopy luminaires be replaced with appropriate lighting fixtures, since fixture failure is imminent. The pedestrian bridge lighting over the train tracks between platforms maintains 0.2 foot-candles. Considering the large amount of pedestrian traffic during the hours of darkness, it is advisable that more luminaires be installed to improve the lighting conditions.

Location:
platform

Description:
platform canopy
lighting

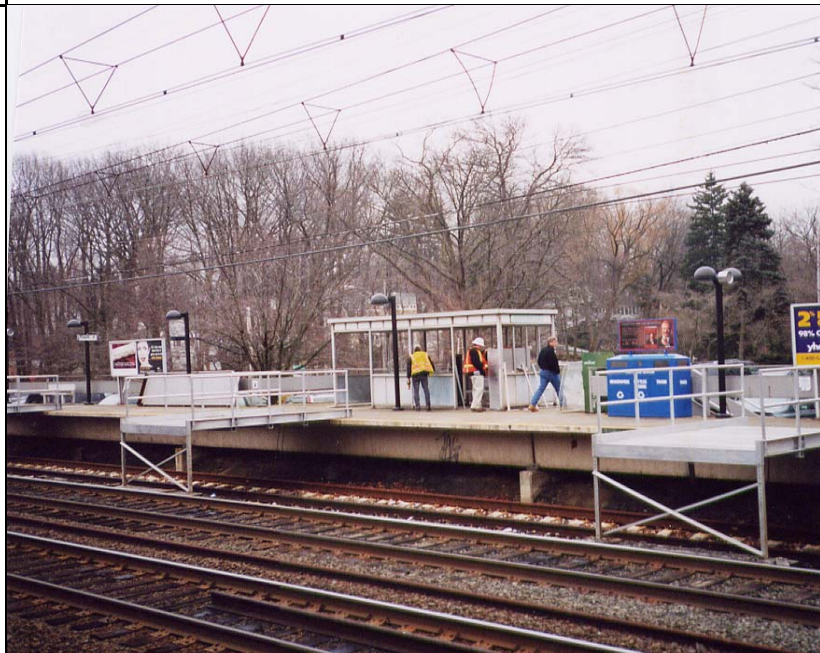
Across track from Station house there is an additional shelter that is being repaired.

Description:
Shelter across
the tracks
Maintenance
work in progress
