Individual Station Report

Branchville

July 2003

CONDITION INSPECTION
BRANCHVILLE STATION

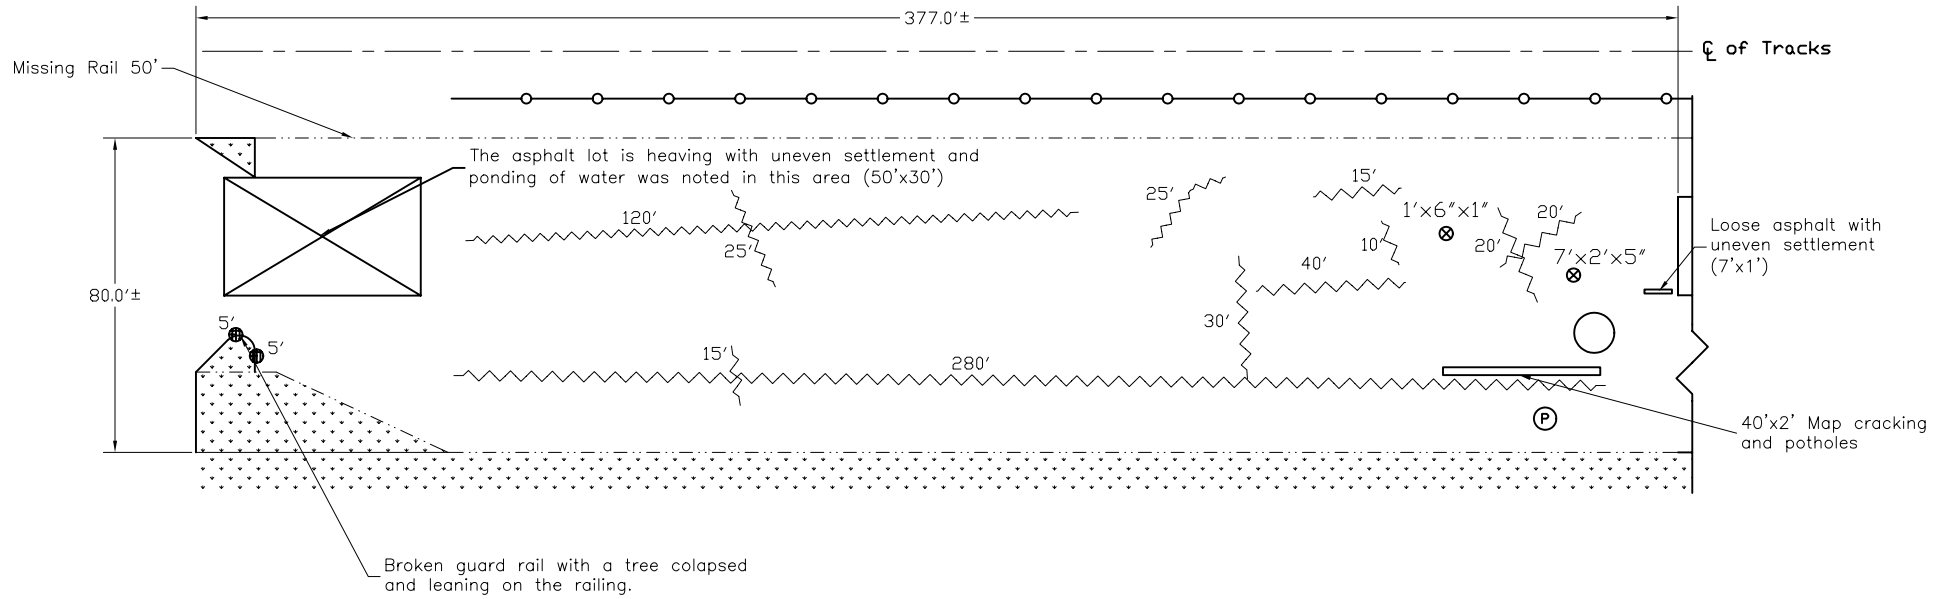
Urbitran Associates, Inc.
Connecticut Dept. of Transportation
Branchville Station Quadrant II Plan
Date: 12-5-01

CONDITION OF PAVED SURFACE: 1

CONDITION OF STRIPING: 2
