Individual Station Report

Riverside

Connecticut Department of Transportation

Urbitran Associates, Inc.

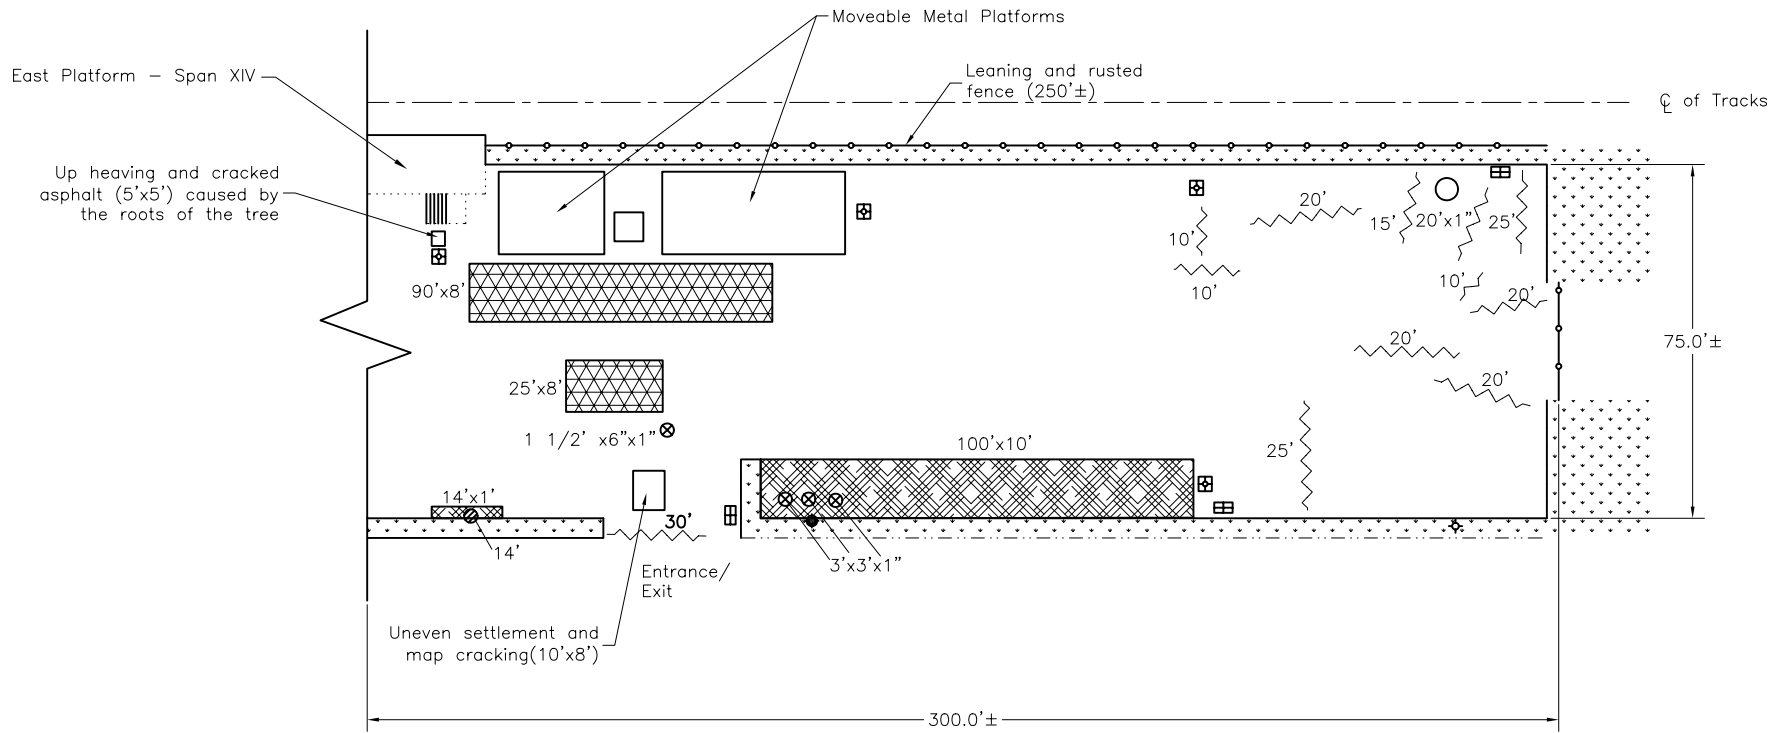
Urbitran Associates, Inc.
Connecticut Dept. of Transportation
Riverside Station Quadrant I Plan
Date: 3/5/02

- NOTES:
1. The potholes vary in size from 4"x4"x1" to 5'x3'x1/2"
 2. There is mapcracking and uneven settlement along the east side (3' wide x 360')

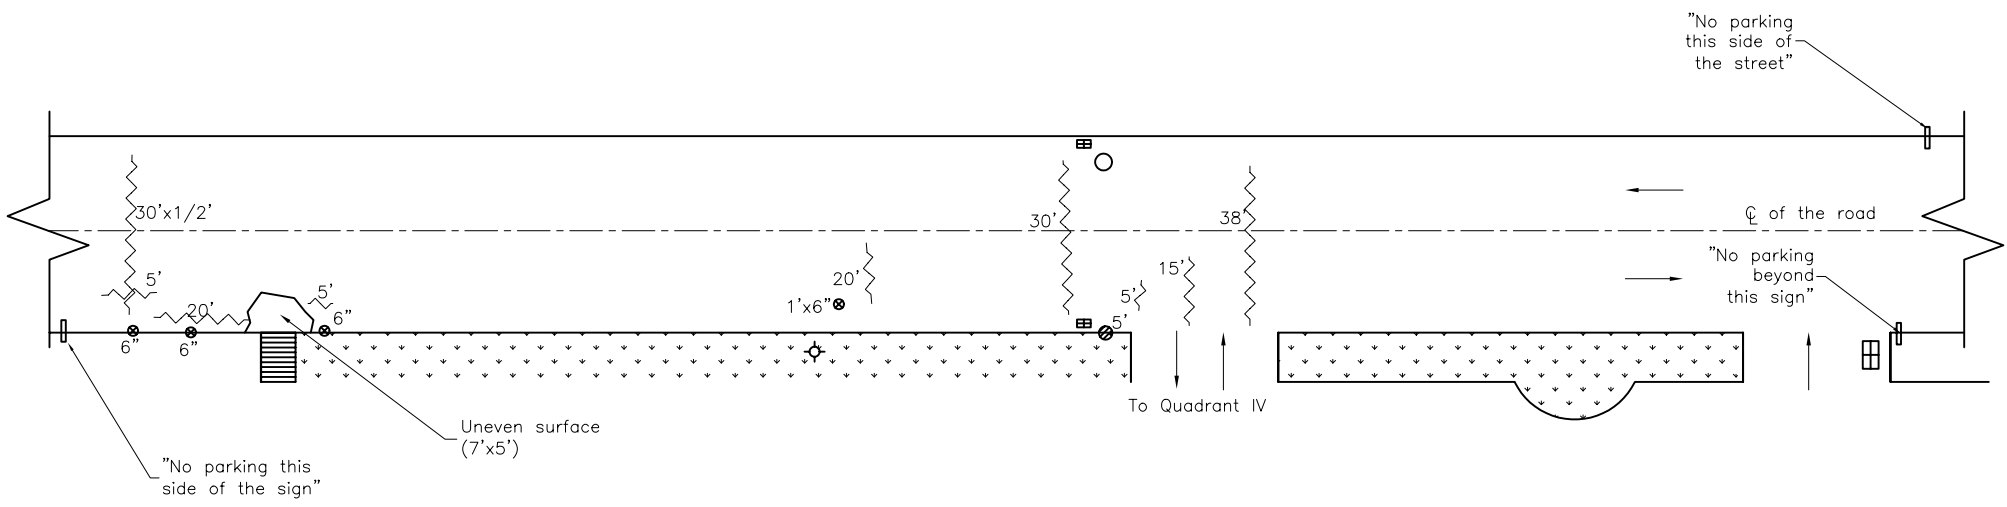
Urbitran Associates, Inc.
Connecticut Dept. of Transportation
Riverside Station Quadrant IV Plan
Date: 3/5/02

1. There is no curb on the west side except for 25' which is damaged.
2. 40% of the asphalt surface is cracked.
3. There are 10 concrete parking blocks displaced on the north side.
4. The sidewalk is cracked with an uneven walking surface.
