CONNECTICUT
DEPARTMENT
OF
TRANSPORTATION

CONDITION INSPECTION
FOR THE
WESTPORT STATION

**CONN. DEPT OF TRANSPORTATION
STATION INSPECTION**

STATION: Westport
 LINE: New Haven Line
 INSPECTION DATE: 8/02/02
 INSPECTION AGENCY / FIRM: UA
 INSPECTORS: RGW
 WEATHER: Sunny, 80's

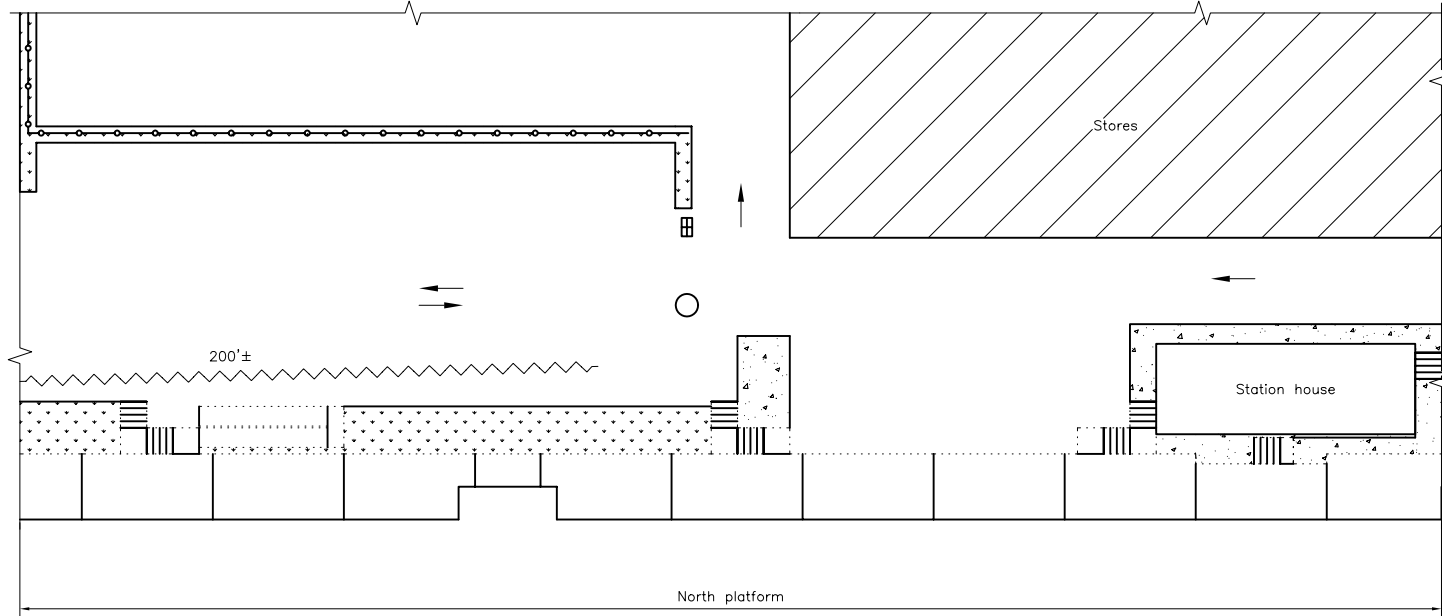
Urbitran Associates, Inc.
Connecticut Dept. of Transportation
Westport Station Quadrant I Plan
Date: 8/03/02

1. The entire asphalt surface contains numerous cracks with vegetation growth. There are multiple locations of potholes and an uneven asphalt surface where ponding of water was noted.
2. The asphalt sidewalk is cracked with an uneven walking surface.
3. There is vegetation growth from the asphalt sidewalk / median.

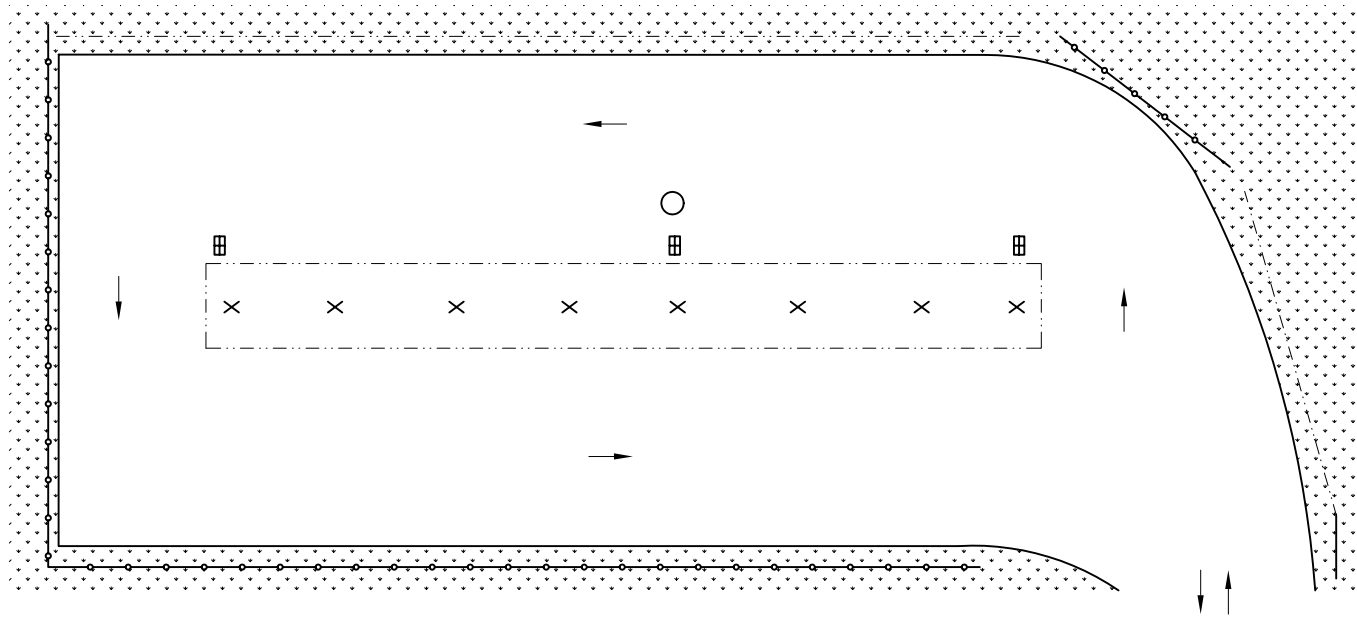
Urbitran Associates, Inc.
Connecticut Dept. of Transportation
Westport Station Quadrant III Plan
Date: 8/03/02

1. The asphalt surface is cracked 1000'±.

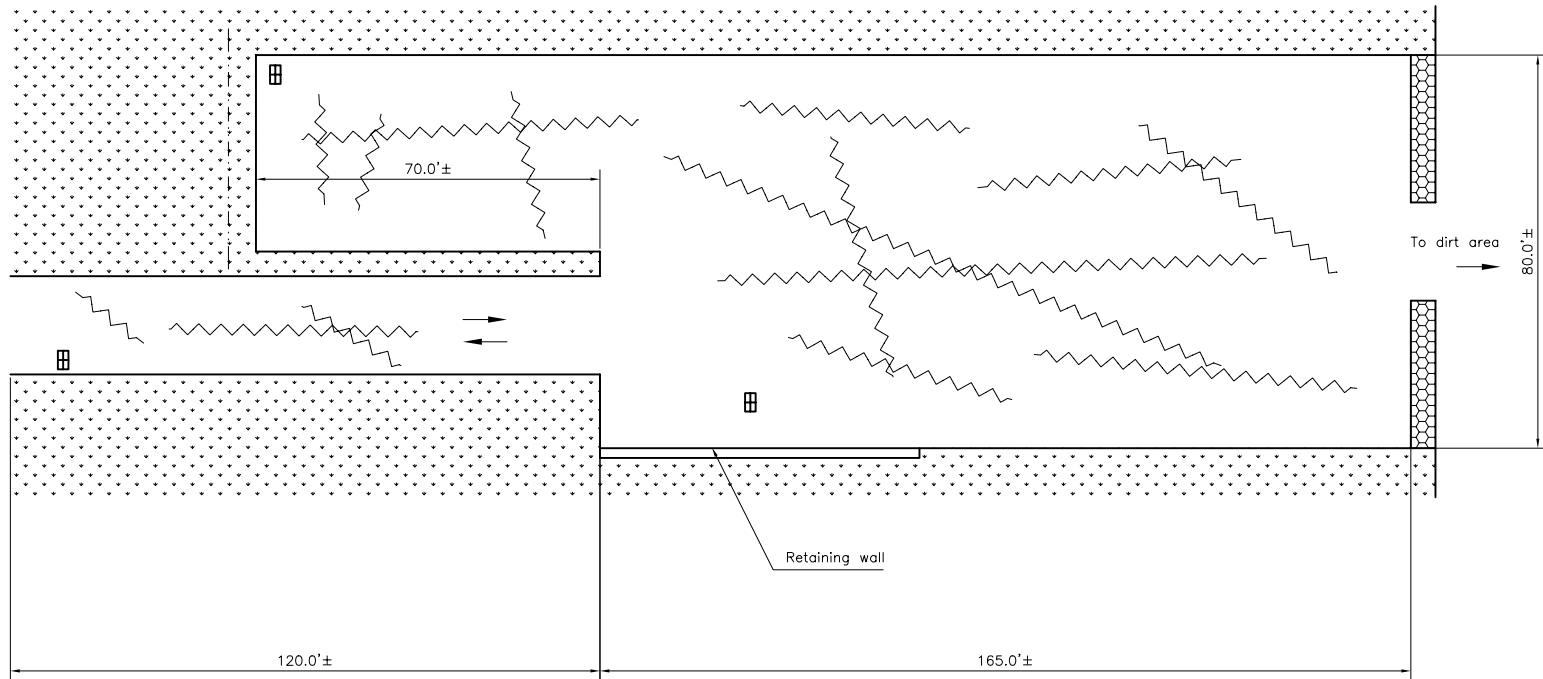
Urbitran Associates, Inc.
Connecticut Dept. of Transportation
Westport Station Quadrant IX Plan
Date: 8/03/02

NOTES:
 1. The asphalt surface is cracked 200'±

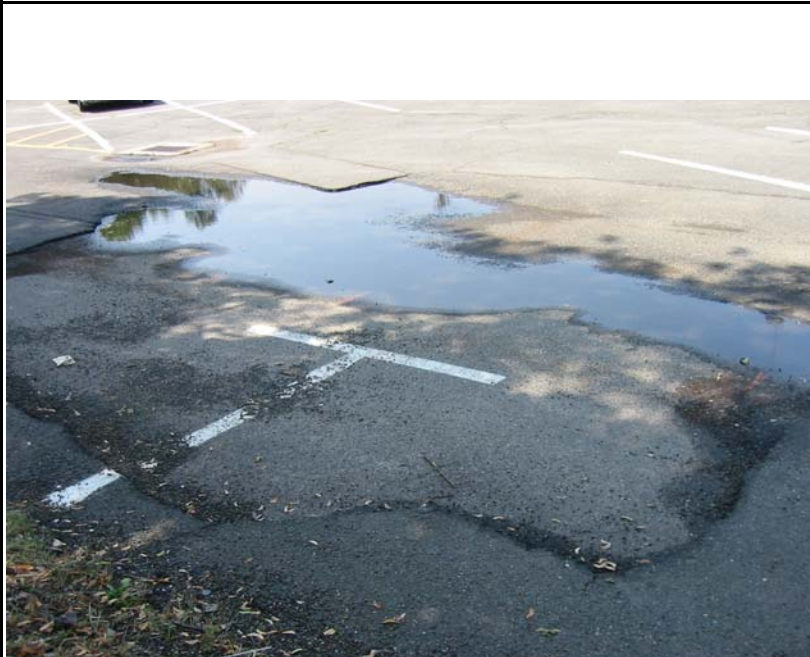
Description: _____
Typical uneven driving
surface and
accumulation of water

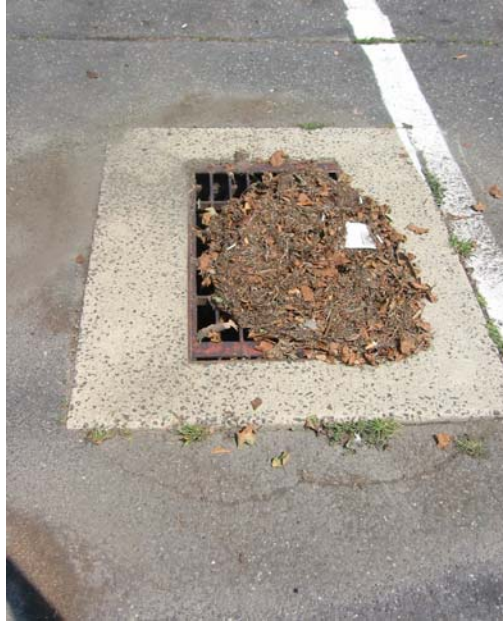
Description: Typical drain covered with vegetation

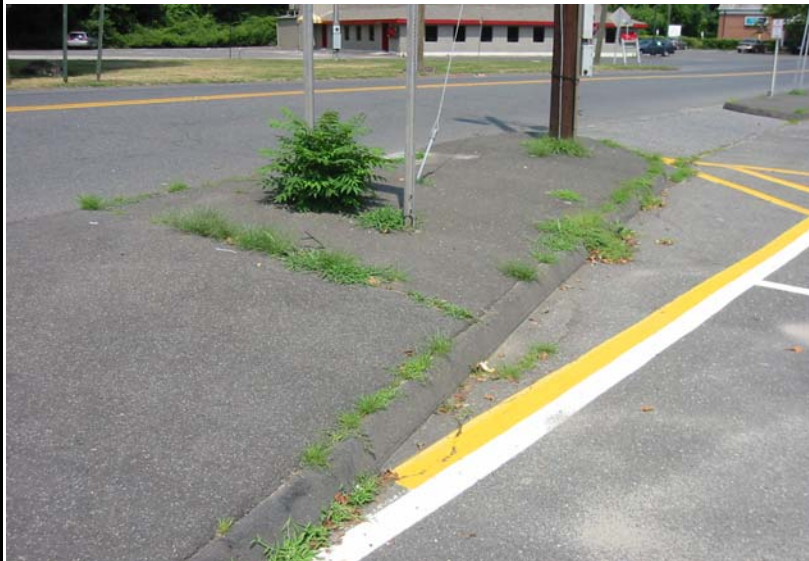
PHOTO NO. 38

Description: Typical asphalt median / sidewalk with vegetation growth

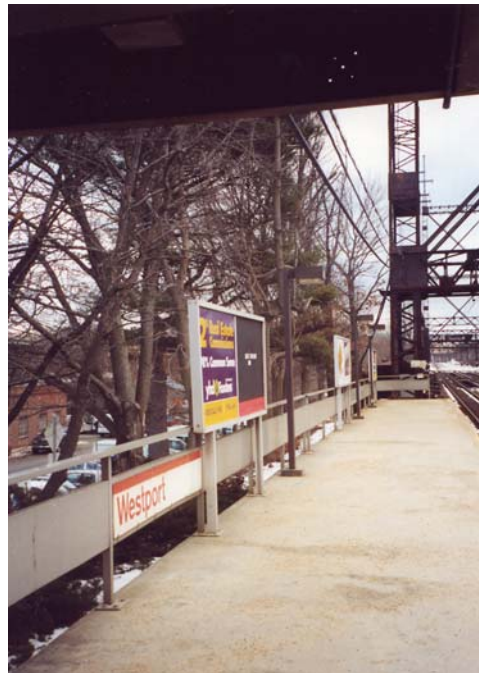
PHOTO NO. 44

Both platforms have pole-mounted luminaires with the southbound platform maintaining an average of 7.56 foot-candles and the northbound platform averages 7.3 foot-candles. The platform lighting conduits and the bases of the poles have totally deteriorated. This deterioration may be caused by the heavy use of salt on the platforms during the winter months. We suggest that the lighting poles and conduits be replaced. The pedestrian tunnel beneath the train tracks maintains an average 9.47 foot-candles. Both platforms and the pedestrian tunnel exceed the minimum light levels recommended by the IESNA.

Description:
platform lighting

Remarks: A typical section of the platform was measured at the location indicated and found to average
7.56 and 7.3 on the southbound and northbound platforms, respectively.
The majority of the light pole bases have failed in the past and attempts have been made to repair them.
Much of the lighting conduit system is corroded and should be replaced.

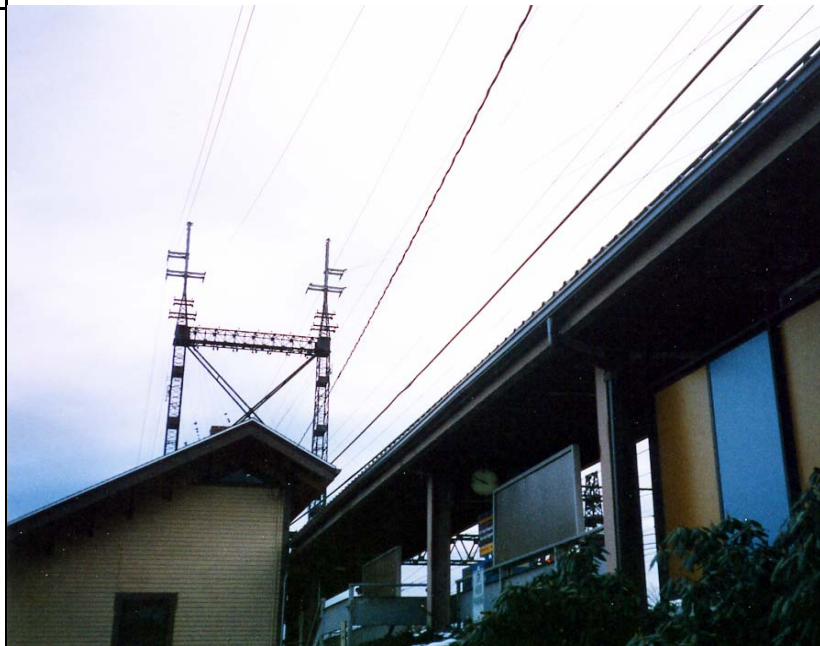
PHOTO NO. 51

The only task at the Westport station was to inspect the platform. On the southbound side of the platform the rain canopy gutters and downspouts are in good condition except for two missing downspouts. The location of one missing downspout is at the end of the building, the lower part of the downspout is missing. At the end of the platform there is one downspout, which is deteriorated. There is another rain canopy at the far end of the platform. This rain canopy is completely rusted, severely deficient and has no gutters or downspouts.

Description:
Main rain
canopy
downspouts
visible
