Re: Docket No. 346 - Implementation of Section 8 of Public Act 07-242, An Act Concerning Electricity and Energy Efficiency

The Connecticut Light and Power Company
Docket No. 346

Late Filed Exhibit HD-01
Dated: 06/29/2009
Q-LF-001
Page 1 of 2

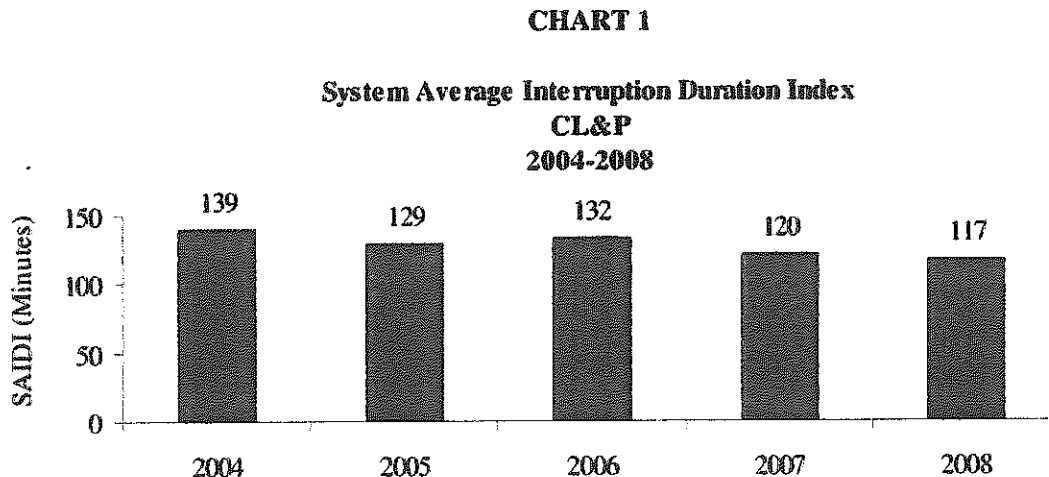
Charts 1, 2, and 3 plot CL&P system reliability data for 2004-2008.

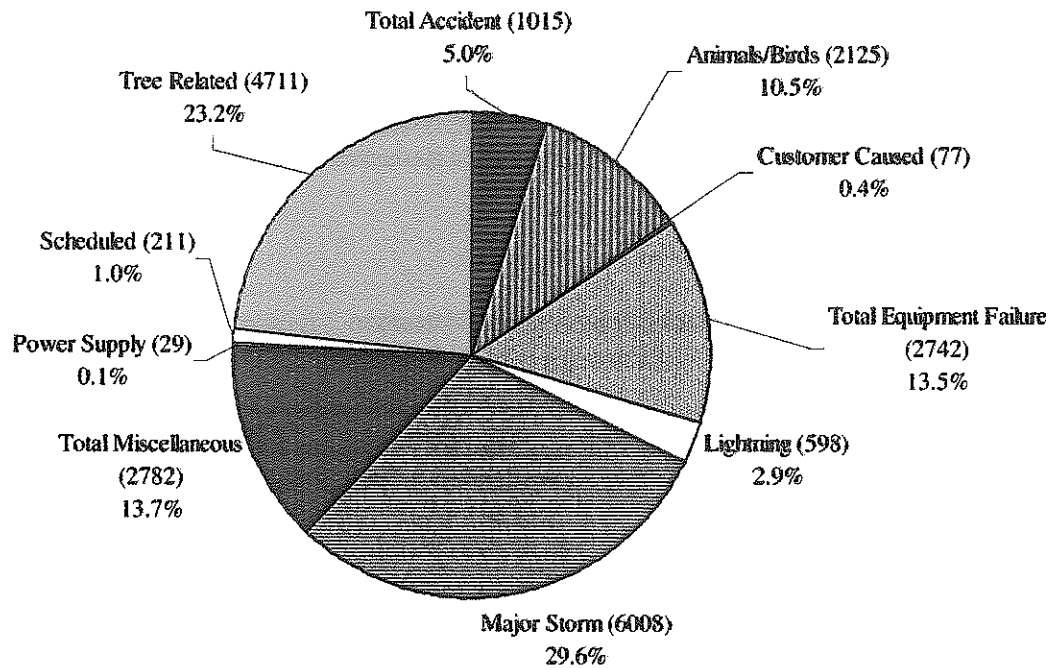
CHART 5

Causes of Outages - CL&P System Four-Year Average (Including Major Storms) 2004-2007

Note: The average annual number of interruptions is included in parentheses next to each cause. The average annual number of interruptions for 2004-2007 was 20,298.

Accident	5.0%
Vehicle	3.4%
Foreign Objects	1.0%
Employee Error	0.6%

Equipment Failure	13.5%
Overhead System	6.3%
Underground Cable	0.5%
DB Cable	3.3%
Transmission	0.0%
Substation	0.2%
Transformer	3.2%

The number of outages by cause during 2008 and the four-year average during 2004-2008 are shown in Charts 4 and 5 respectively. The total number of interruptions including major storms in 2008 was 14,598.
