Re: DOCKET NO. 461 - Eversource Energy Application for a Certificate of Environmental Compatibility and Public Need for the construction, maintenance, and operation of a 115-kilovolt (kV) bulk substation located at 290 Railroad Avenue, Greenwich, Connecticut, and two 115-kV underground transmission circuits extending approximately 2.3 miles between the proposed substation and the existing Cos Cob Substation, Greenwich, Connecticut, and related substation improvements.

Re: Docket No. 461 - CSC 461 Greenwich Substation and Line Project

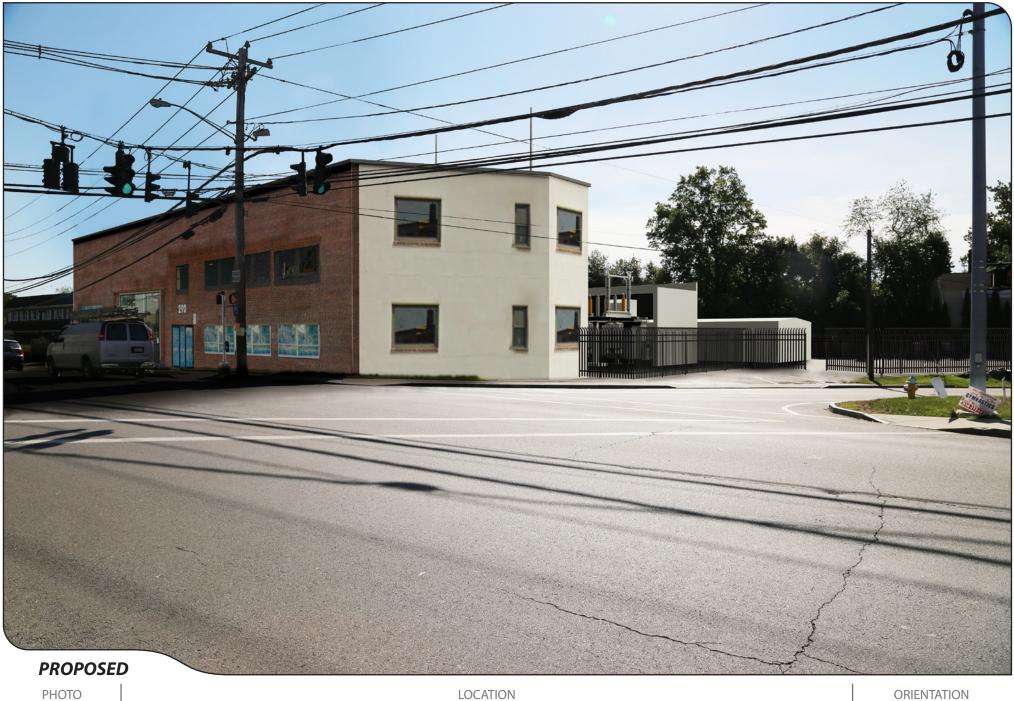
1

Any alternative design for the GIS building must be evaluated for technical merit, feasibility and cost.

A simple brick facade would possibly blend in better; however, blending a design into a neighborhood is a very subjective exercise.
