## CONNECTICUT SITING COUNCIL

RE: **Post-Construction Report - DOCKET NO. 437** – New Cingular Wireless PCS, LLC Certificate of Environmental Compatibility and Public Need for the construction, maintenance, and operation of a telecommunications facility located at 111 Second Hill Road, Bridgewater, Connecticut.

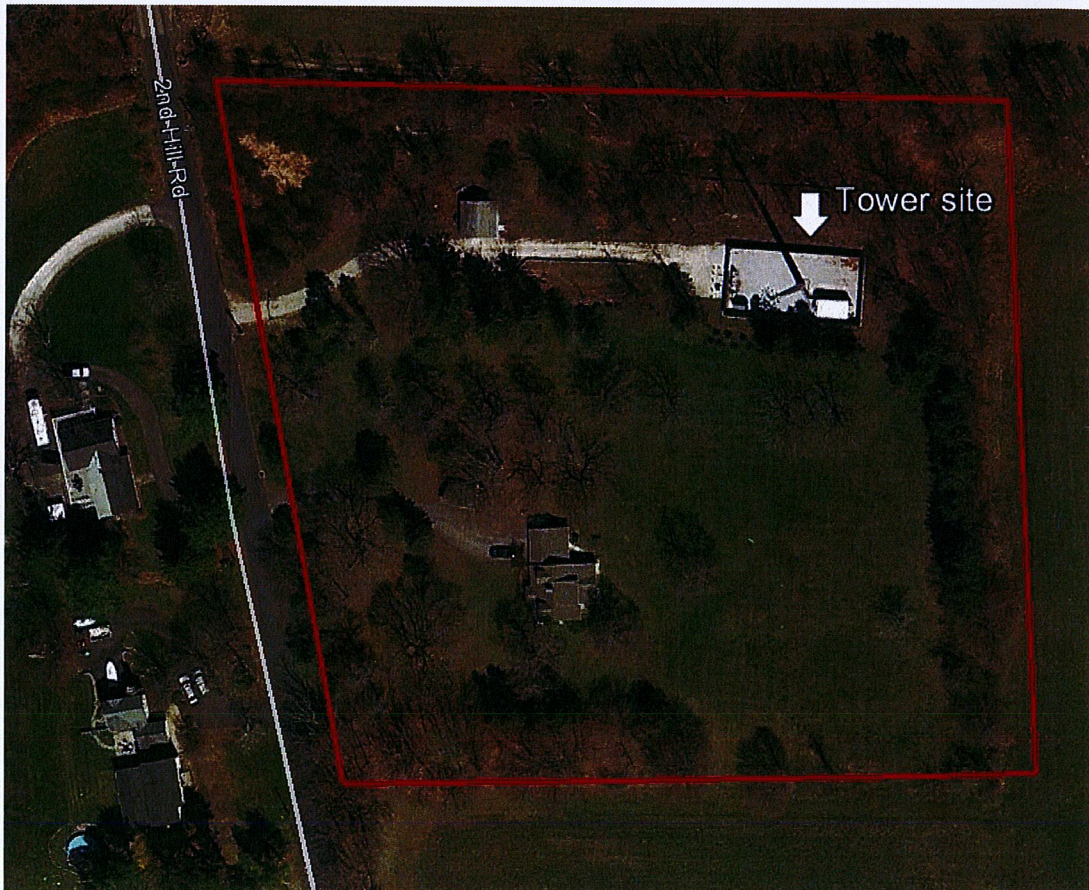
The site property consists of a 4.5-acre residentially developed parcel on the east side of Second Hill Road. The tower site is located in northeast corner of the parcel. A residential dwelling, maintained lawn and shade trees are adjacent to the site.

Close up view of parcel and tower site.

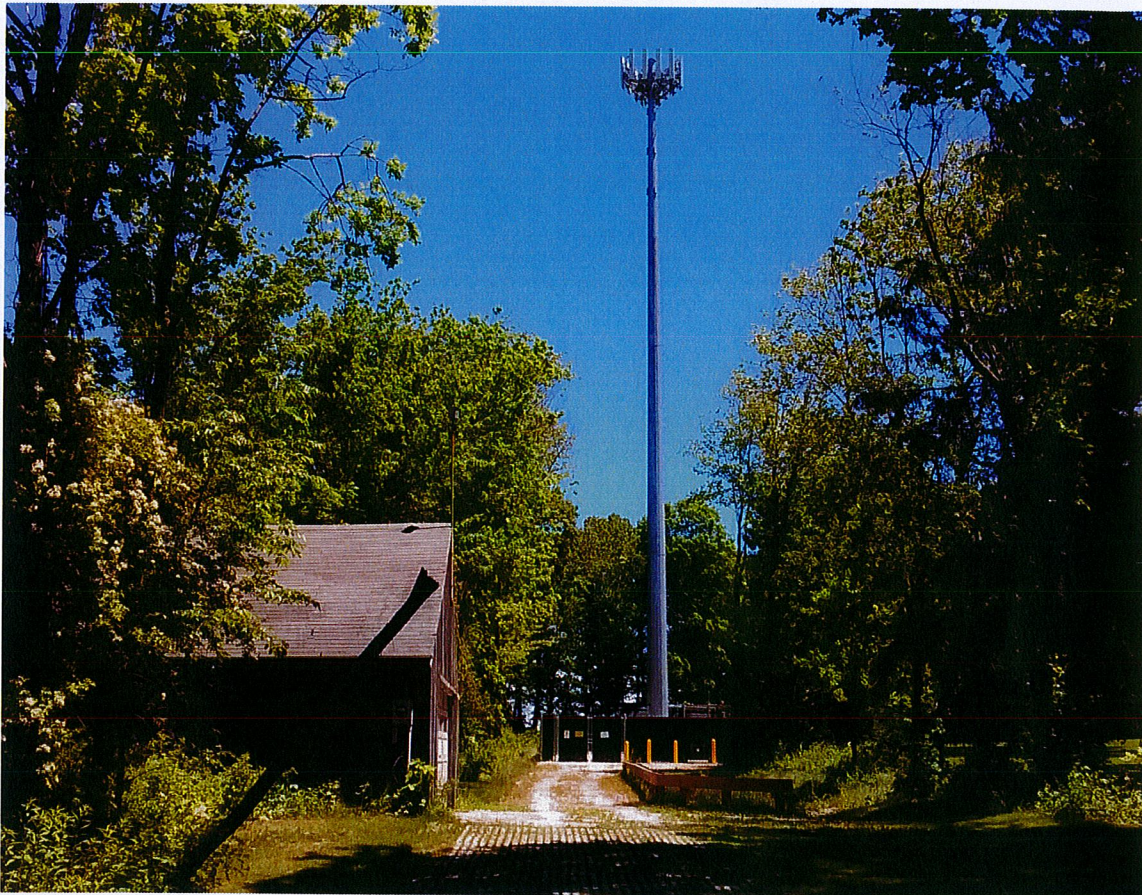
View of tower from access drive.

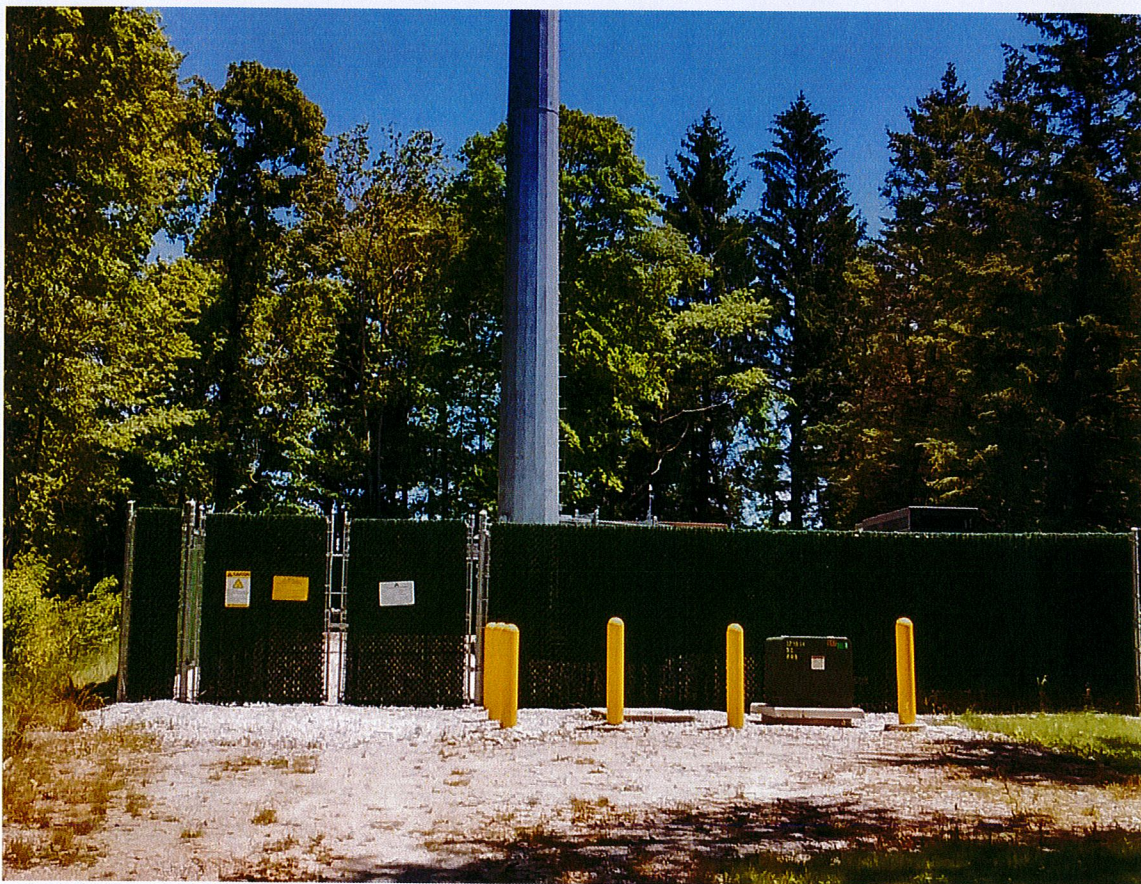
Compound entrance area.

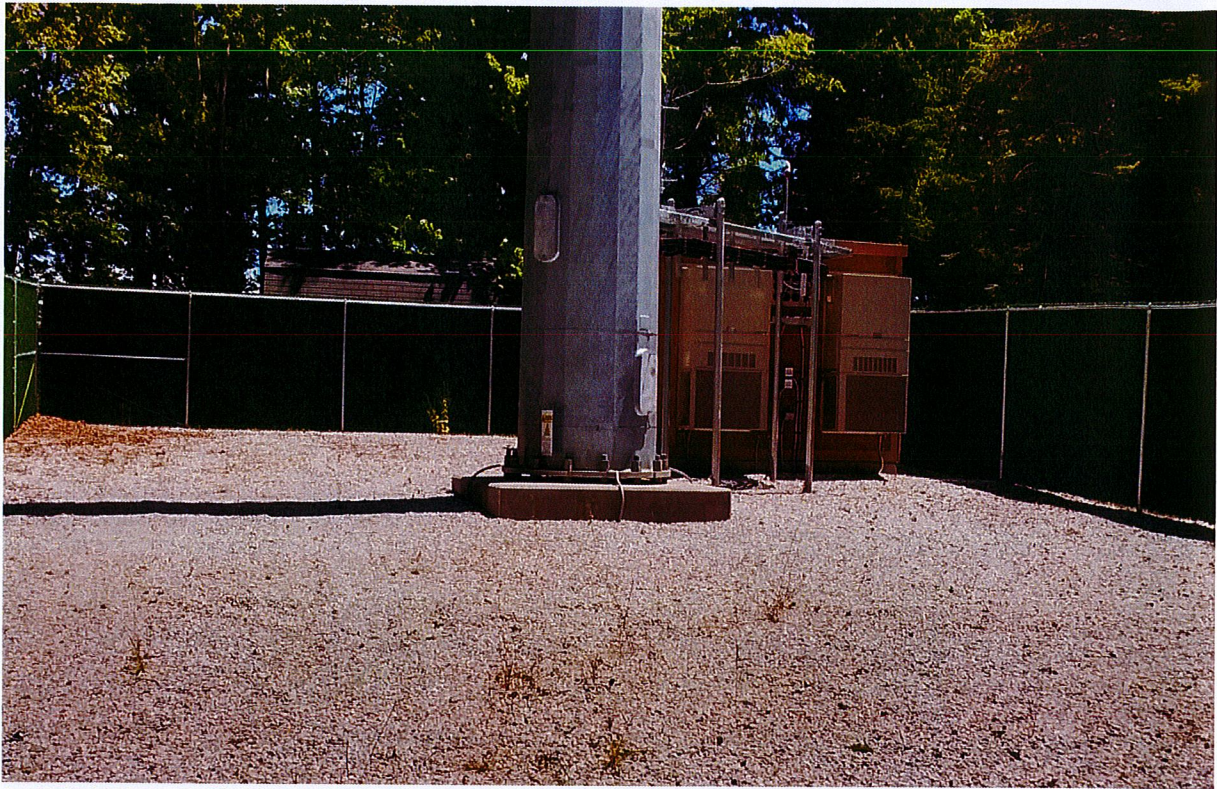
Compound interior.

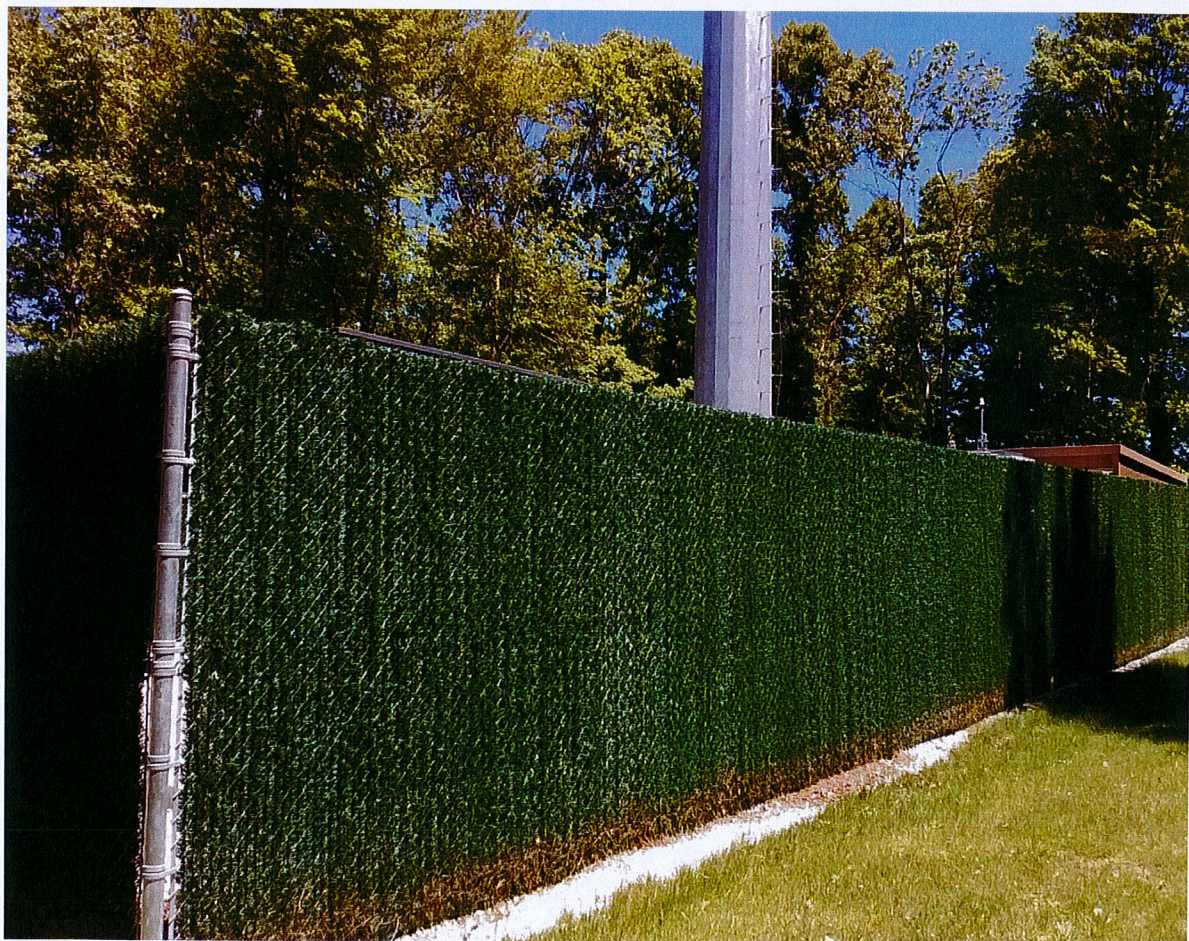
A 45-foot by 90-foot equipment compound was constructed at the site and enclosed by an eight-foot high chain link fence covered with a faux evergreen hedge treatment to shield views of the compound interior. Landscaping was installed along the southwest side of the compound.

Fence treatment.

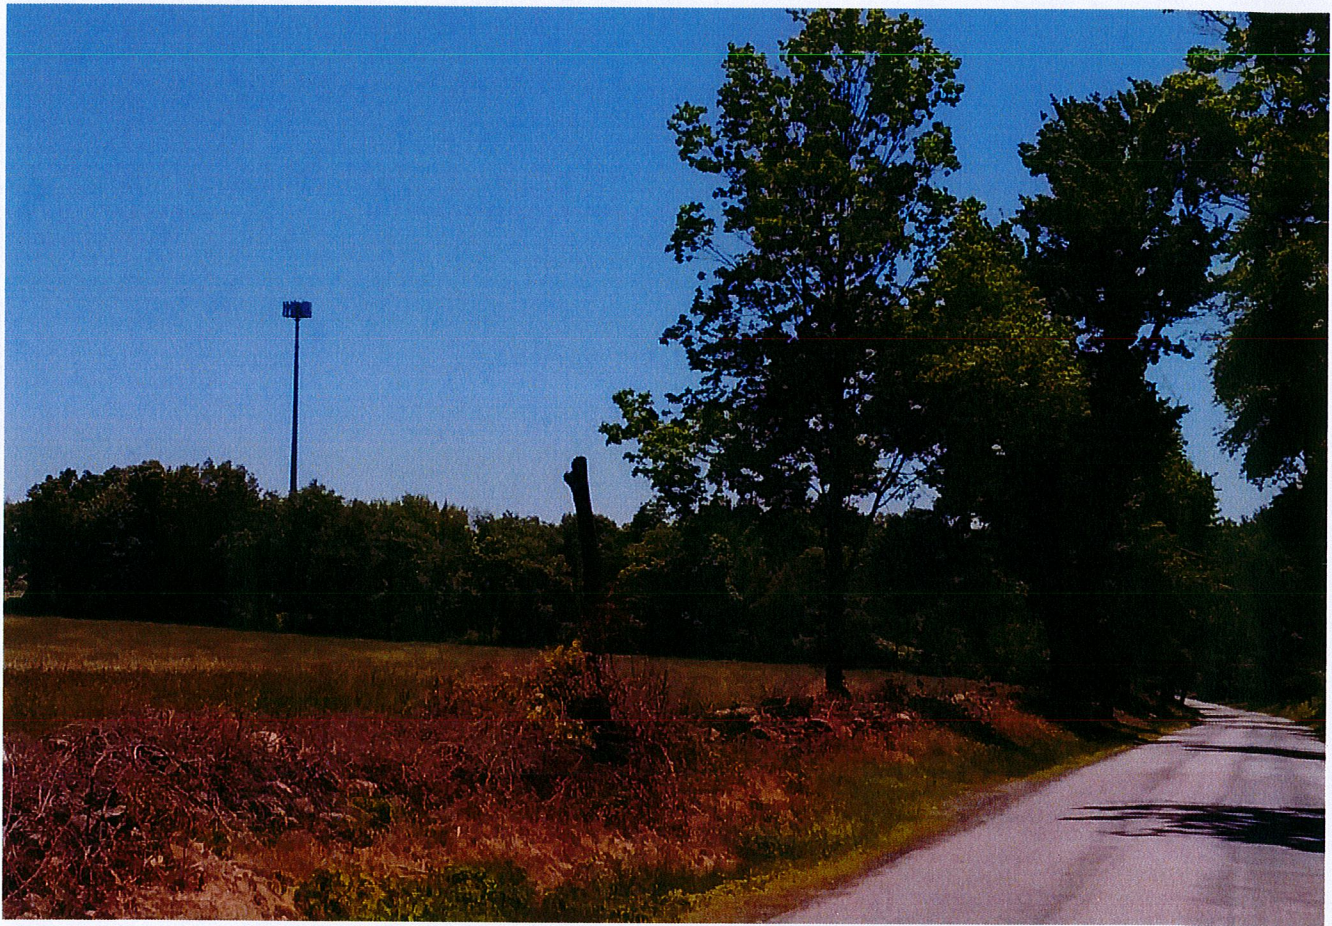
Views of the facility are minimal due to the relatively undeveloped nature of the surrounding area. Most views of the facility would be from open field areas north and south of the site. One farmhouse on abutting property to the south most likely has views of the facility across an open field area. The tower is also visible across a field north of the site, along Second Hill Road. No other sustained views from public roads in the immediate area were observed.

View of tower across field north of site, along Second Hill Road.

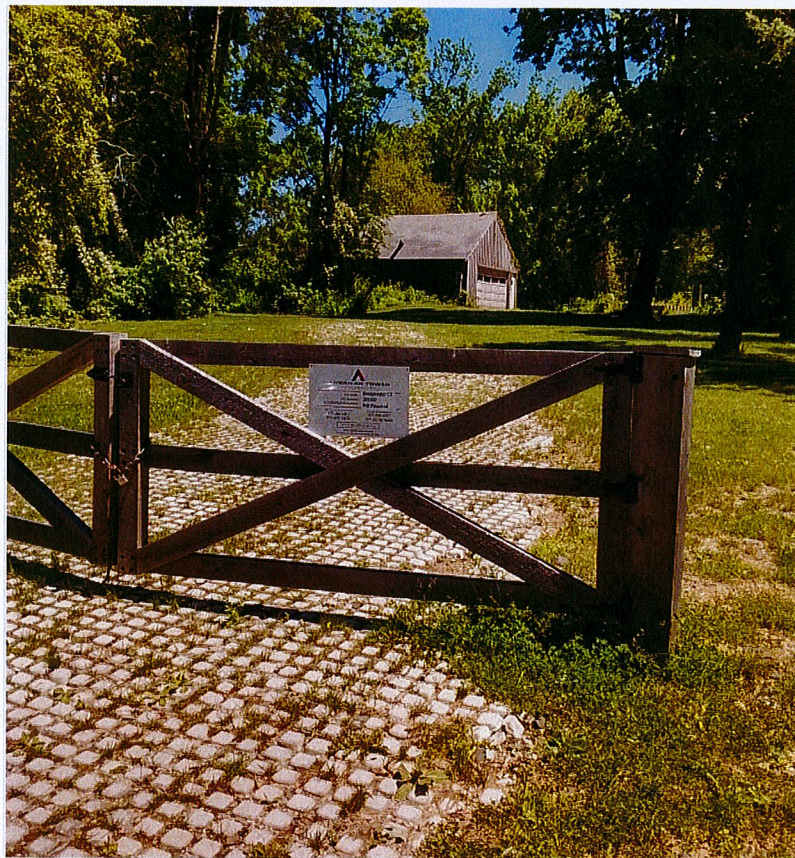
A new 350-foot long access drive, constructed of grass pavers, extends to the site from Second Hill Road. A rip rap lined drainage swale was constructed to direct flows from the south side of the access road to the north side. A wood entrance gate was installed along the road and a wood guard rail was installed above the drainage swale crossing.

Access road wood gate and grass pavers.
