# STRUCTURE NO. 04601

NORTH BEAR HILL RD  
over  
NATCHAUG RIVER  
CHAPLIN

Indepth Inspection  
on  
7/8/2009

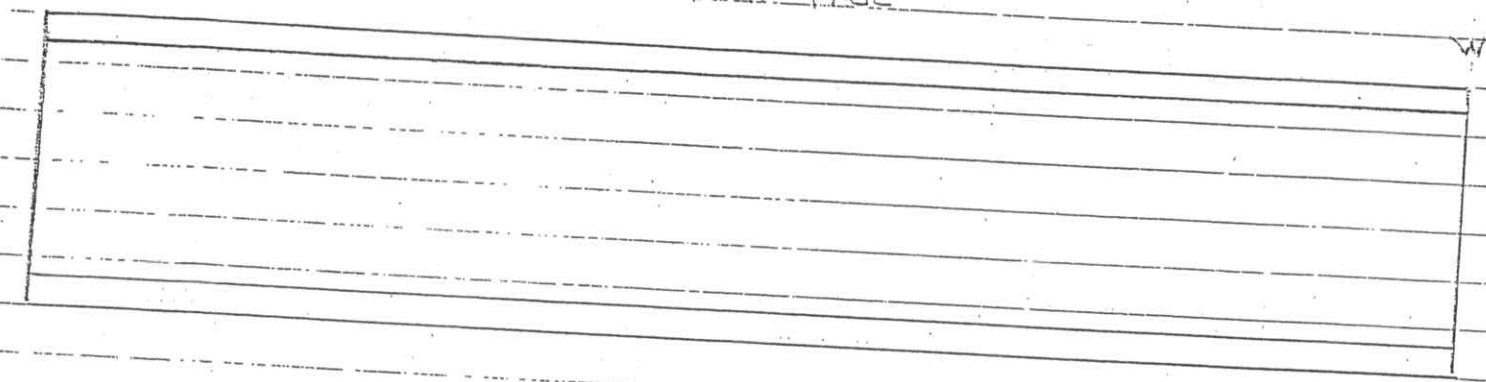
Stringer # 7 SPAN # 2

MEASUREMENTS TAKEN 22" FROM BEAM END

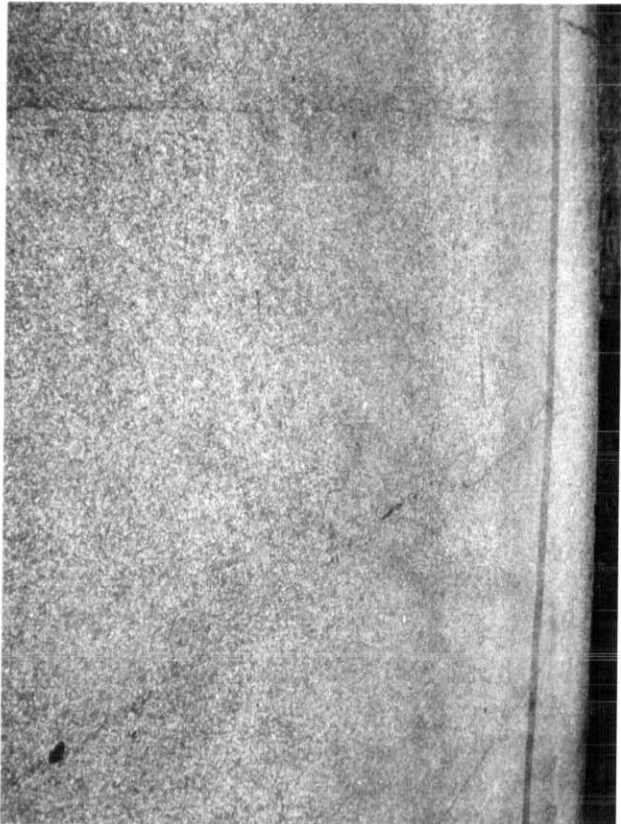
<p>Photo # 8: WEARING SURFACE OF SPAN # 2.</p>
