CONNECTICUT
DEPARTMENT
OF
TRANSPORTATION

CONDITION INSPECTION
FOR THE
FAIRFIELD STATION

**CONN. DEPT OF TRANSPORTATION
STATION INSPECTION**

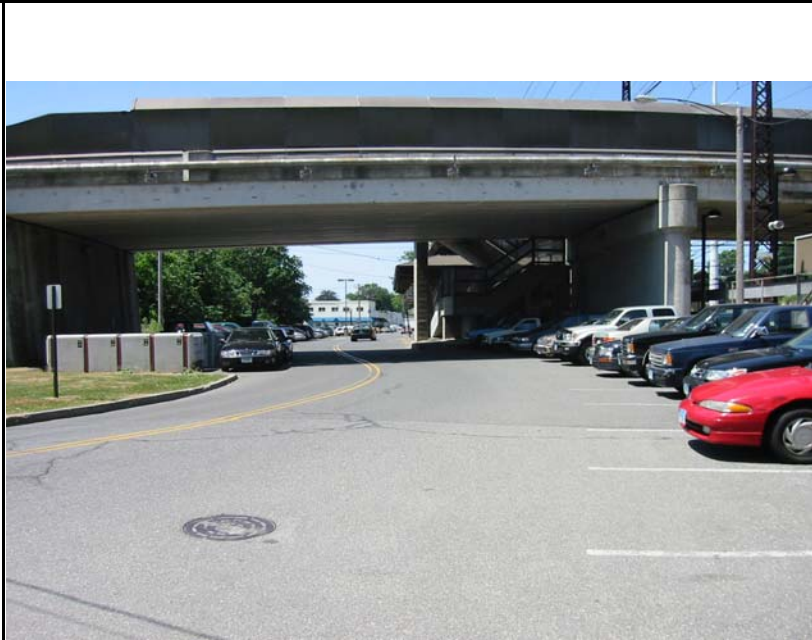
Description: General view of Quad I

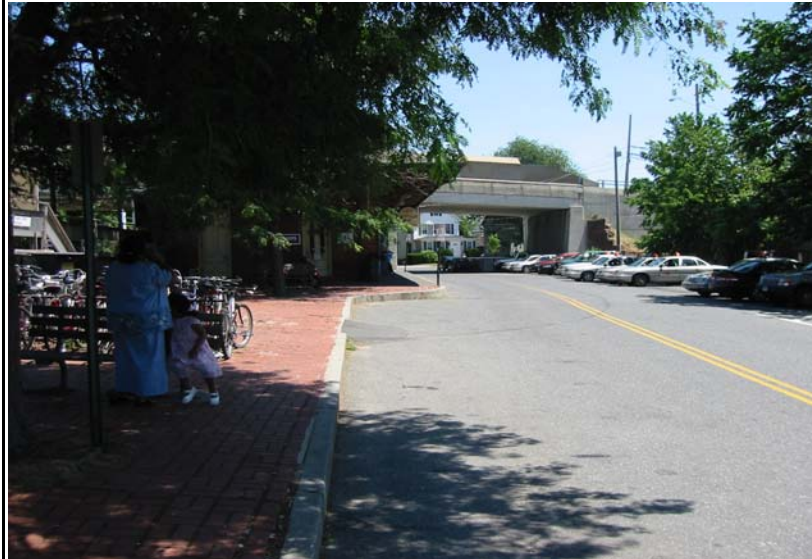
PHOTO NO. 2

Location: South end of Quad I

Description: General view of Quad I

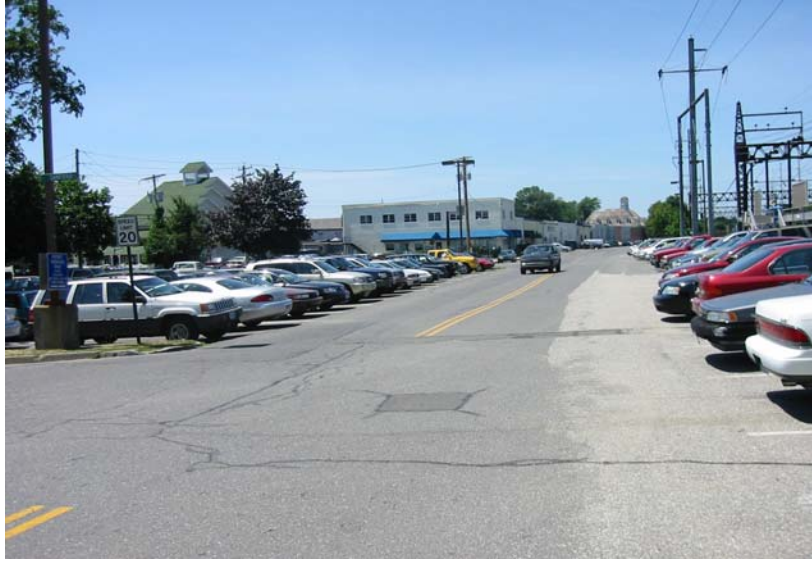
Description: General view of Quad II

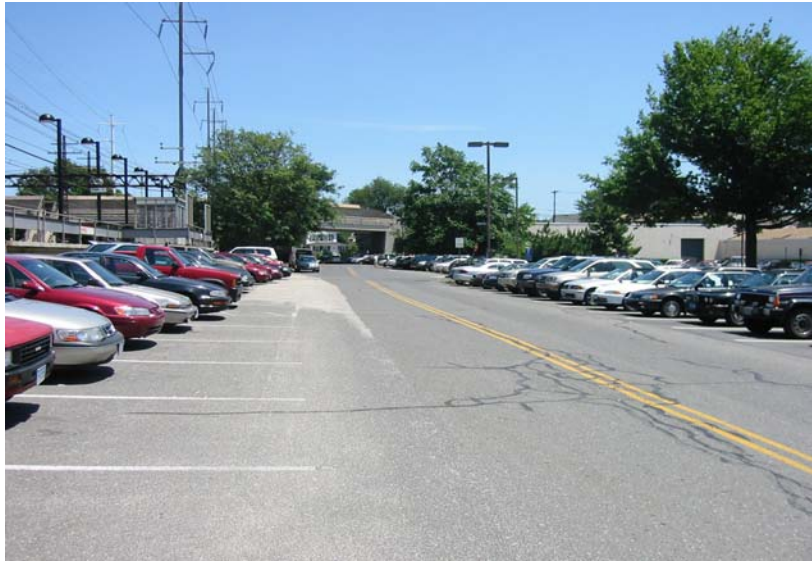
PHOTO NO. 4

Location: South end of Quad II

Description: General view of Quad II

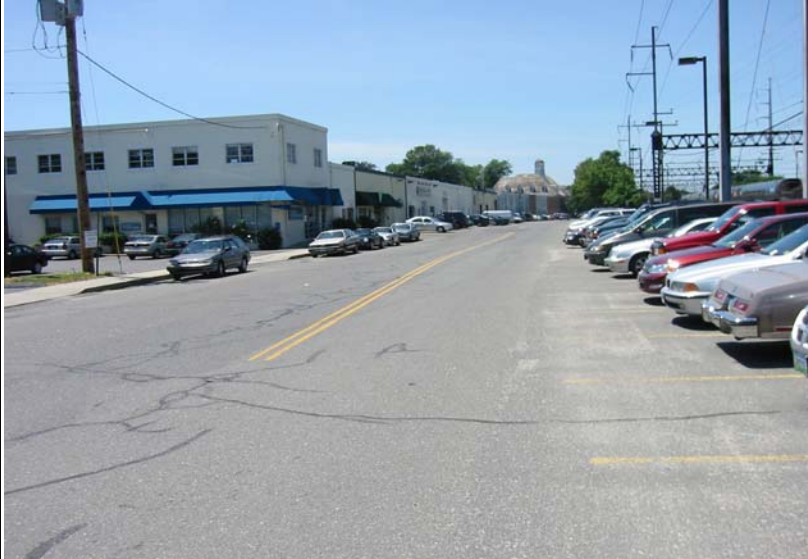
Description: General view of Quad III

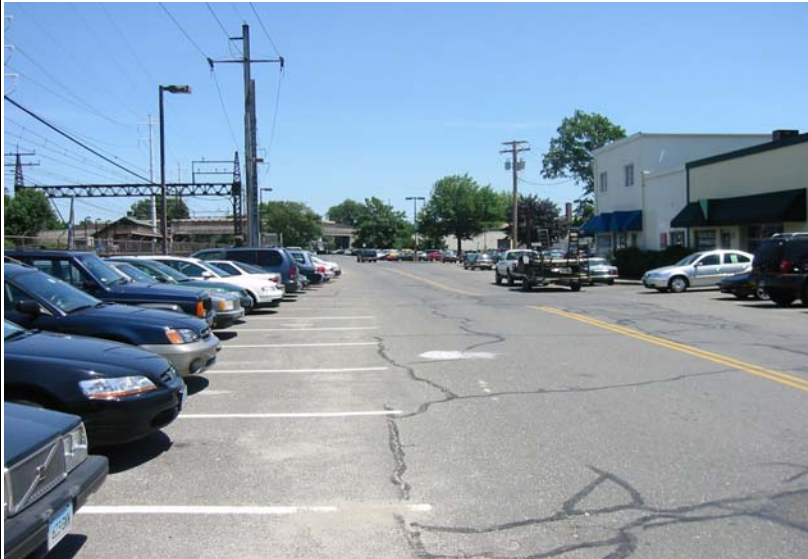
PHOTO NO. 6

Location: South end of Quad III

Description: General view of Quad III

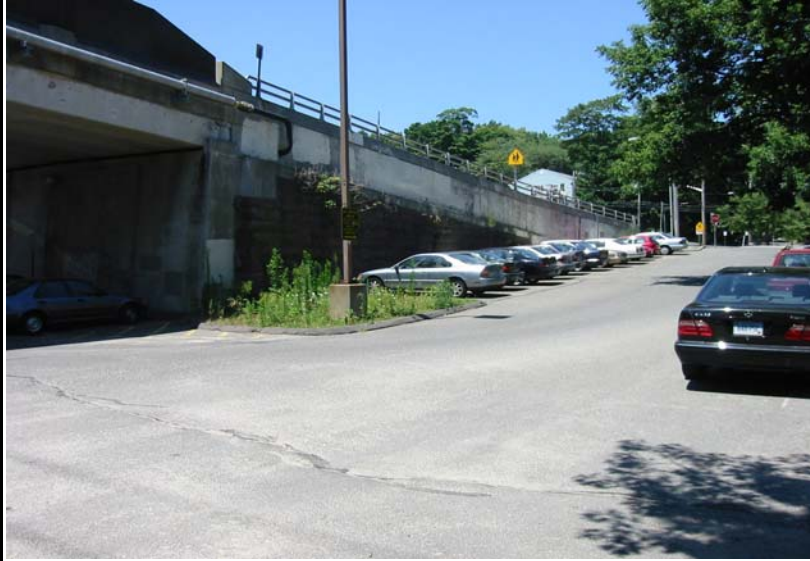
Description: General view of Quad IV

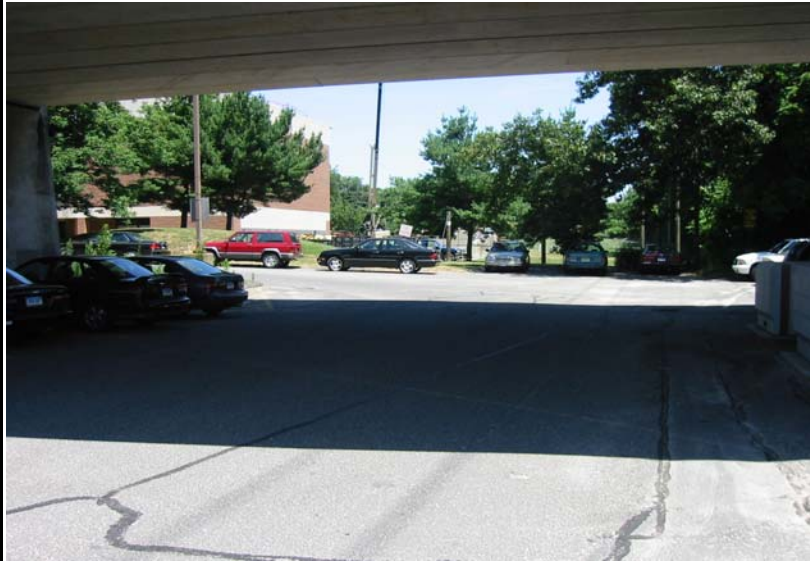
PHOTO NO. 8

Location: South end of Quad IV

Description: General view of Quad IV

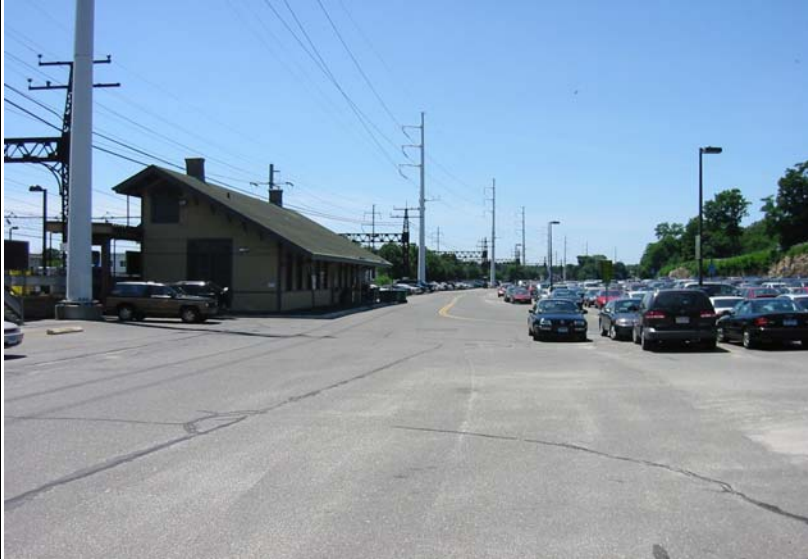
Description: General view of Quad V

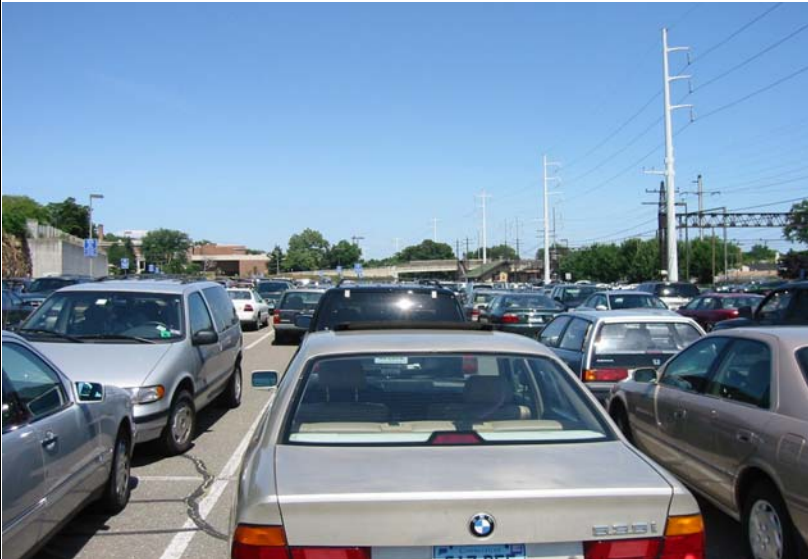
PHOTO NO. 10

Location: South end of Quad V

Description: General view of Quad V

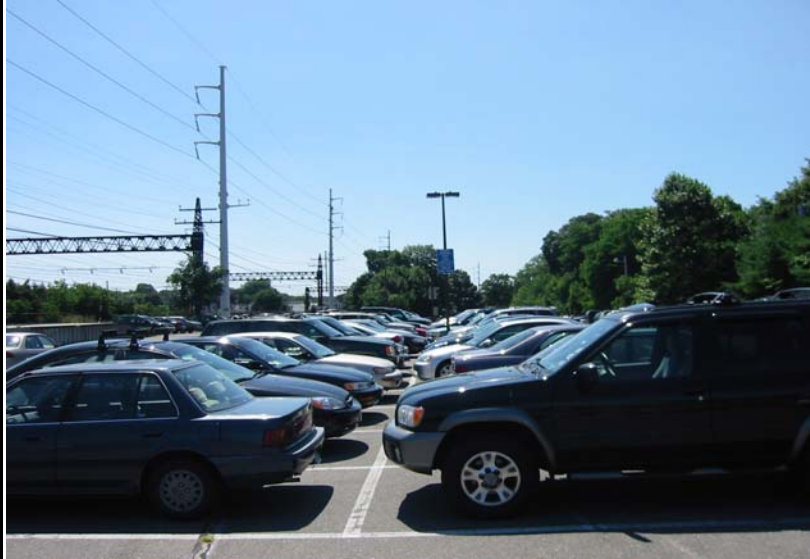
Description: General view of Quad VI

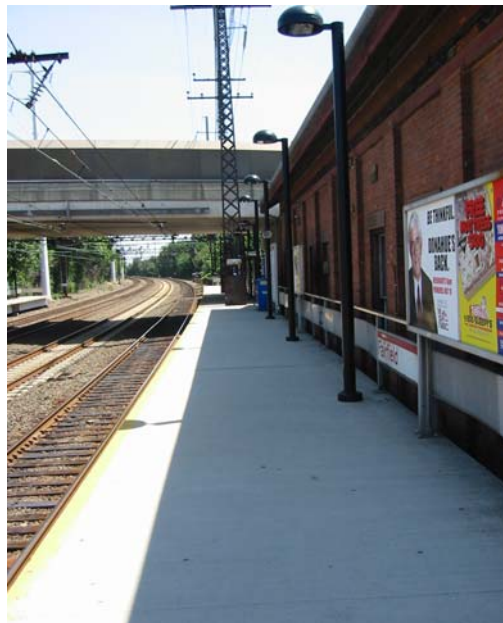
PHOTO NO. 12

Location: Middle of Span VII (NH)

Description: General view of the New Haven platform

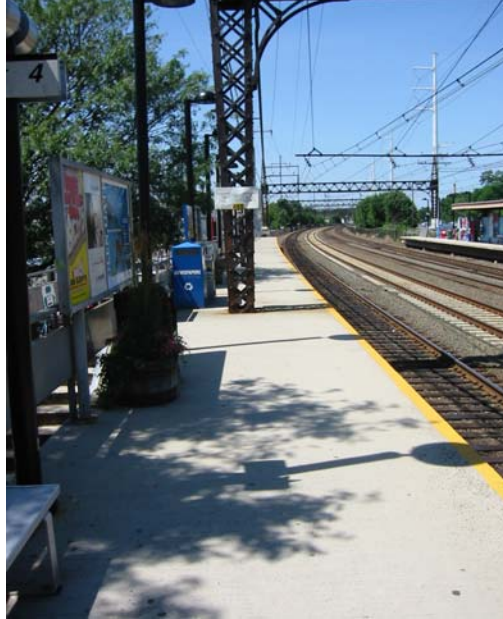
Description: General view of the
New Haven platform

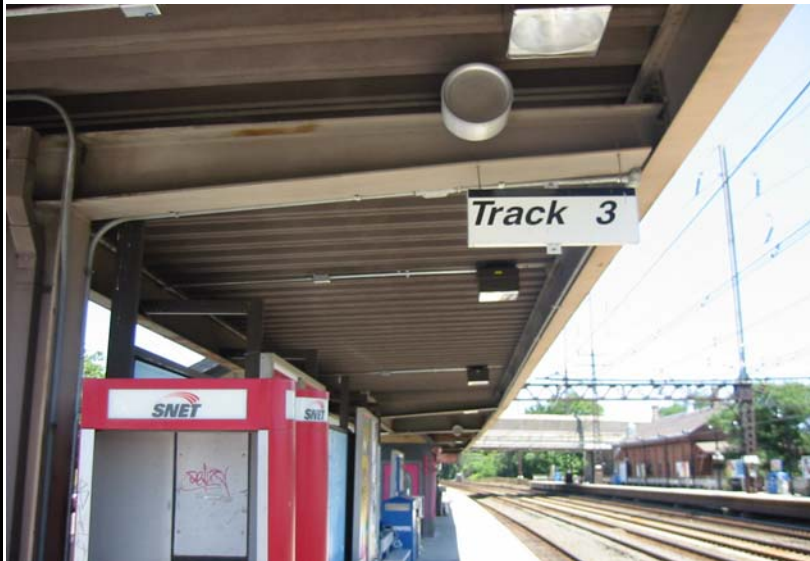
PHOTO NO. 14

Location: Span II (NY)

Description: General view of the
canopy

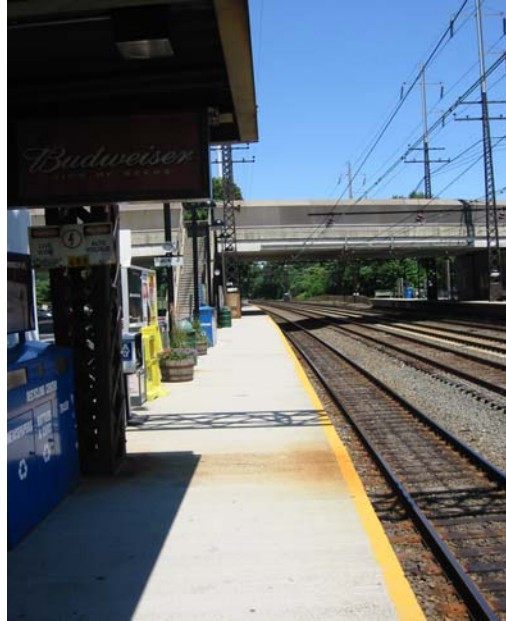
Description: General view of the New York platform

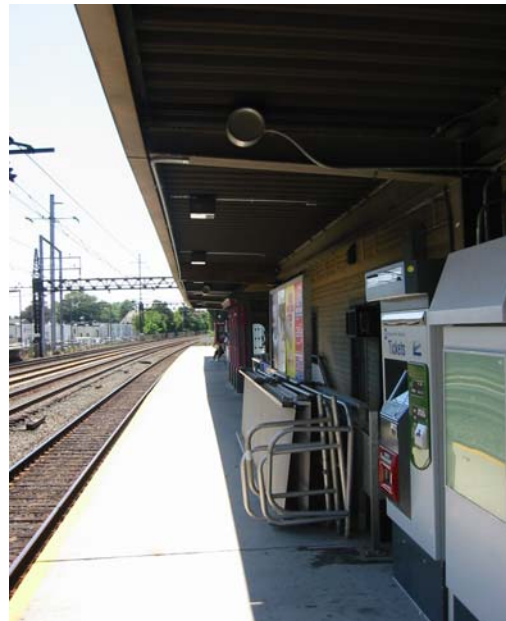
PHOTO NO. 16

Location: Middle of Span VI (NY)

Description: General view of the New York platform

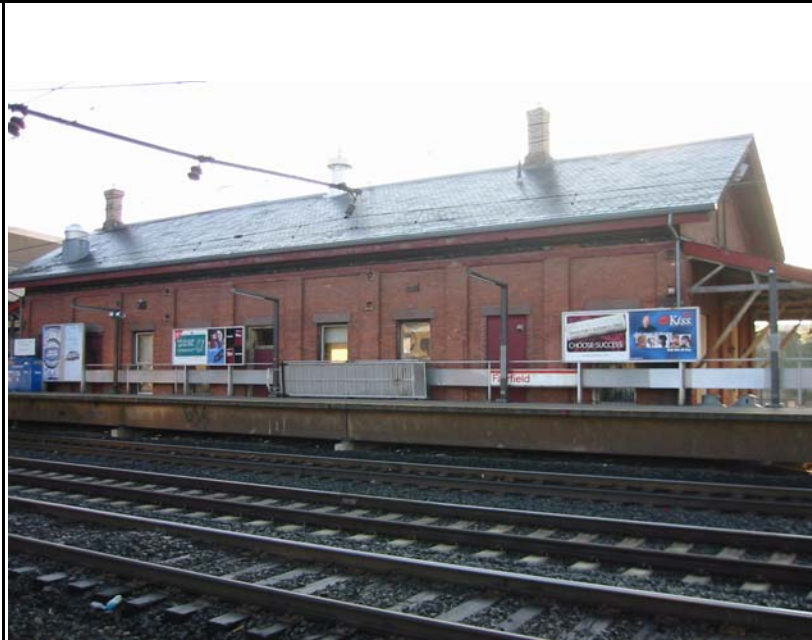
Description: General view of the New Haven bound station house

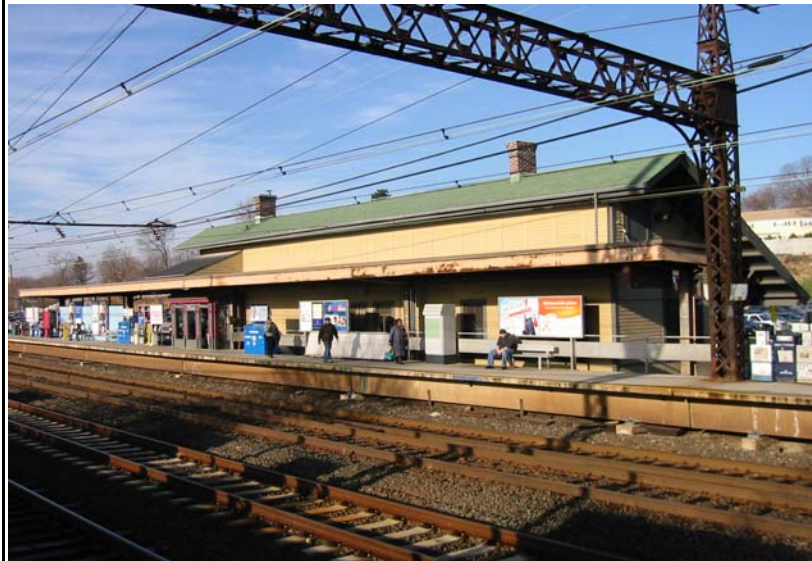
PHOTO NO. 18

Location: New Haven bound platform

Description: General view of the New York bound station house

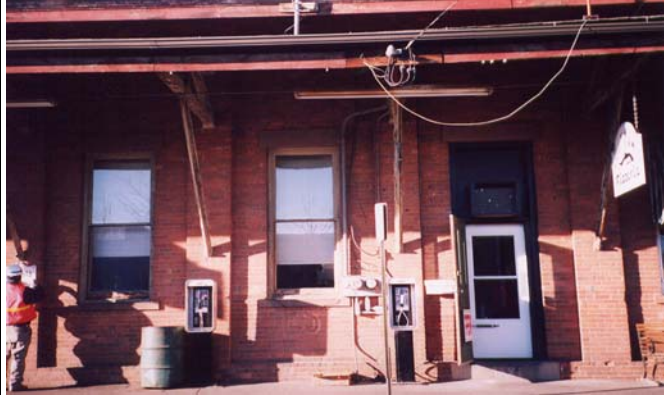
PHOTO NO. 55

Location:
parking lot
attached to the
building
Description:
electrical service
drop

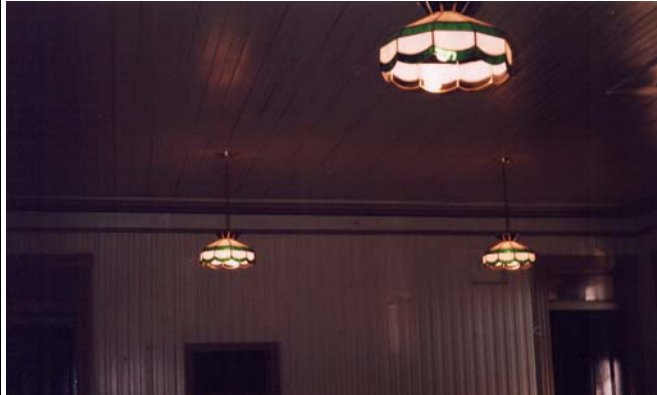
PHOTO NO. 56

Remarks: A typical section of the waiting room was measured and found to average 3.28 foot-candles.
 There are no emergency or exit luminaires located in the building.

Remarks: A typical section of the waiting room was measured and found to average 16.7 foot-candles.
 The only emergency or exit lighting is located in the men's room.

The southbound station building waiting room lighting maintains an average of 3.28 foot-candles. The northbound station building maintains an average of 16.7 foot-candles. We recommend that additional luminaires be installed in the southbound waiting room to elevate the light levels to at least IESNA recommended levels.

Location:
waiting room
Description:
waiting room
lighting

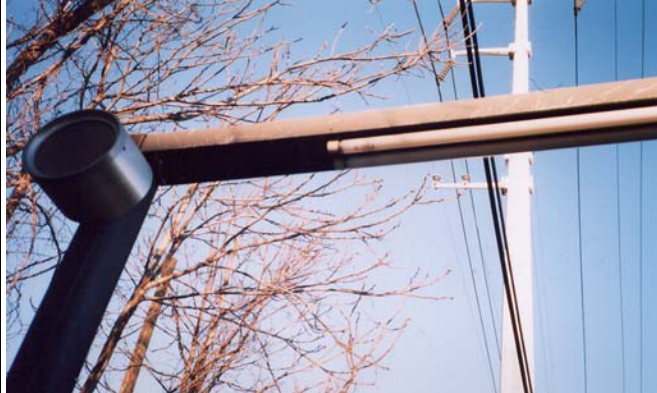
The northbound platform exceeds the minimum maintained light level per IESNA recommended practice while the southbound platform is slightly below the recommended 5 foot-candles. Luminaires and poles on both platforms have serious deterioration and should be replaced.

Description:
platform lighting

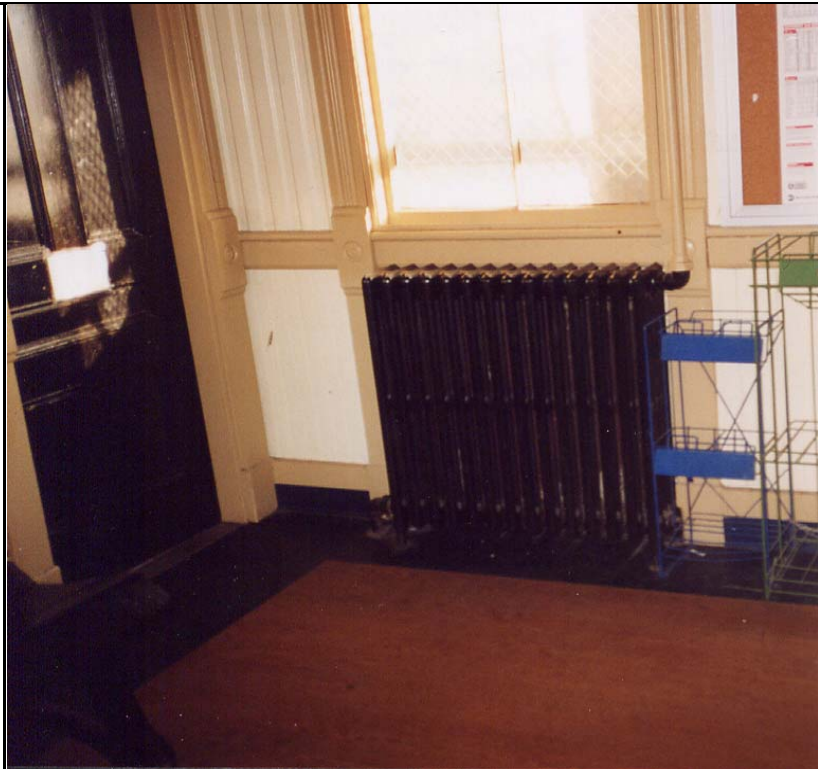
RADIATOR: Cast iron radiators (hot water), Good Condition

Description:
Ticket Waiting Area
Hot Water Radiator

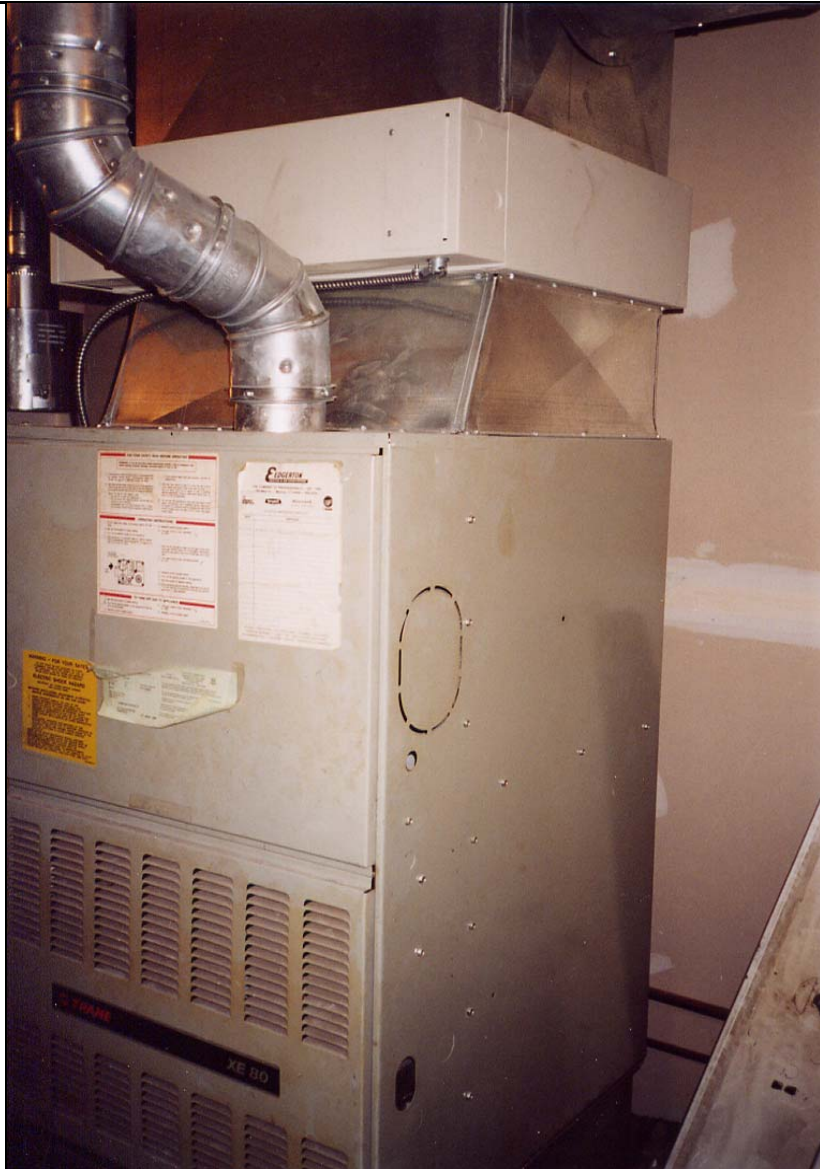
Description:
Trane Heating Unit
with Filter Air Cleaner

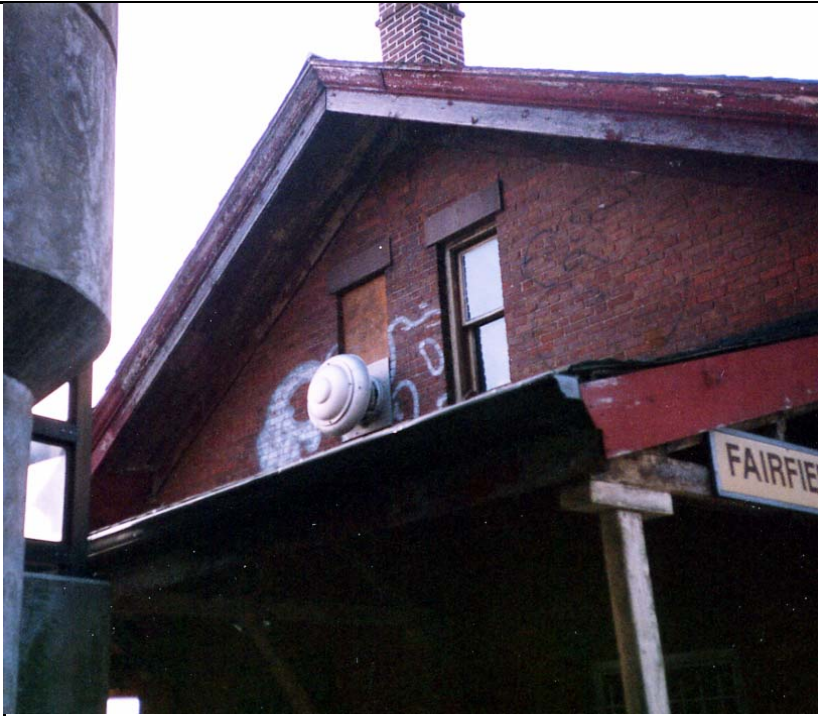
2 kitchen exhaust fans, 1 on the roof, 1 on the wall, both in good condition

Description:
Pizza Place
kitchen wall
exhaust fan

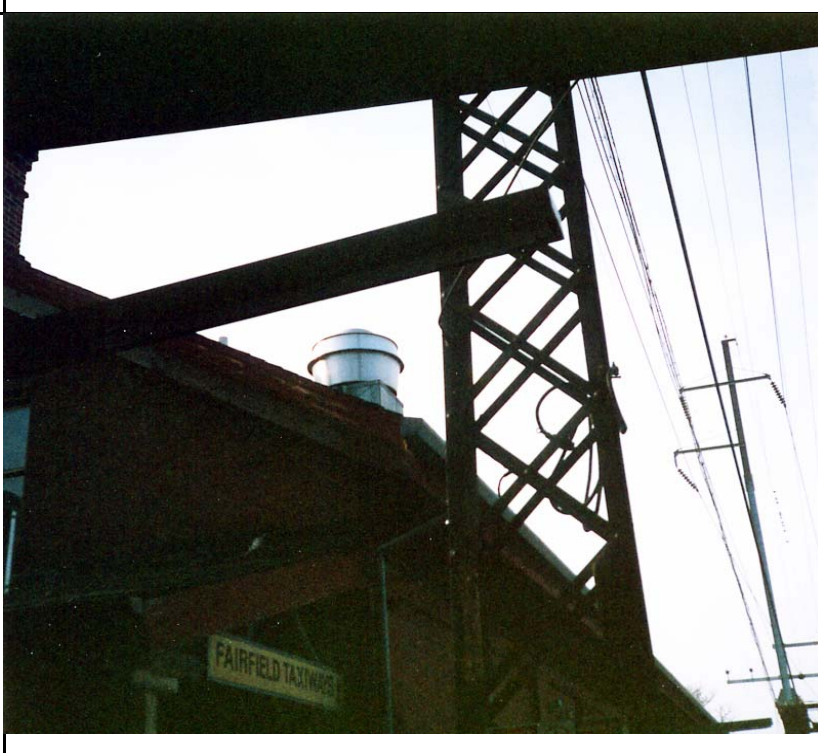
PHOTO NO. 64

Location:
CAB DISPATCHER
AND PIZZA PLACE

Description:
Pizza Place
kitchen roof
exhaust fan

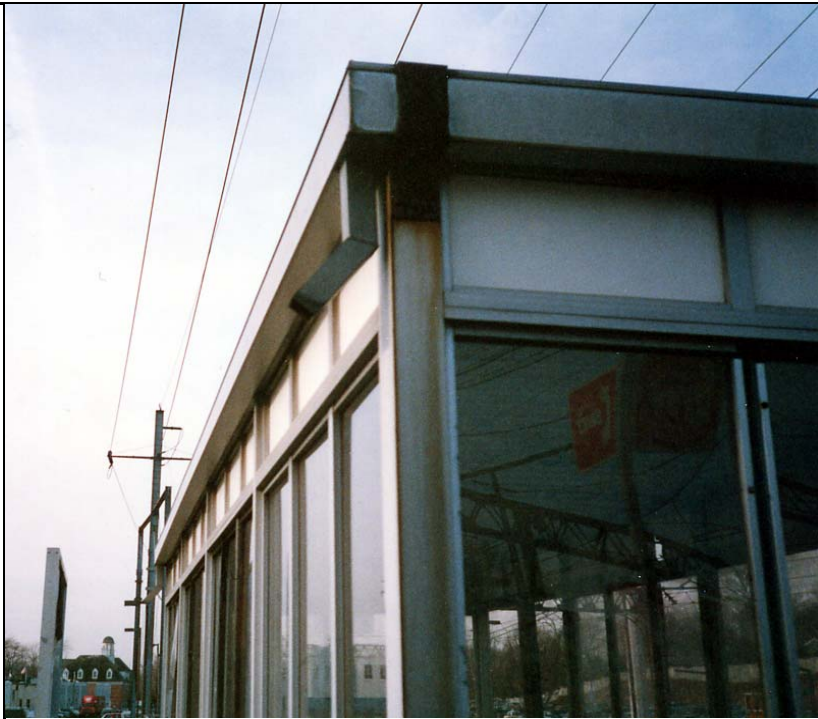
Description:
Platform shelter
with aluminum
gutters and
short downspouts

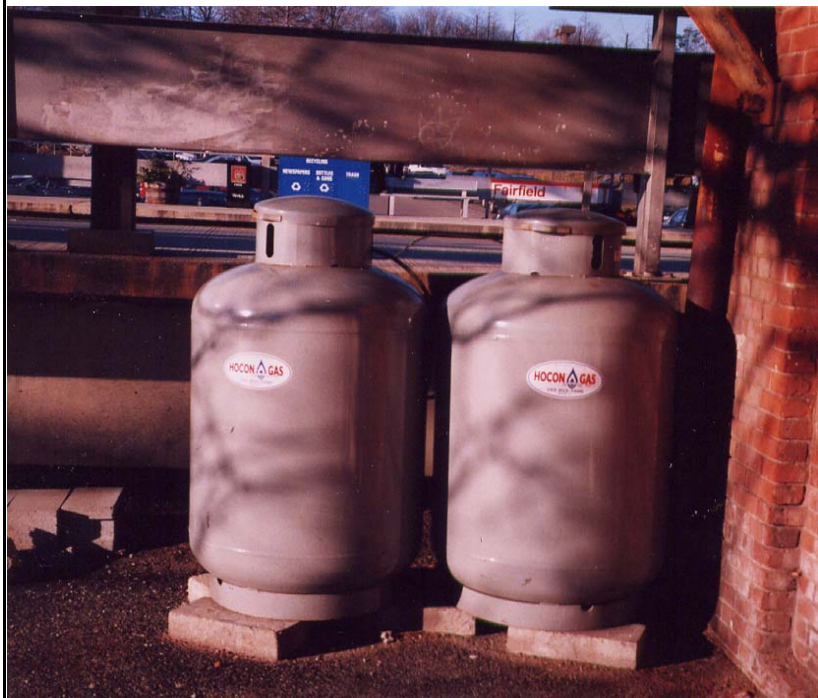
PHOTO NO. 66

Location:
FAIRFIELD STATION
CAB DISPATCHER

Description:
Gas (fuel) Propane
cylinders adjacent
to the building
